REDUCING VULNERABILITY OF BUILDINGS TO FLOOD DAMAGE

Guidance On Building In Flood Prone Areas

Prepared for the Hawkesbury-Nepean Floodplain Management Steering Committee

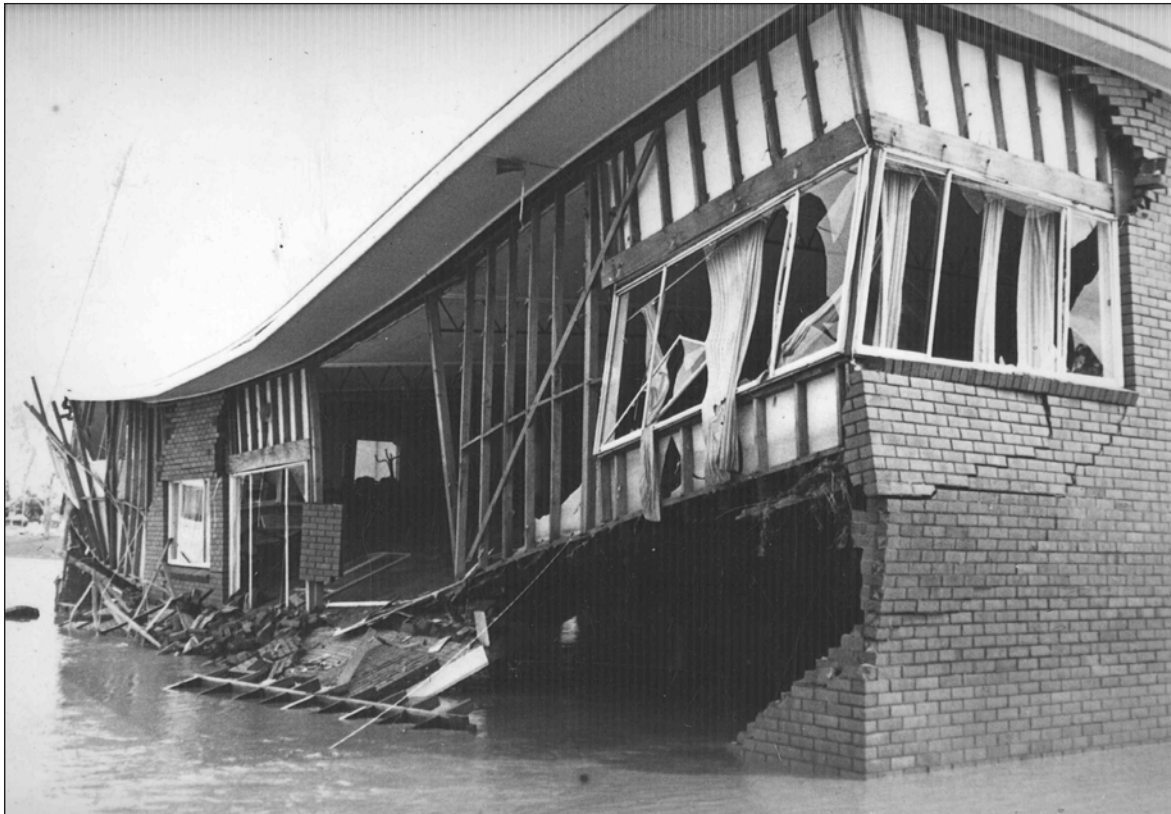
Figure 2 Severe structural damage to buildings of traditional design and construction

In severe conditions of depth and velocity an individual house can be totally destroyed. However, even in still water the house structure can easily suffer damage in excess of \$20,000. This figure does not include costs for replacing any contents, (Figure 2).

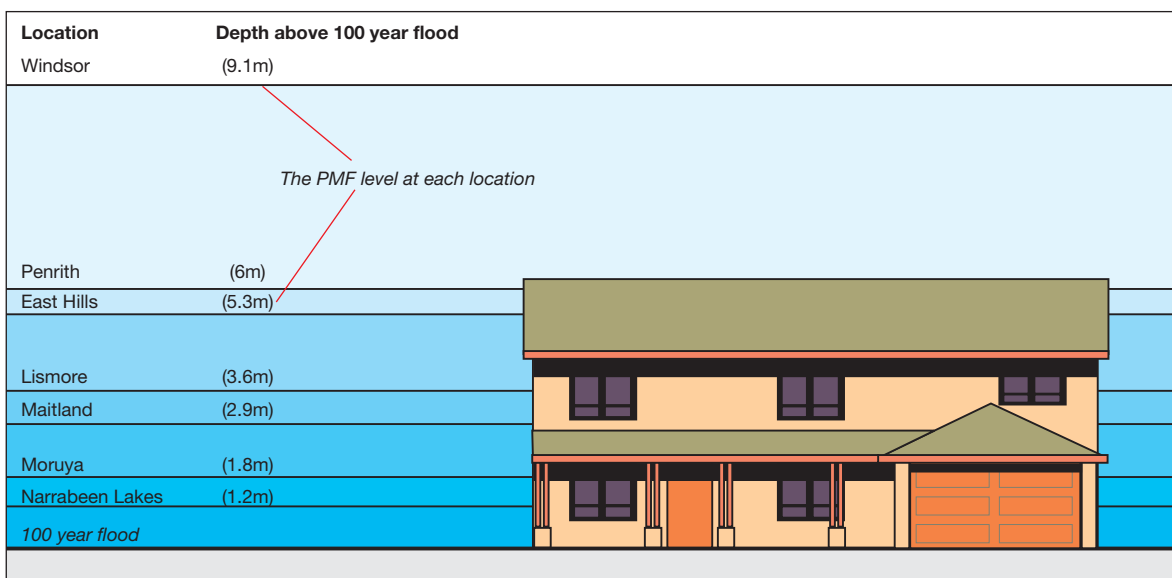
Figure 3 Comparison of flooding potential in New South Wales

level. Accordingly, some houses with floors constructed above the planning level can still be fully submerged by floodwaters in larger floods. Even the Hawkesbury-Nepean flood of record in 1867, which is less than a 0.5% probability event (or 1 in 200 AEP), would result in two metre deep flooding over the floor of houses with floor levels at the current 1 in 100 AEP flood level. Although the chance of floods higher than the planning level may be small, the impacts on a house and its contents may be quite severe and therefore the damage risks remain relatively high. (Figure 3).

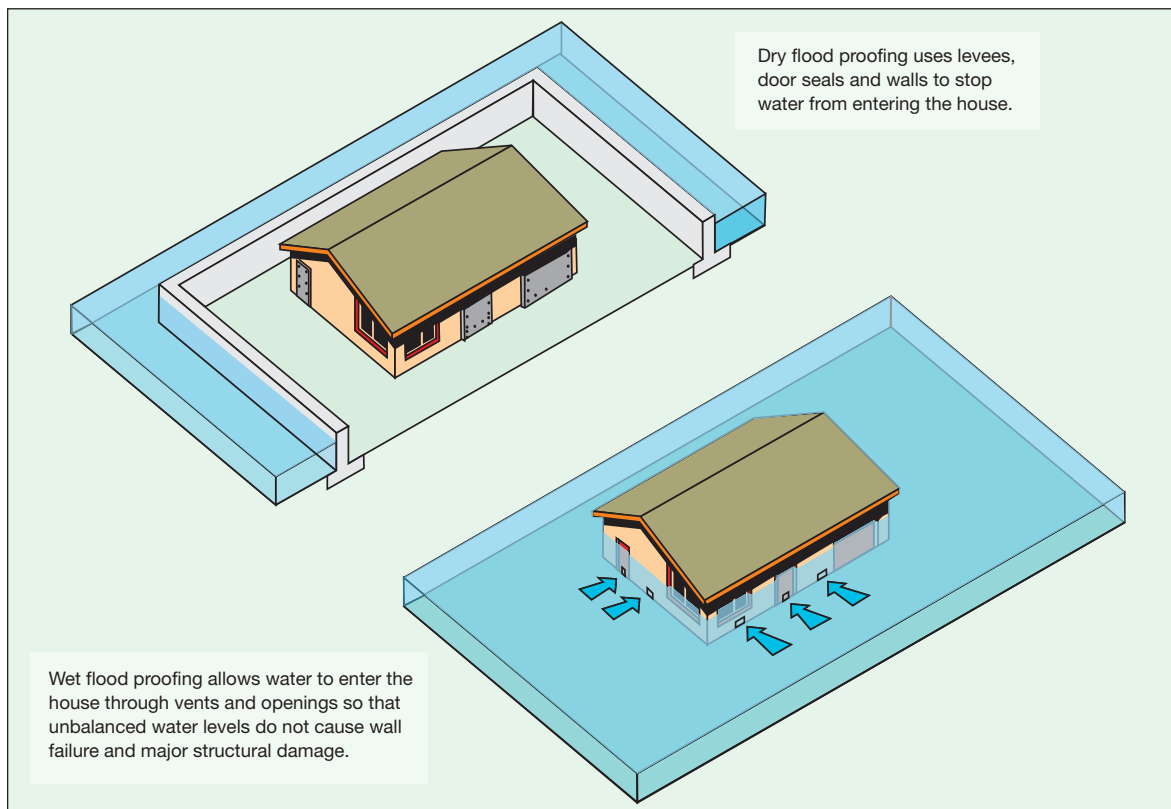
Figure 4 Wet and dry flood proofing

The approach in these guidelines is to “wet flood proof” a house because depths of inundation are potentially high. On floodplains like the Hawkesbury-Nepean River, it is better to allow water to enter the house to avoid water loads,

which can cause structural damage or collapse the walls. Flooded buildings that need only cleaning and superficial repairs can be reused quickly. In contrast, houses with major wall damage are difficult to assess structurally, and are likely to require lengthy and expensive reconstruction.

An alternative approach is to “dry flood proof” a house. This works on the principle that actions are taken to prevent water from entering a house such as constructing permanent or temporary barriers such as levees, sandbags or door seals. While there are arguments for and against each approach, dry flood proofing measures are normally expensive, cumbersome, require maintenance and, in many cases, need the occupant to be present to seal openings prior to flooding. (Figure 4).

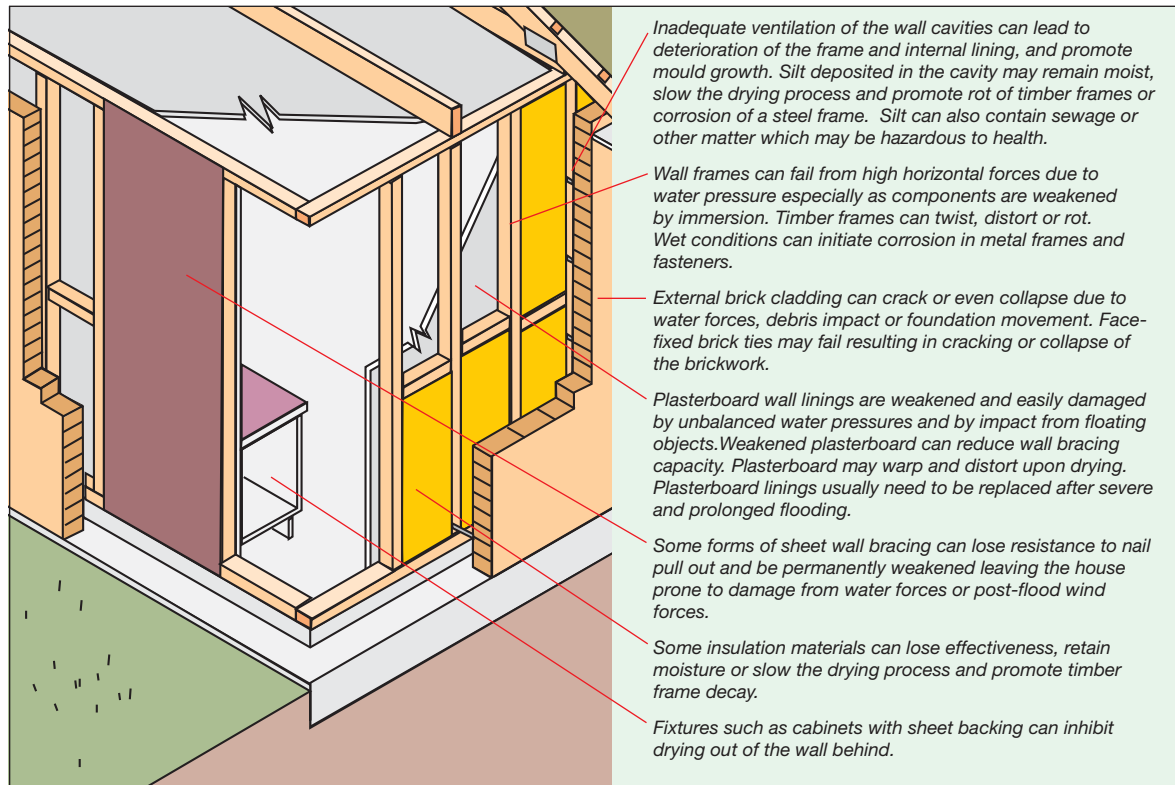
Figure 5 Problem areas in most common form of external wall construction – brick veneer

The illustrations in Figures 5, 6 and 7 indicate some of the more significant and common problems with various forms of house construction affected by floods. Full information is provided in the relevant sections of these guidelines.

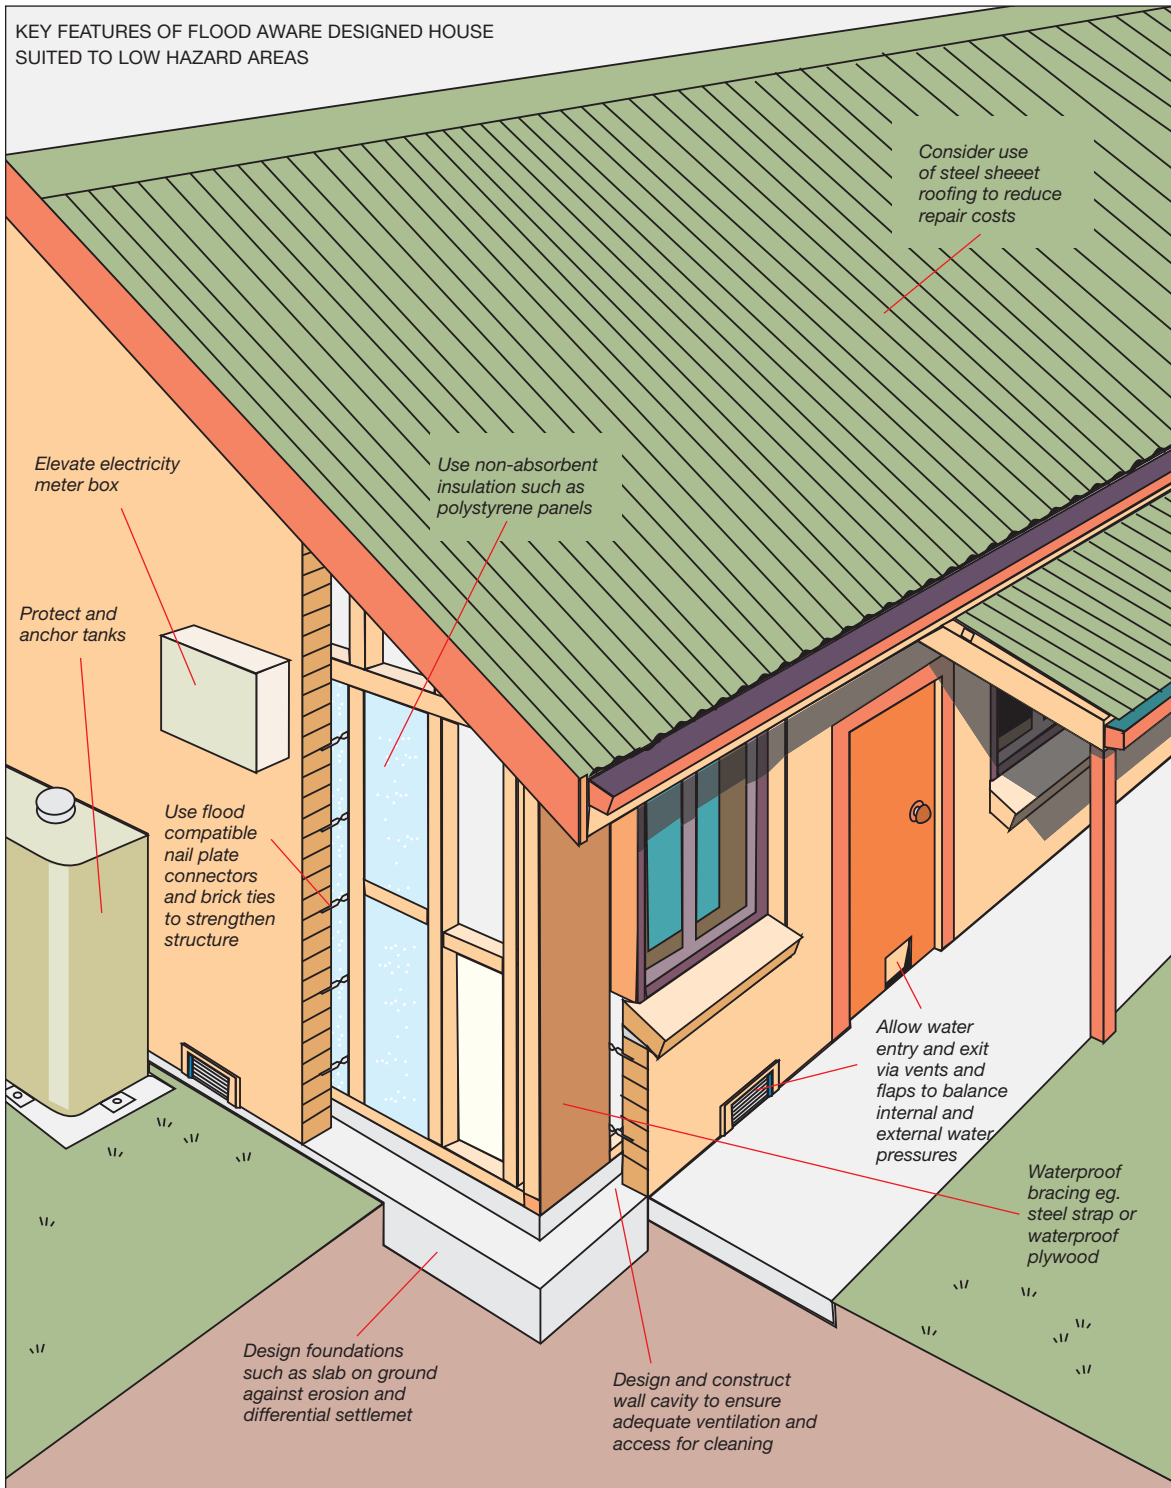
Figure 8 Single-storey flood aware design for low hazard areas

The illustrations in Figures 8 and 9 depict the key suggestions from these Building Guidelines to achieve flood-aware housing which:

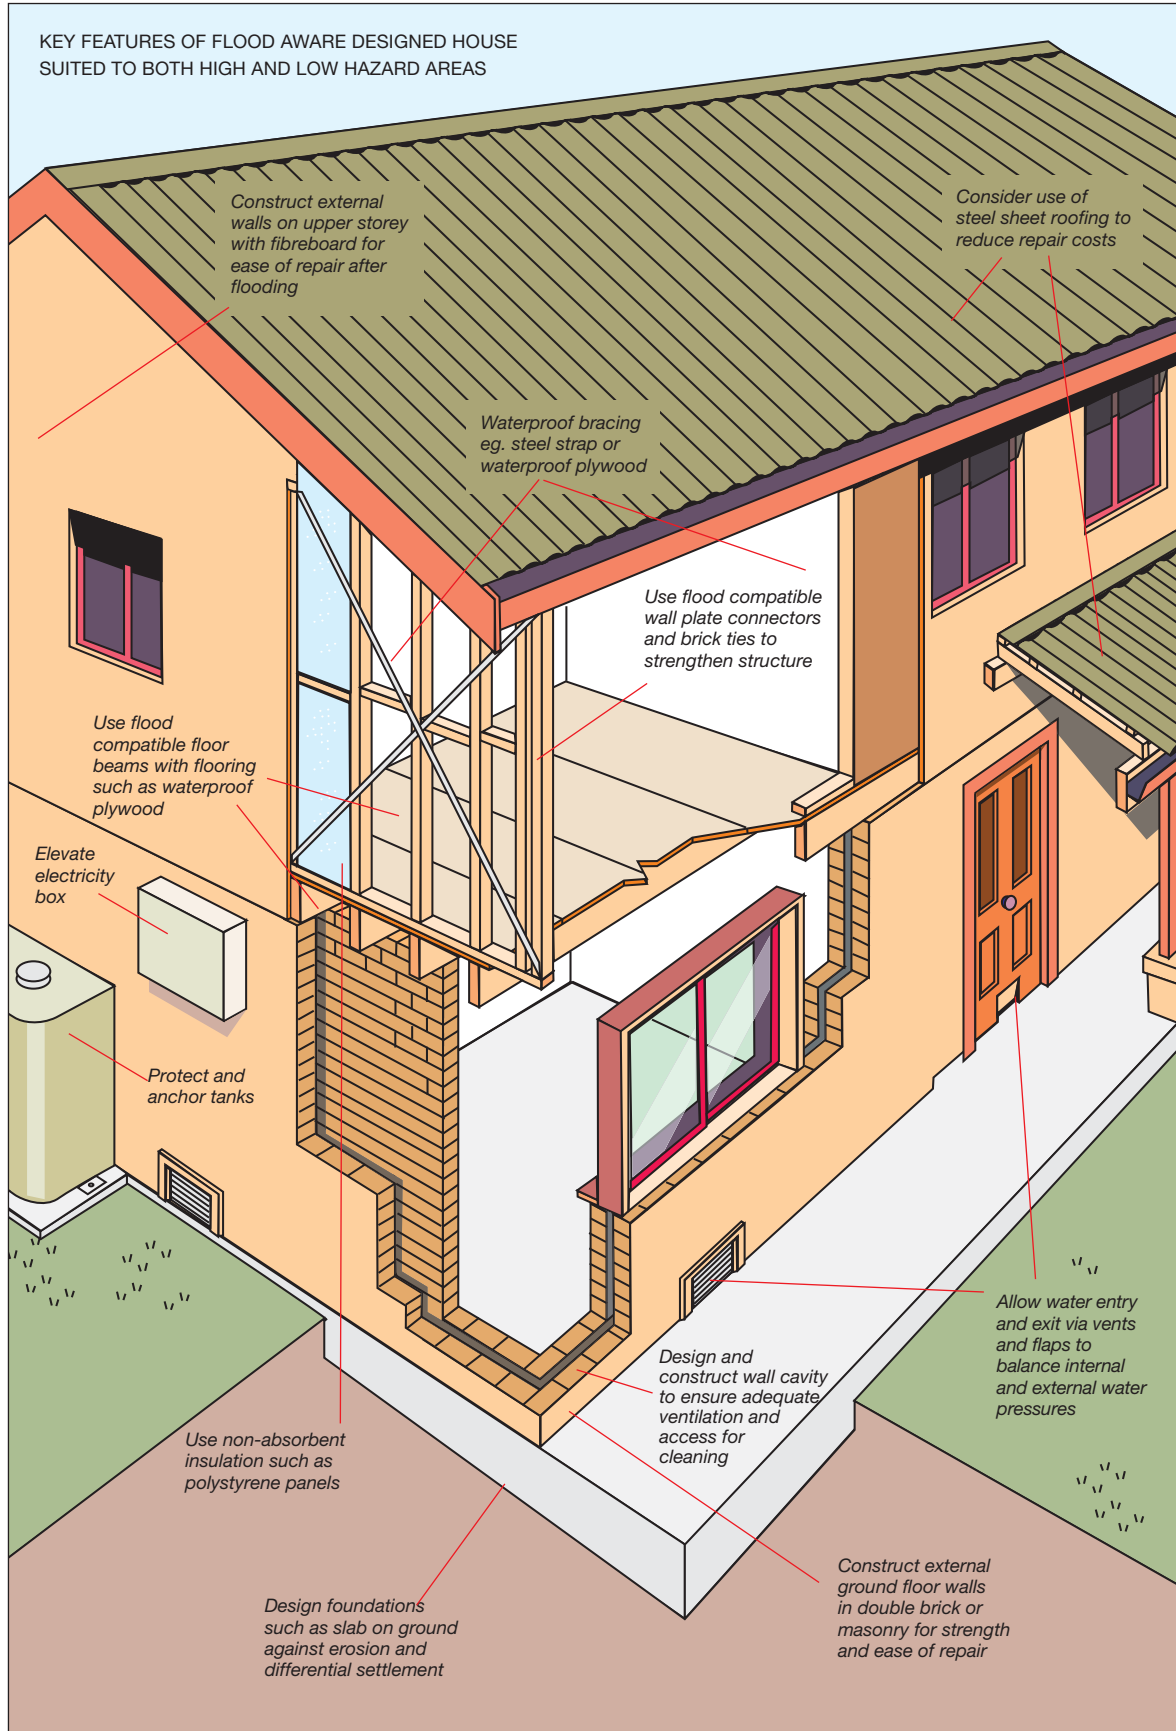
Figure 9 Two-storey flood aware design for high hazard areas

The long-term benefits of designing and building a flood-aware two-storey house, which can provide a family greater assurance against loss of the building and dramatically reduce their personal liabilities from flood damage, far outweigh the initial cost of building.

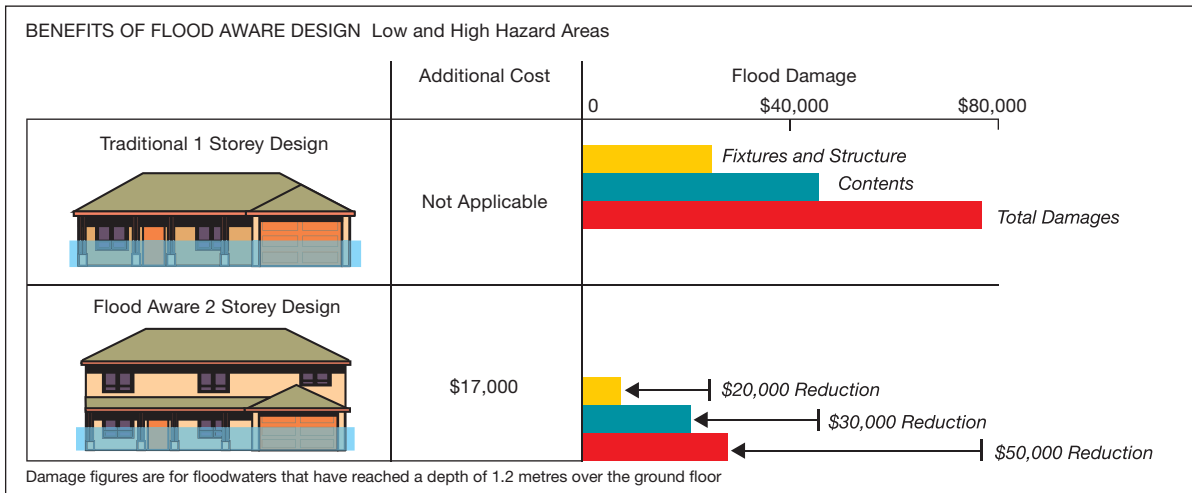
Figure 10 One-storey versus two-storey

Figures 10, 11 and 12 provide a cost comparison of one and two storey flood aware housing with standard house construction. The indicative costs provided are based on a two-storey house with a 100m² ground floor area and 80m² upper floor area and a single-storey house with a floor area of 180m².

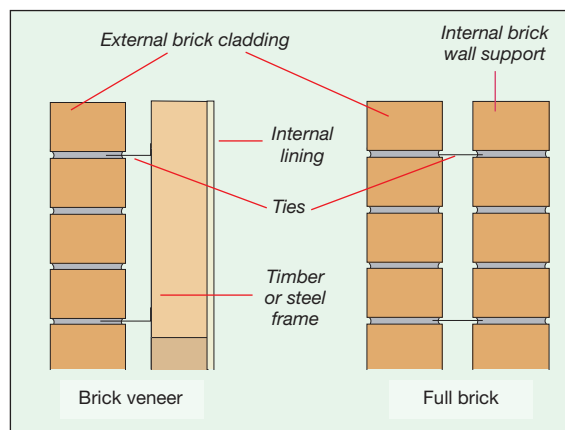
Figure 13 Structural components of brick wall

steel frame (brick veneer) or another brick wall (full brick) which supports the roof structure, (Figure 13). There are many ways in which these wall units can fail and more detail on failure mechanisms is provided in Appendix A.

- cracking of the brickwork (to varying degrees);
- bowing of the wall;
- collapse of all or part of the external brick wall (or cladding) either inward or outward;
- in brick walls, the timber frame may snap or the steel frame bend although the brick veneer may suffer significant damage long before this would happen; and
- in double brick walls, the inner brick wall may collapse upon failure of the external wall.

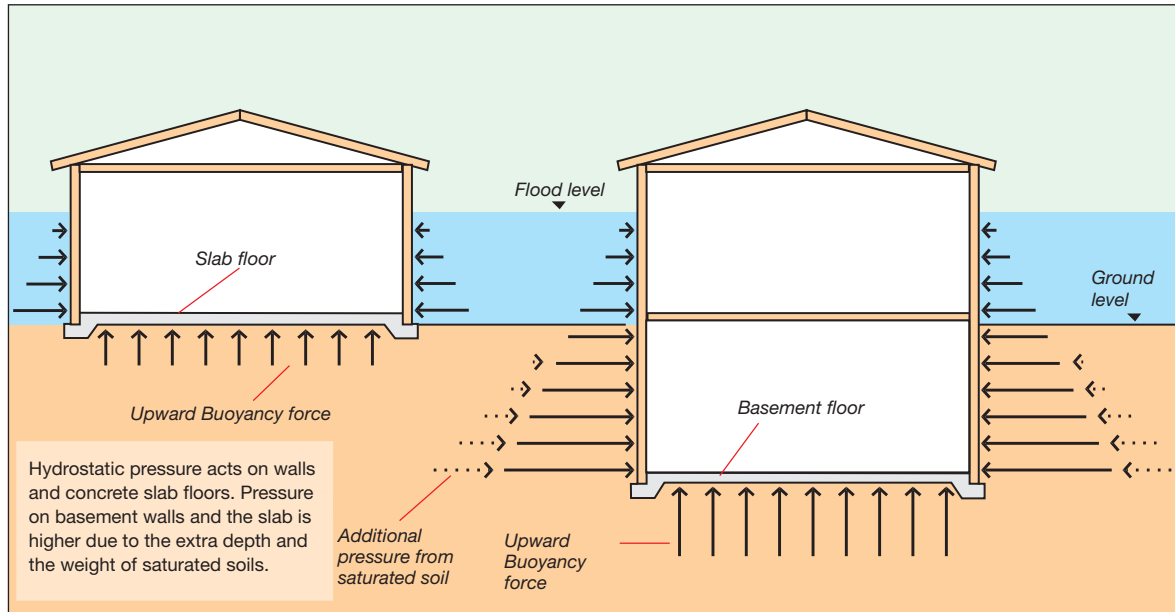
Figure 14 Hydrostatic forces

A difference of just 1 metre in water levels inside and outside a brick house could result in bowing, cracking and even collapse.

The pressure exerted by still water is called “hydrostatic pressure”, (Figure 14). A solid object can only exert a downward pressure as a result of its weight. In contrast, a fluid such as water exerts the same pressure in all directions (i.e. downwards, upwards and sideways) and these always act perpendicular to the surface on which they are applied. As hydrostatic pressure is also caused by the weight of water, it increases as the depth of water increases. The pressures exert a force or load which is a function of the product of the water pressure and the surface area upon which the pressure acts. Hydrostatic loads consist of three types: lateral loads, vertical loads and uplift loads.

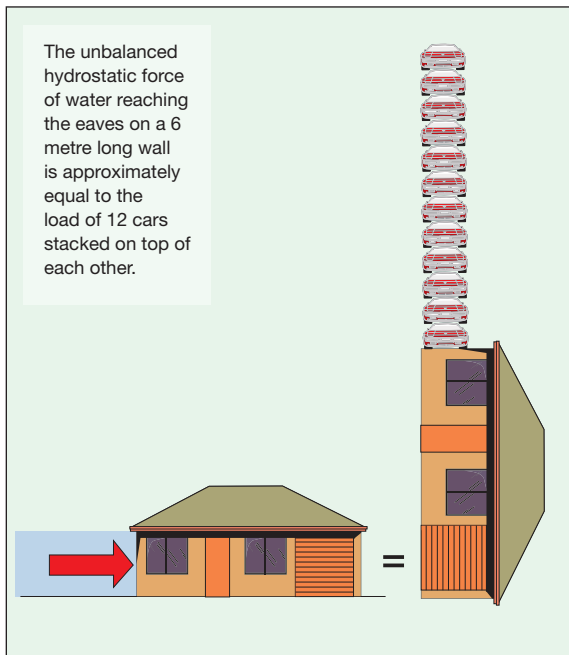
Figure 15 Unbalanced water forces on a wall can be very large

The force on a vertical wall in still water increases rapidly with depth (it is proportional to the square of the water depth). For example, when water is up to the eaves of a single-storey house, the force on the wall is similar to the weight of two cars for every metre of wall length, (Figure 15). If this force is applied to only one side of a standard brick wall (i.e. if water is excluded from entering the house to balance the forces on the wall), this force will easily destroy the wall. Tests conducted by the US Army Corps of Engineers have shown that the maximum depth of water a cavity or brick veneer wall can support without collapsing is only 0.75 to 1.0 metre, (Figure 16).

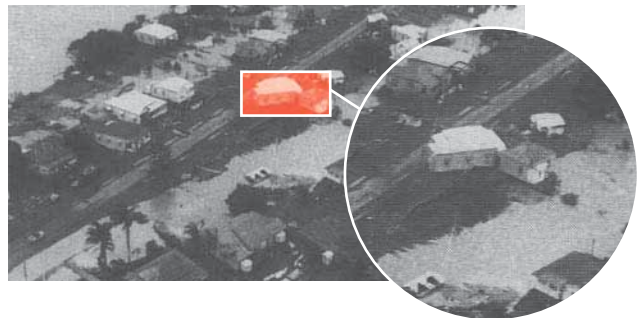
Figure 17 Lightweight clad houses may float

This unbalanced force can also cause houses to float. This is a problem with lightweight structures such as weatherboard houses, which can lift off the piers and float downstream (Figure 17). In overseas examples where basements are common, the buoyant force on the basement floors has pushed entire houses out of the ground.

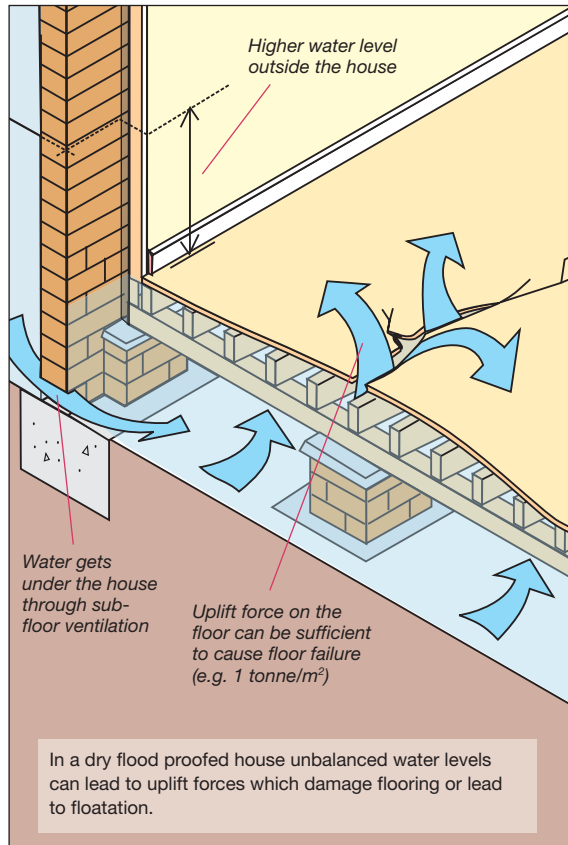
Figure 18 Uplift forces on suspended floors

Houses with suspended floors could suffer structural damage due to the buoyancy forces on the timber floor, even at relatively small depths, especially if the house is tightly sealed so that water cannot enter the house, (Figure 18).

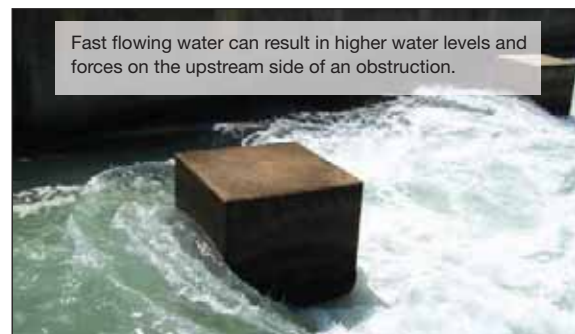
Figure 20 Example of water levels around an obstruction

These changes in level are illustrated in Figure 20 where fast flowing water passes around a block in a channel that is used to “dissipate” energy in flowing water to reduce velocity downstream.

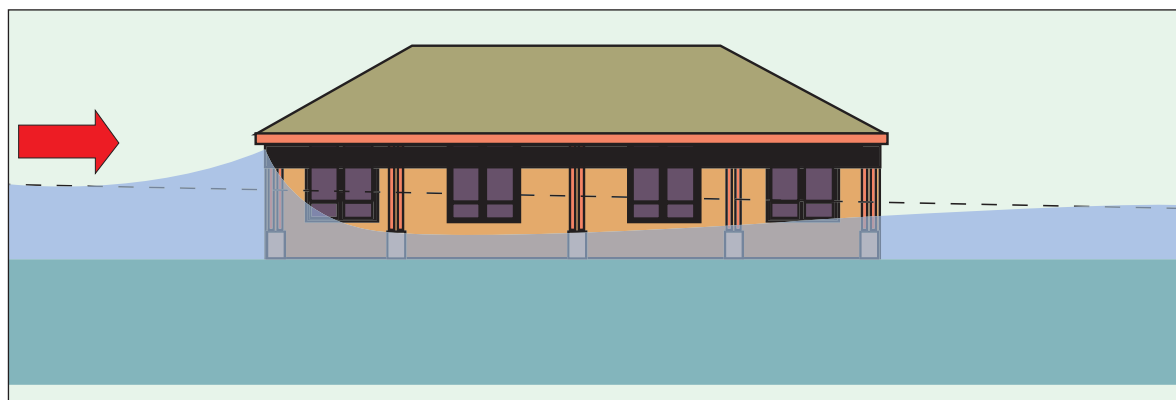
Figure 19 Levels of moving water around a house

Changes in pressures and forces are associated with the change in water level as water flows around the house. As shown in Figure 19, the water depth increases on the upstream walls (facing the flow) and decreases on the side and rear walls. Significant suction/outward loads are created on the side walls as the water flows along the sides of the house. On the side of the house that faces away from the flow (the downstream side) the water also creates a suction that pulls on walls.

With outside flowing floodwaters, the water level inside a closed house (i.e. doors and windows closed) will be relatively flat and at a level somewhere between the external upstream and downstream levels. Accordingly, the increased water depths that normally occur on the upstream walls result in an inward force on the wall. Similarly, the decreased water depths that normally occur on the side and downstream walls result in an outward force on the wall which tends to strip the wall away from the house.

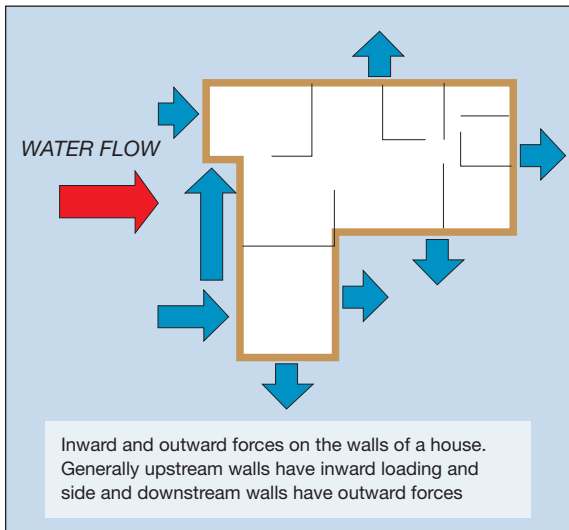
Figure 21 Direction and relative magnitude of pressures around a typical house

These forces vary for house shape, size, flow behaviour, etc. but as a rough guide water flowing at 4 m/s is likely to produce wall forces which are equivalent to the hydrostatic forces due to unbalanced water reaching the level of the eaves. The pressures estimated using computer modelling of a typical house are shown in Figure 21 where the arrow length is proportional to the pressure.

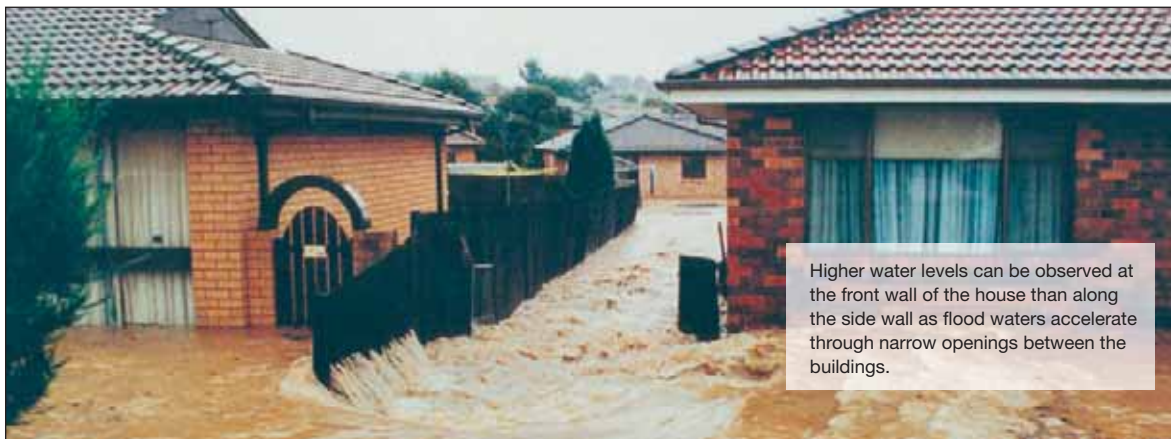
Figure 22 Flow between houses

Calculating all the pressure and associated forces imposed on a house from flowing water is complex and depends on many factors. It is important to realise that water velocities may be increased if the flow is channelled between houses or between a house and other obstructions, (Figure 22). Thus significantly higher velocities can occur after an area has been developed. This is discussed in more detail in Appendix B.

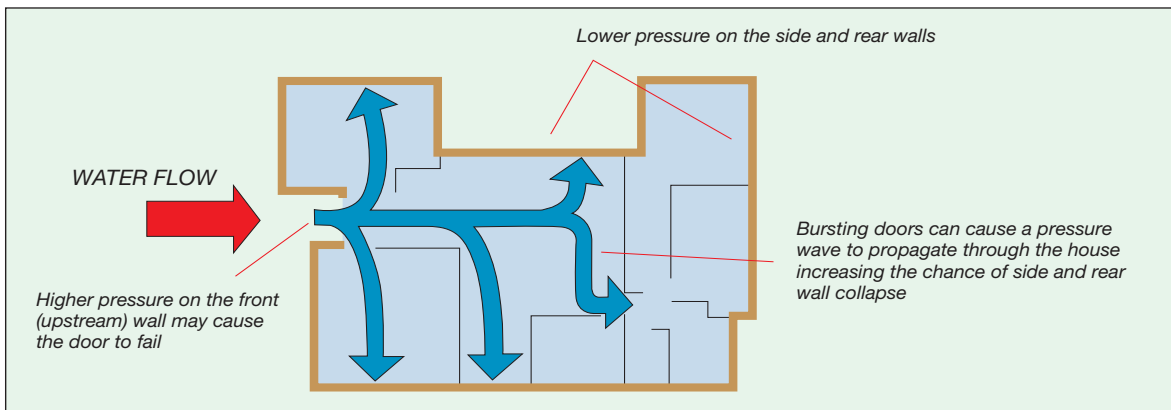
Figure 23 Collapse of walls due to pressure surges

If houses are not properly designed to resist the forces associated with flowing water, it is possible that sections of the house can fail in sequence and result in very severe damage. For example, the downstream and side walls of houses can fail due to “negative” pressures i.e. those acting in an outward direction on the outside of the walls. These walls may continue to resist these forces, but if an upstream wall, door or window should fail suddenly, it is possible for a pressure wave to travel through the house which could cause wall collapse. This can be made worse if there is little water in the house and a “wave” rushes through the house (see Figure 23).

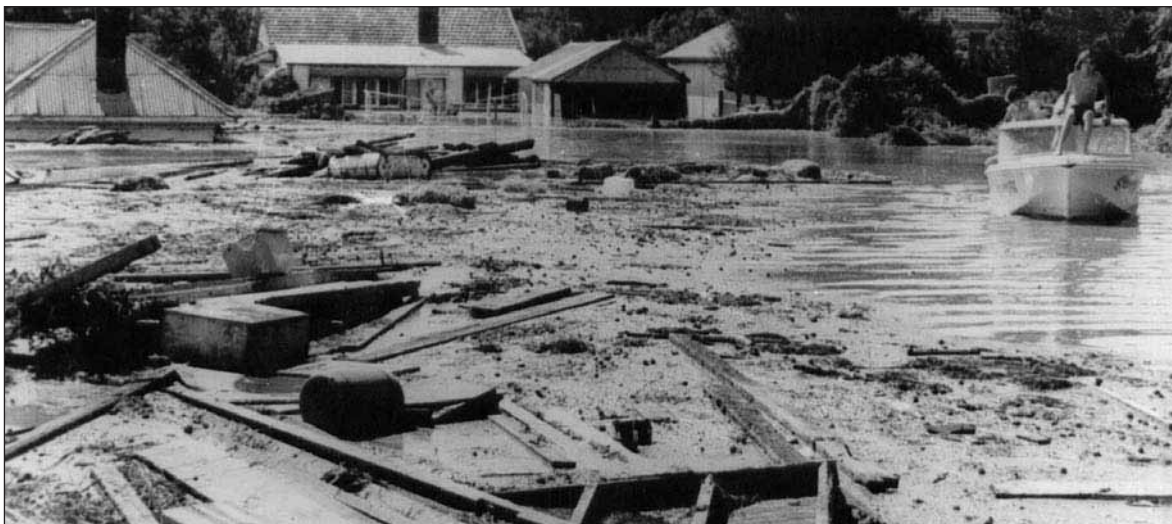
Figure 24 Accumulation of debris at Windsor 1978

Floodwaters can move a wide range of floating objects which can vary in size and weight e.g. from small plastic bottles to large trees and sometimes even motor vehicles and caravans, (Figure 24).

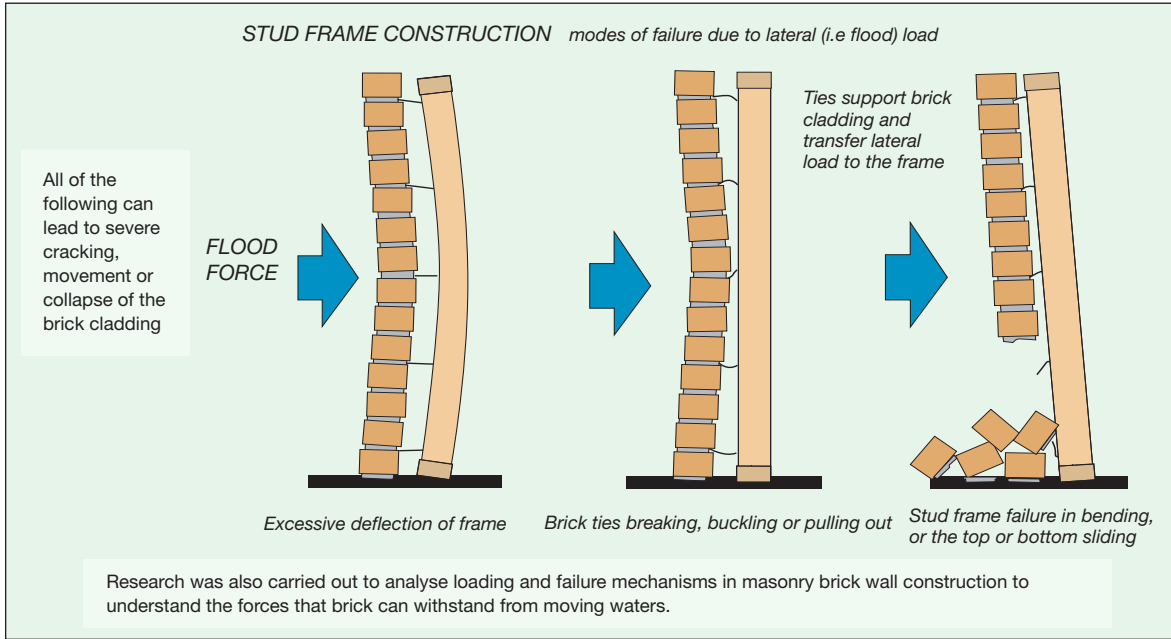
Figure 25 Brick wall failure

The brick wall is the weakest link in the wall system. A difference of less than 1 metre of water each side of the wall could cause extensive bowing, cracking and possibly even collapse.

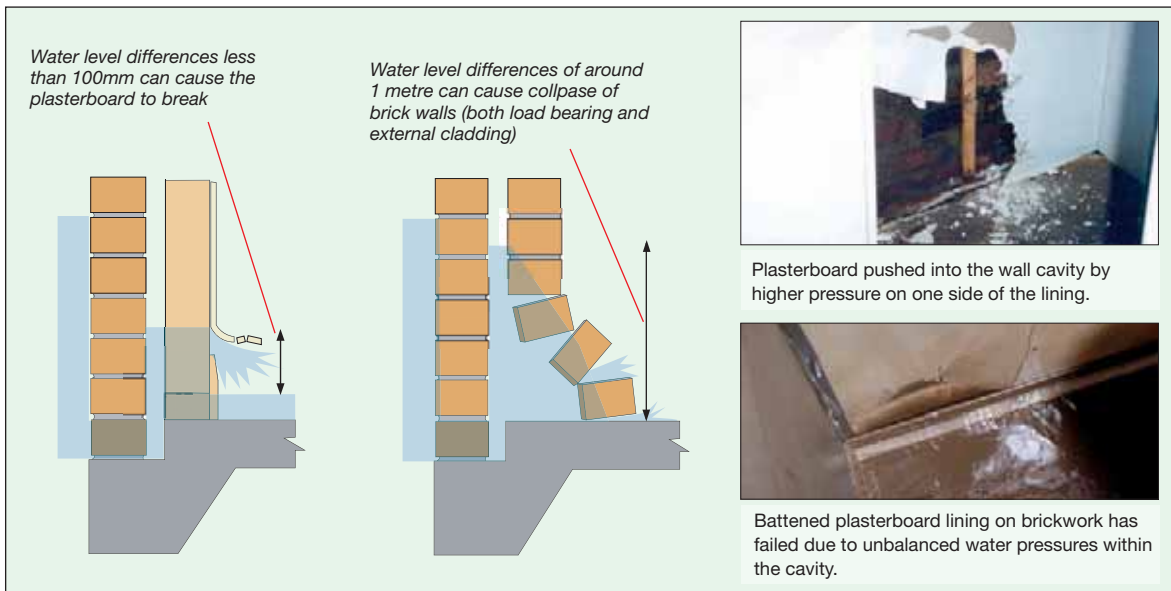
Figure 26 Problems caused by differential water levels

Water levels inside and outside the house need to be balanced to prevent extensive structural damage from water forces.

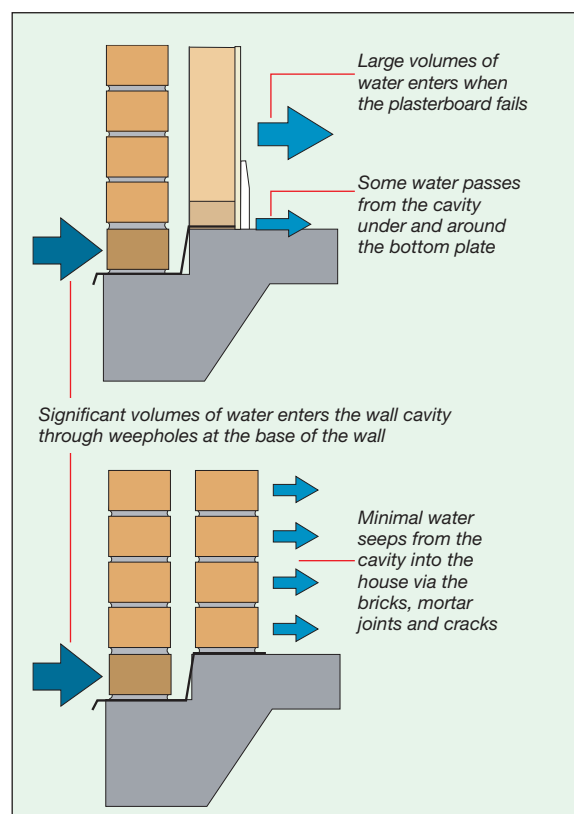
Figure 27 How water enters a house

- through the waste outlets and floor drains via the gully trap surface grates installed in the sewer lines
- under the external doors,
- into the wall cavity through the weepholes (unmortared vertical joints) at the base of the brick cladding, and
- from the wall cavity into the house via small gaps around the skirting boards and internal lining, (Figure 27).

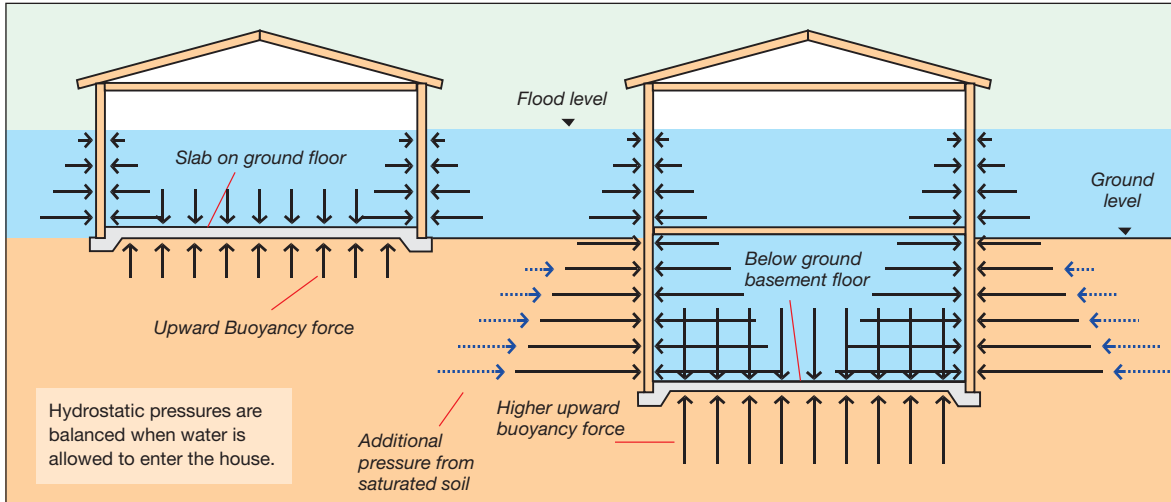
Figure 28 Balanced hydrostatic forces

Approximately 0.2m² of openings should be provided for a house with an enclosed floor area of 200m² for each predicted 1 metre/hour rate of rise.

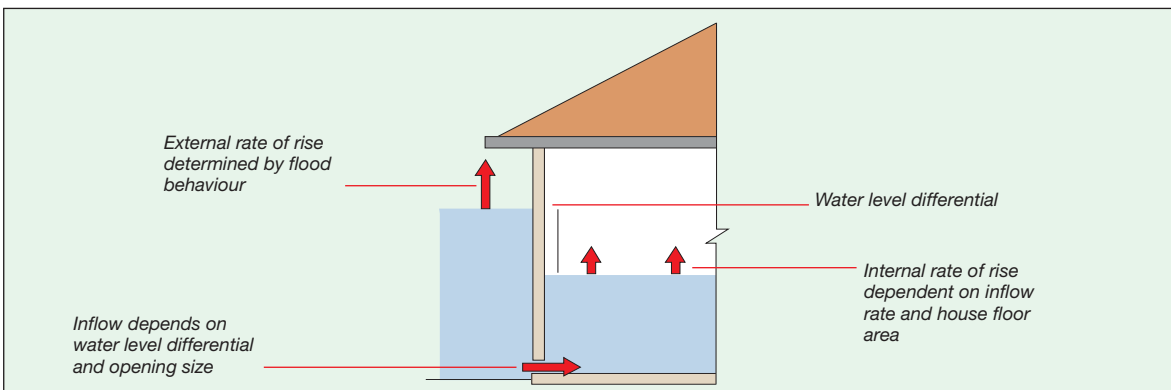
Figure 29 Rates of floodwater rise

A lower standard, of providing around 200,000mm² (i.e. 0.2m²) of openings for a 1 metre/hour rate of rise and an enclosed area of 200m² would be sufficient in situations to which these guidelines apply. The opening size can be scaled up or down in a linear fashion depending the rate of rise and/or the size of the enclosed area. However, the amount given by this

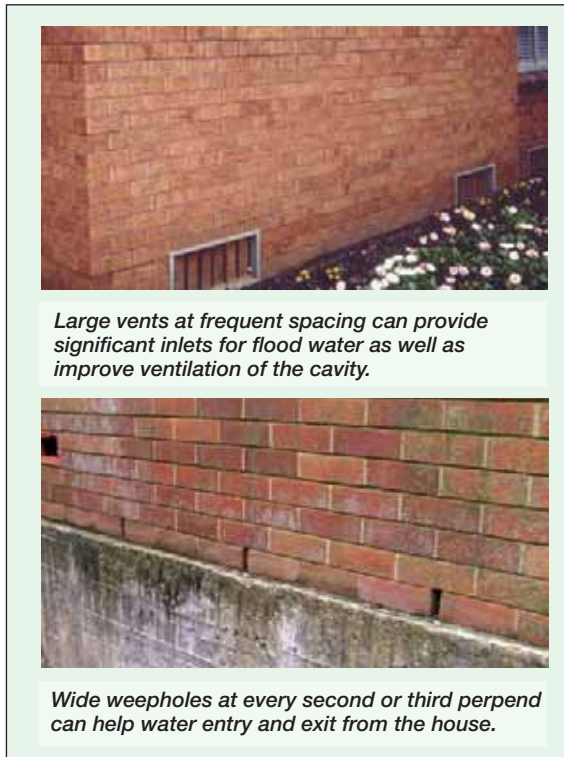
Figure 30 Water inlets in external brick cladding

Four of the preferred options for creating openings are given below and illustrated in Figure 30.

To help disperse water throughout the house, it is best to provide openings in a number of locations rather than one. This might be achieved by a number of openings 100mm high and 600mm wide.

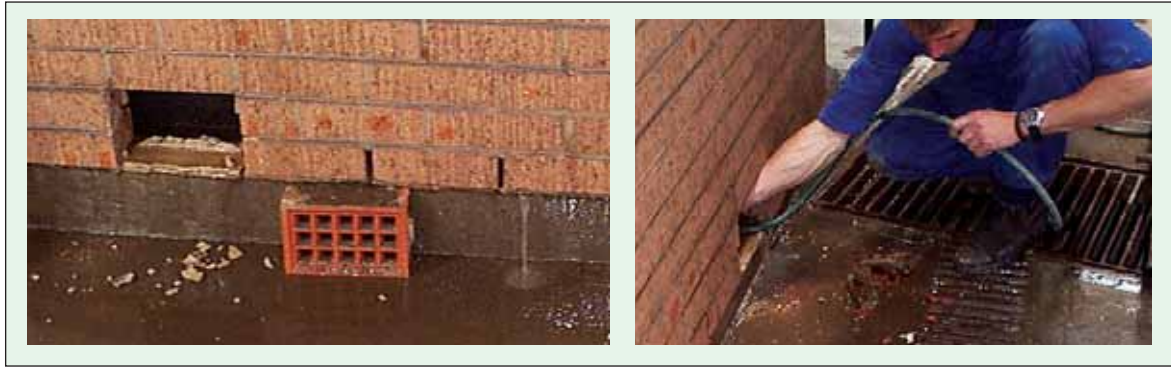
Figure 31 Removable vents allow easy cleaning and flushing of the cavity

Consideration should be given to making vents easy to remove so that a hose can be inserted fully into the cavity to assist cleaning and flushing. A weaker mortar could be used around the vent so that it could be removed after a flood, (Figure 31).

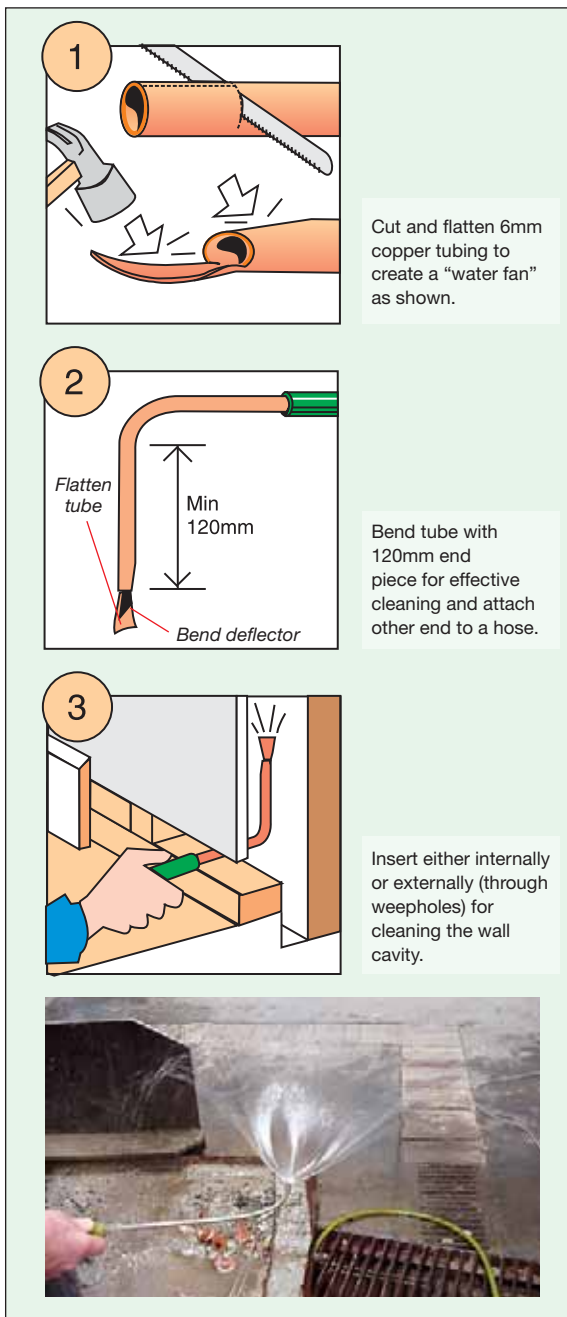
Figure 32 Constructing a nozzle for cleaning cavities

Alternatively, a special nozzle can be easily made so that it can be fed in through the weepholes to help clean out silt after a flood, (Figure 32).

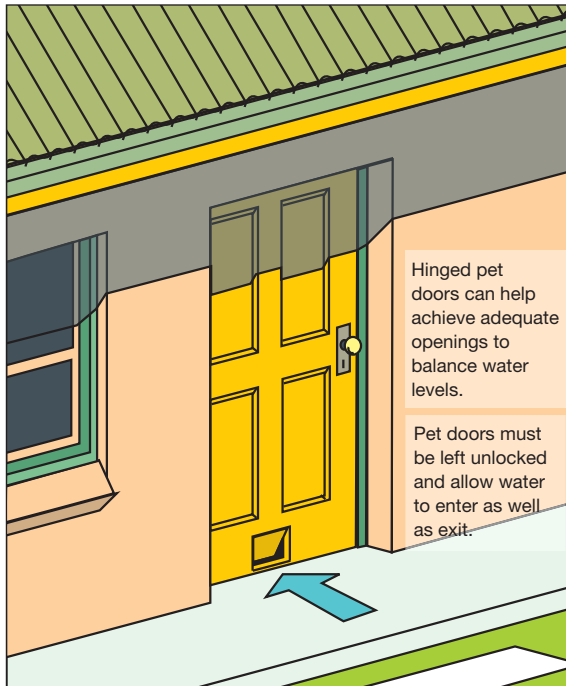
Figure 33 Use of pet doors for water entry

3. **Hinged “pet doors”** installed in external doors, need to be left unlocked at all times but could be used in conjunction with security screen doors that do not impede their opening. To permit water to escape as the flood recedes, it is important that hinged doors can operate effectively in both directions, (Figure 33).
4. **Internal wall vents.** Vents can be installed in the lower sections of the wall. There are a range of products in plaster, metal and plastic suitable for brick and plasterboard lined walls. These should operate effectively and are either clipped in or fastened with screws or glues.

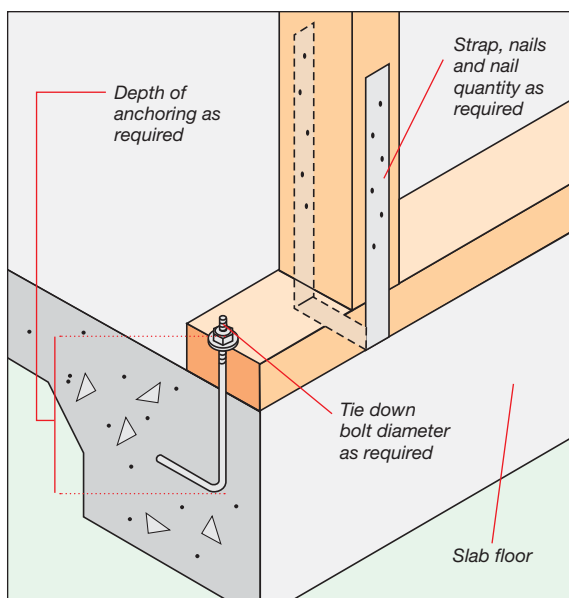
Figure 34 Tie down of bottom plates to concrete slab

The stronger connection requirements to withstand the additional shear forces from flowing flood waters can be determined through the N classification system and reference to “AS 1684.2 – 1999 residential timber-framed construction”. Examples of some common tie down methods are shown in Figures 34, 35 and 36.

The stronger connections needed to effectively anchor bottom plates used in timber frame construction to concrete floor slabs or flooring joists and in strengthening the walls to ceilings connections, would normally arise from potential increased horizontal forces (i.e. shear forces) caused by the impact of flowing flood waters against the wall structure. In houses with the timber frame resting on a concrete slab floor, uplift forces should be limited by the adoption of “wet flood proofing”. However, in the case of platform floor construction where the frame is positioned on top of sheet flooring, there is a greater possibility of uplift. This may occur when insufficient flood waters have entered over the floor and the weight of the superstructure is unable to counter higher hydrostatic pressures pushing up against the entire suspended floor. In this type of construction, the tie down connections will need to act to resist higher shear and uplift forces.

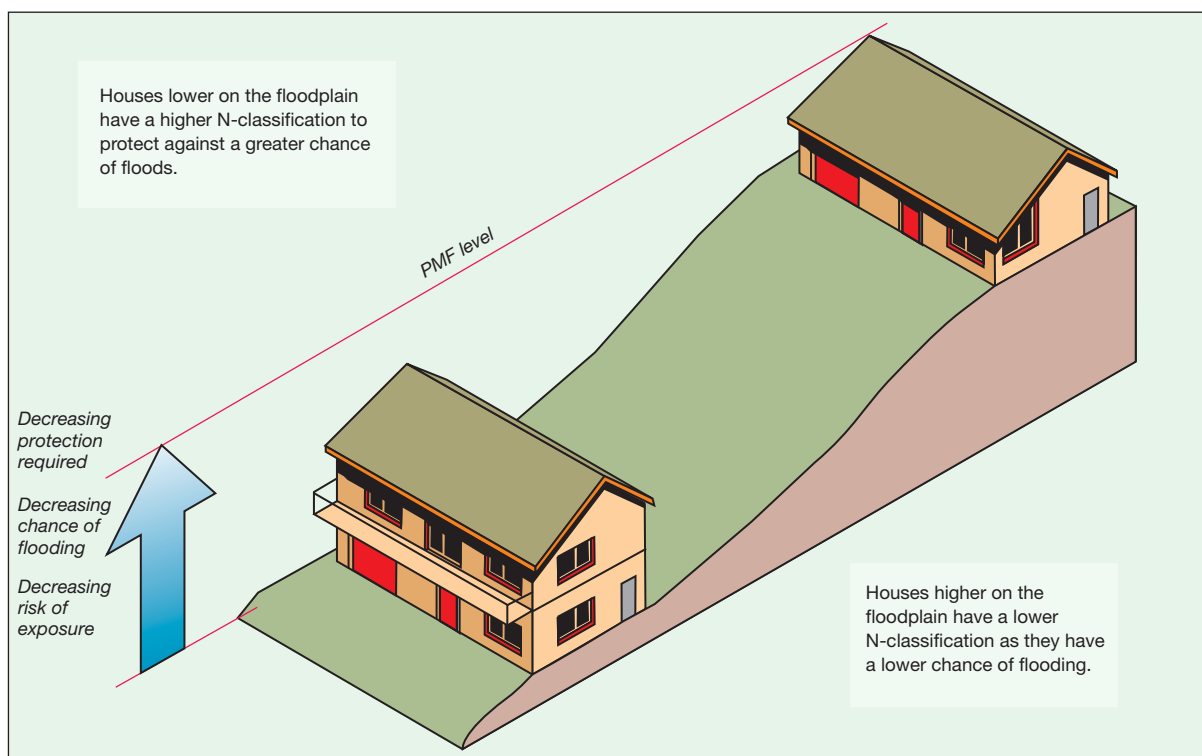
Figure 37 Using N-classifications for designing flood-aware houses

The adapted procedure suggests a suitable design N rating for a house based on the water velocity of a flood event that reaches the eaves level. Thus, the N1 would apply to low velocities and N6 for higher velocities. As a guide, each step increase in meeting the N rating forces to
