REDUCING VULNERABILITY OF BUILDINGS TO FLOOD DAMAGE

Guidance On Building In Flood Prone Areas

Prepared for the Hawkesbury-Nepean Floodplain Management Steering Committee

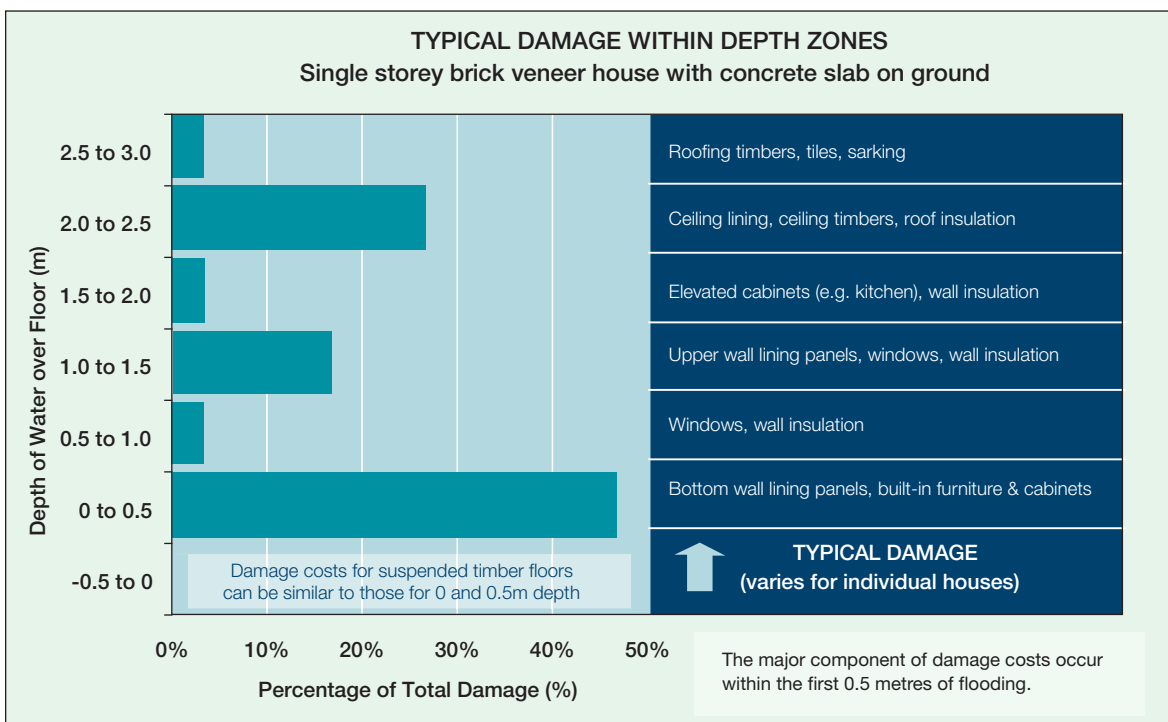
Figure 38 Increasing damage resulting from deeper floods

The damage to a building will vary with depth of water above the floor level, (Figure 38). Provided the foundations are adequate, damage below floor level is limited.

With a further rise in floodwaters there is then damage to wall linings, insulation, and fixtures such as built-in storage areas and cabinets. Increasing amounts of silt can also be trapped within the wall cavities. Furniture and appliances can begin to float and cause impact damage to wall linings and windows.

Damage can increase markedly when flooding rises above the ceiling and the lining, insulation, and roof timbers become wet.

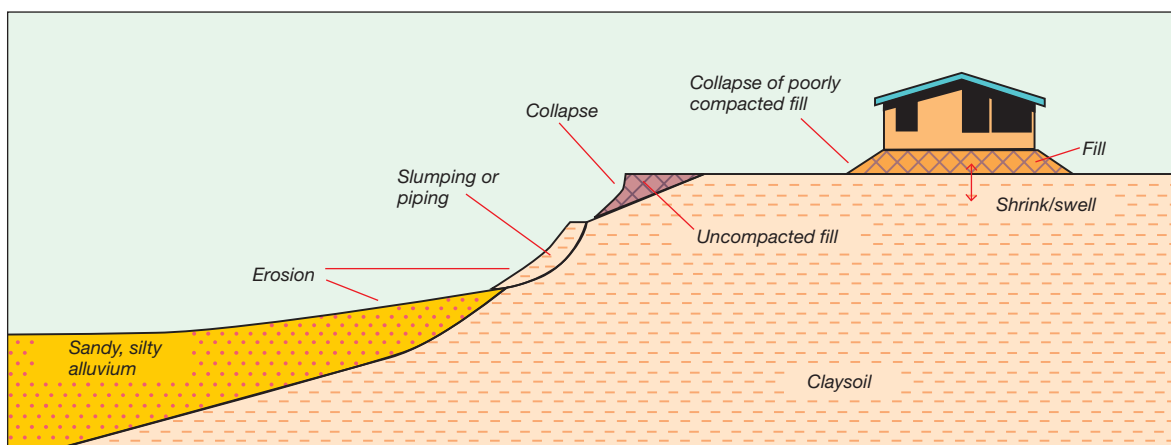
Figure 40 Principal geotechnical failure modes

The following geotechnical failure modes have been identified as the principal modes of failure that would accompany flooding:

These are discussed in detail below and illustrated in Figure 40.

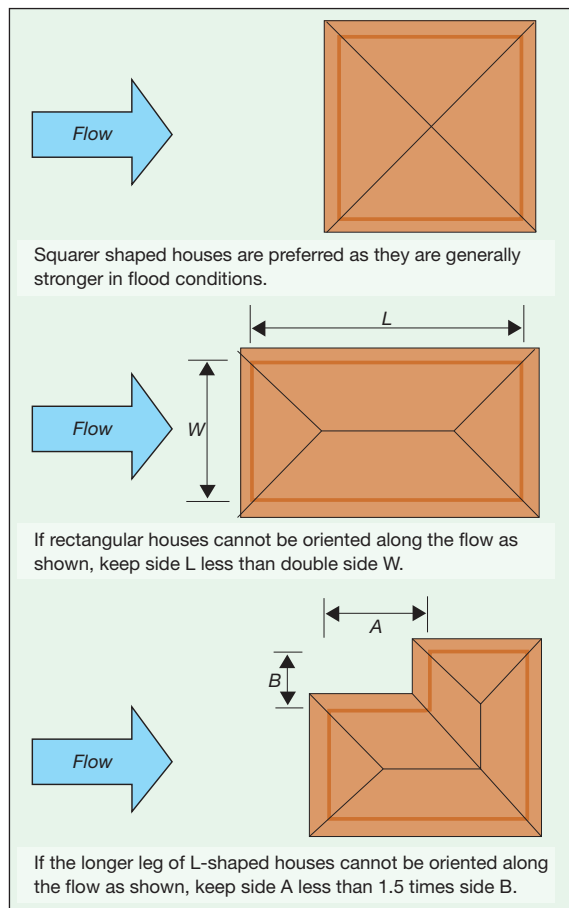
Figure 41 Effect of building orientation and shape

Figure 41 shows a range of plan configurations that will reduce the pressure of floodwater on the house.

side walls may be unwise (NB In this context, the front wall refers to that wall facing the water flow which implies a side wall is parallel to the flow). It is possible that brick side walls may collapse at a lower velocity than the front wall, but orientating the house across the flow can reduce the clearance between houses which increases the local velocity around the house. These matters are complex and difficult to analyse because many factors relating to the building structure and flow of water come into play. The impact of structure and water flow are also highly dependent on the individual circumstances. Conventional houses have greater limitations than other types of buildings and are only suitable for areas of relatively low velocity.

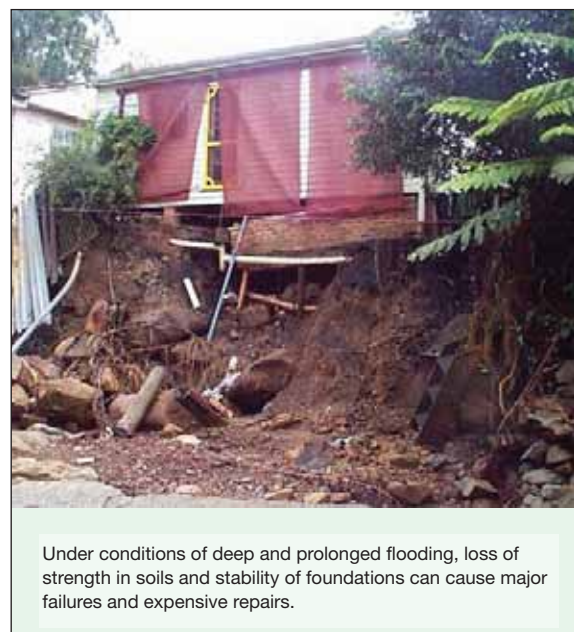
Figure 42 Undercutting from erosion

Erosion can be an issue with some soil types and with embankments created by cut and fill. The problem areas are the edge of an embankment or near the corner of a building, (Figure 42). The edges of any obstruction to the flow of water can generate faster currents, which increase the chance of scouring. Depending on factors such as the soil type and vegetation, erosion may develop when these local velocities are as little as 0.2 m/s although more commonly a figure of 1 m/s is a concern.

Embankments should not be steep (with a minimum slope of 2 horizontal to 1 vertical) and have a good vegetation cover year round. Where

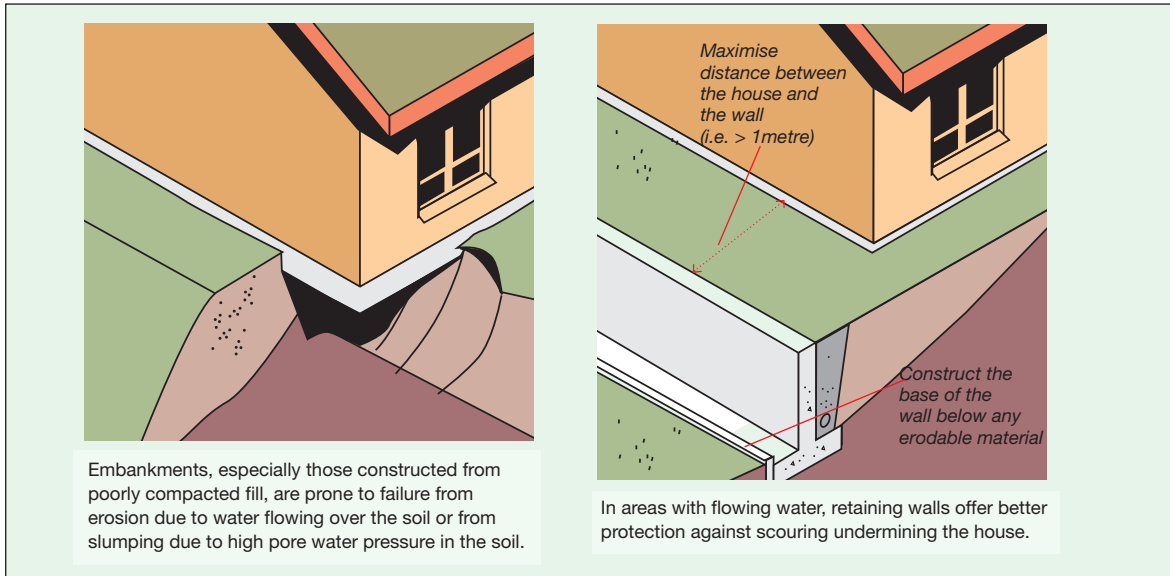
Figure 43 Protective retaining walls to prevent undermining of the house

Where flowing water can cause erosion to embankments, retaining walls can protect the site from undercutting.

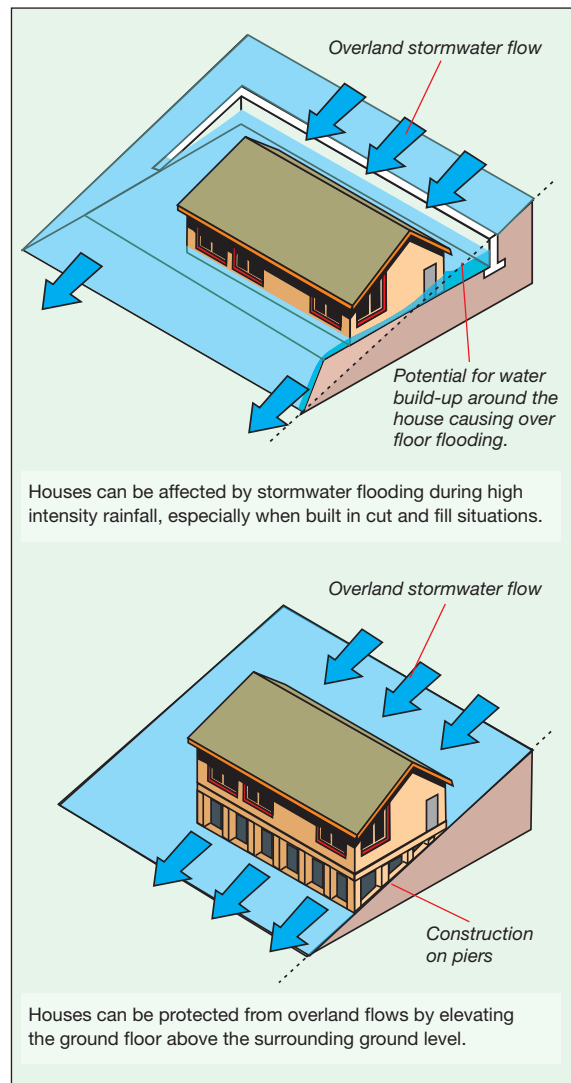
Figure 44 Diverting local run off

Clearly, houses should not be located in potential overland flow paths. Protection from overland flow is best achieved by elevating the floor above the surrounding ground and landscaping the site to shed rather than collect and/or pond local runoff.

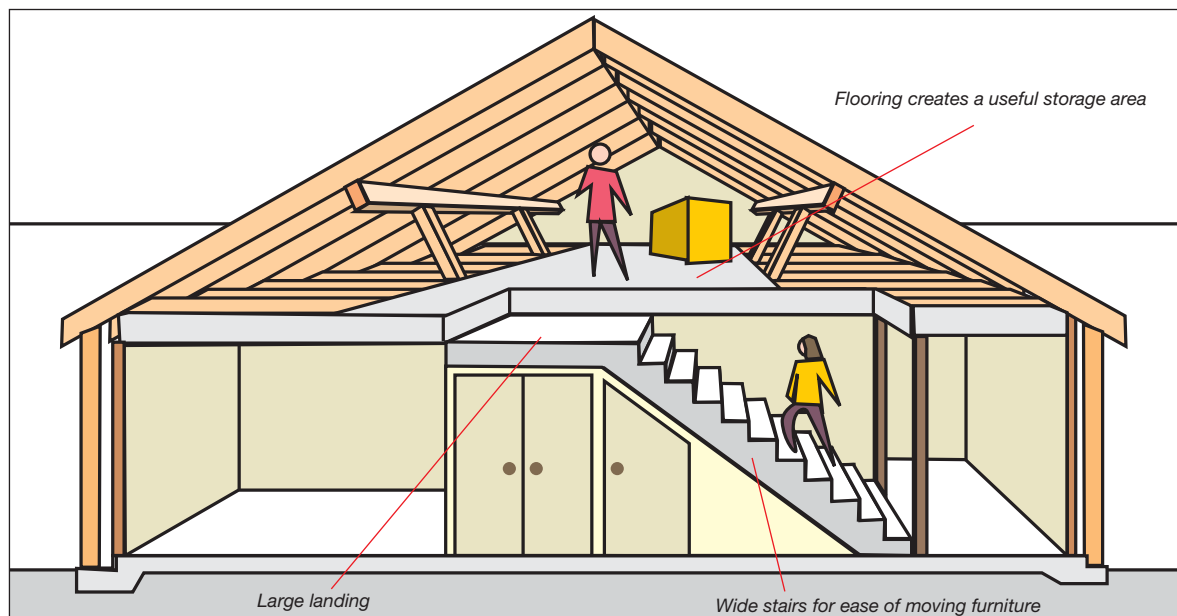
Figure 45 Attic space for emergency storage

One option for a single-storey house is to utilise the roof space to store valuable contents during a flood. A storage attic could be added in the roof space of a single-storey house. (Figure 45) This is not a habitable room, but is sufficient to store house furniture, electrical equipment and belongings in times of flood.

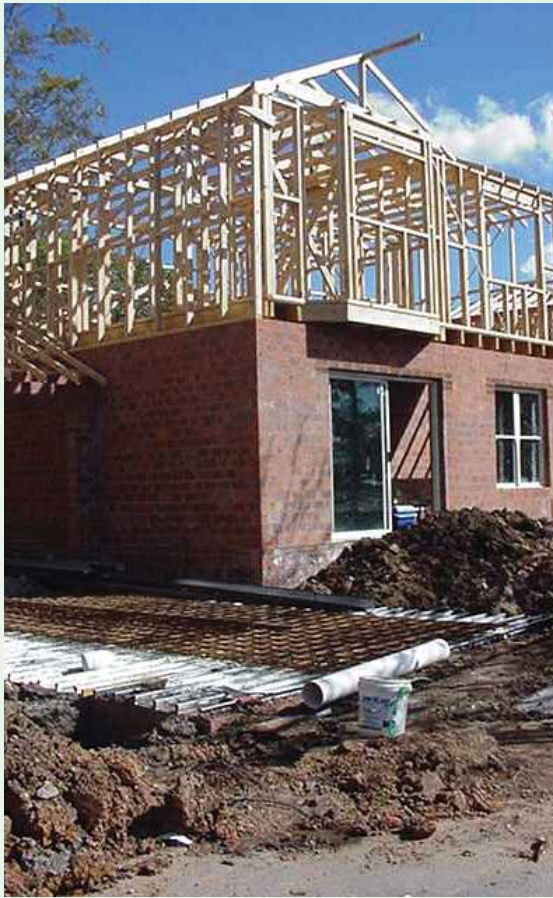
Figure 46 Two-storey designs to suit areas with potential for deep flooding

An example of a house design which can reduce flood damage. The lower ground floor was constructed with material not weakened or affected by floodwaters ie. full masonry. The upper floor, which has a much lower chance of being flooded, uses lower cost traditional frame construction and provides an opportunity to reduce damage to contents. The external wall sheeting used on the upper storey walls is both less expensive and easier to repair if damaged.

The three photos show different stages of construction. With good finishing technique both levels of the house have the same appearance.

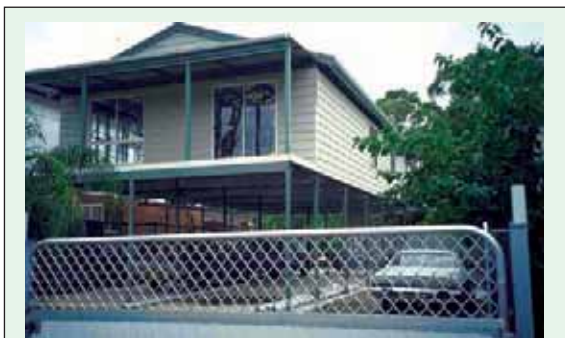
Figure 49 Raised house construction provides a high level of protection

Footings for high-set houses may be pads or braced posts (possibly with some framed walls between) supporting the house structure above. The use of such supporting posts usually means the house has to be a lighter clad frame structure. This type of construction is particularly useful where the floodwater velocity is likely to damage a standard on-the-ground house. The open ground floor area “substructure” not only reduces the chance of damage to the house but can also minimise the impact of the structure on the flood behaviour. However, it is very important that the substructure be designed to withstand the floodwater and debris forces. It would be

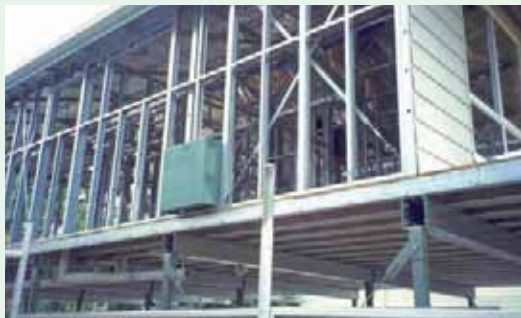
This house is reasonably flood compatible. The elevated living area greatly reduces the chance of flooding.

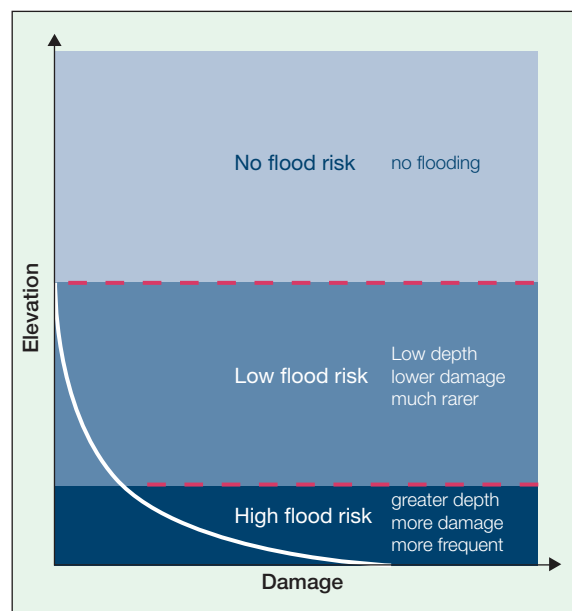
Figure 50 Higher elevation and lower flood risks

- areas on the floodplain where there remains potential for very deep flooding above the flood planning level, a higher-set development could greatly reduce the probability of flooding, perhaps even raising the habitable areas above the PMF, (Figure 50). Large scale multi-storey developments provide substantially greater opportunities to adopt more effective measures compared to individual project homes because they can be designed

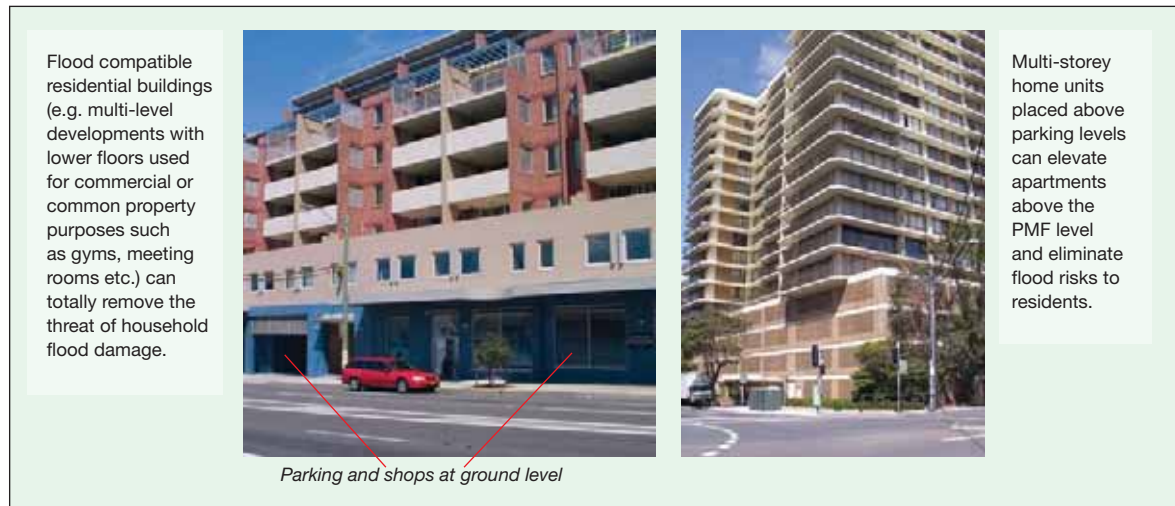
Figure 51 Multi-storey units

Even greater benefits can be achieved if high-rise unit developments are used in some of the more vulnerable flood prone areas, (Figure 51).

- enable some if not all units to be located above the PMF leaving only garages and common property at the lower levels at risk of flood damage. Confinement of losses to common property represents a substantial reduction in the liability of individual unit owners over the liability of owners of detached houses,
- be specifically designed to resist forces of flowing water using more robust steel or reinforced concrete construction (Figure 52),
- provide a last resort refuge for occupants unable to evacuate in time.

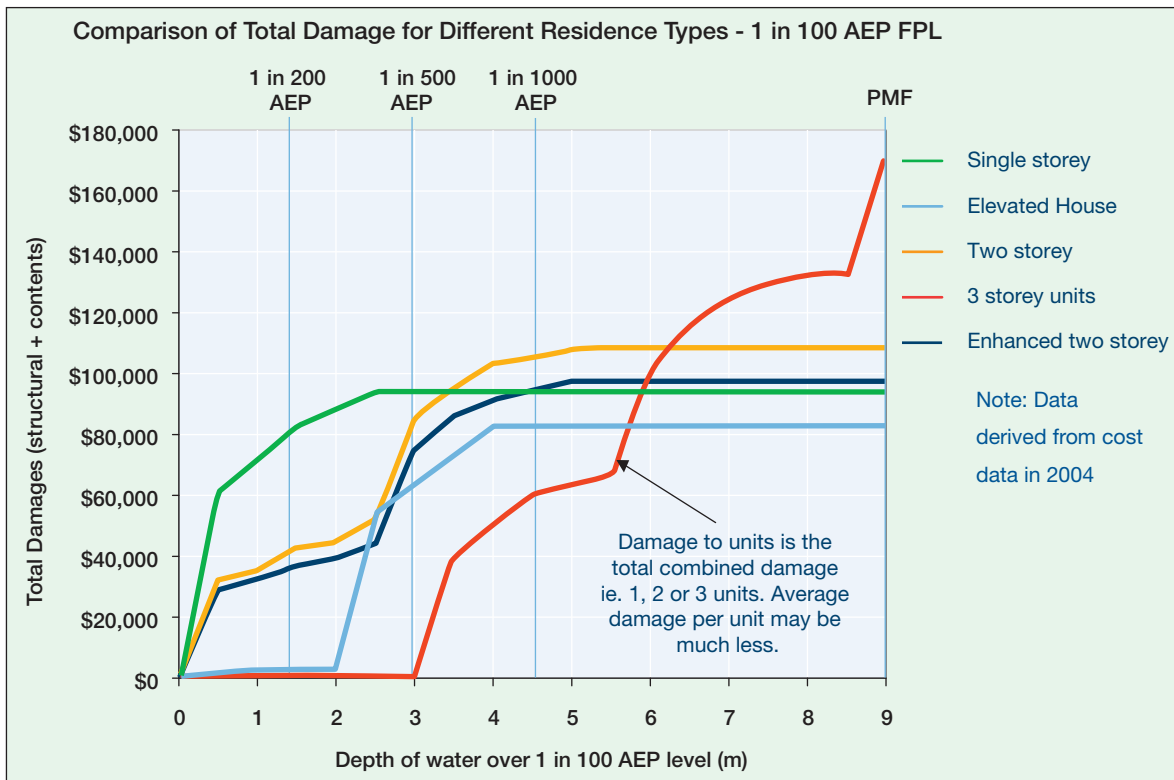
Figure 53 Damage cost comparisons

Curves on Figure 53 highlight the lower combined structural and contents damage costs of alternative housing types such as 2 storey or multi – storey units for floods which moderately exceed the ground floor FPL. This damage information helps to define the socio – economic merit of each alternative and would therefore need to be considered when planning for any new or redevelopment. However, it should be noted that these curves do not directly reflect other possible benefits of these alternatives such as reduced trauma and quicker recovery from severe flooding.

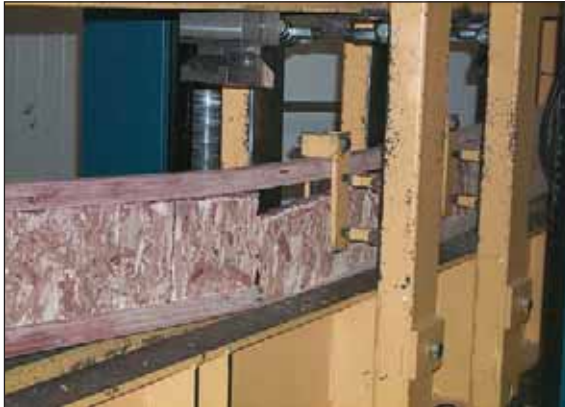
Figure 54 Testing of building components

An understanding of the consequences of immersing various products in water has been gained from CSIRO testing. This information can suggest possible modifications or allowances to maintain the performance of the product when flooding occurs.

The above example shows a test on the effects of flooding on manufactured support beams which are increasingly used as an alternative to solid timber beams because of weight and cost savings.

Hence, particular attention must be paid to components that perform a load bearing function within the structure of a house. In this situation, materials which weaken or distort when wet must either not be used, especially if there are residual problems even after drying, or an appropriate allowance made for the distortion or loss of strength, (Figure 54).

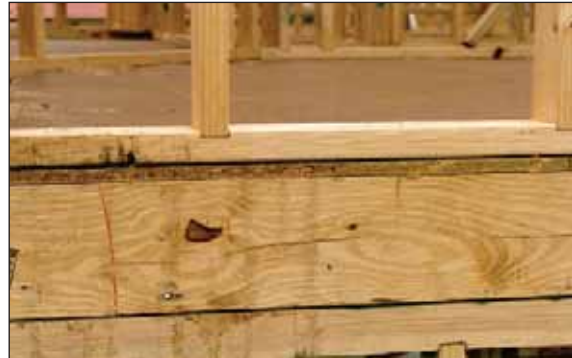
Figure 55 Selecting appropriate materials

Distinction should also be made between components that can be readily replaced and those which can only be replaced at great expense. It is therefore imperative that difficult to access elements such as framing and fixtures in wall cavities are flood-resistant, while it is not so important that internal cladding be flood resistant as the extent of damage is very evident and it can be readily repaired or replaced, (Figure 55).

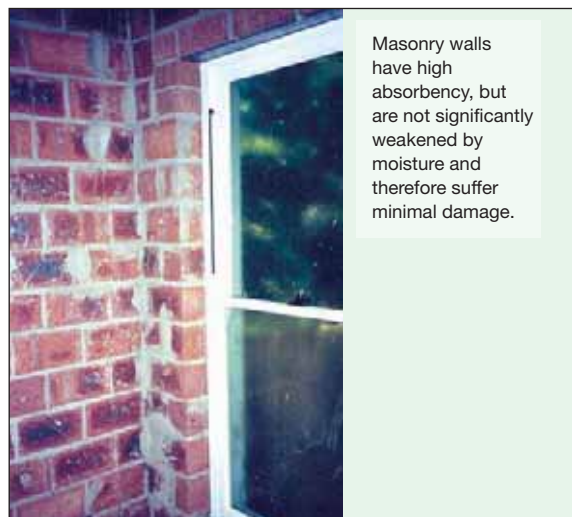
Figure 56 Masonry walls and absorbency

Materials in the top left corner of Table 4.3.1.2 are highly absorbent but will not be damaged by immersion. They are stable, but will dry slowly, (Figure 56). Care needs to be taken in combining these materials with others that are damaged by long-term exposure to moisture as these can take up to 3 months to dry out.

Masonry walls have high absorbency, but are not significantly weakened by moisture and therefore suffer minimal damage.

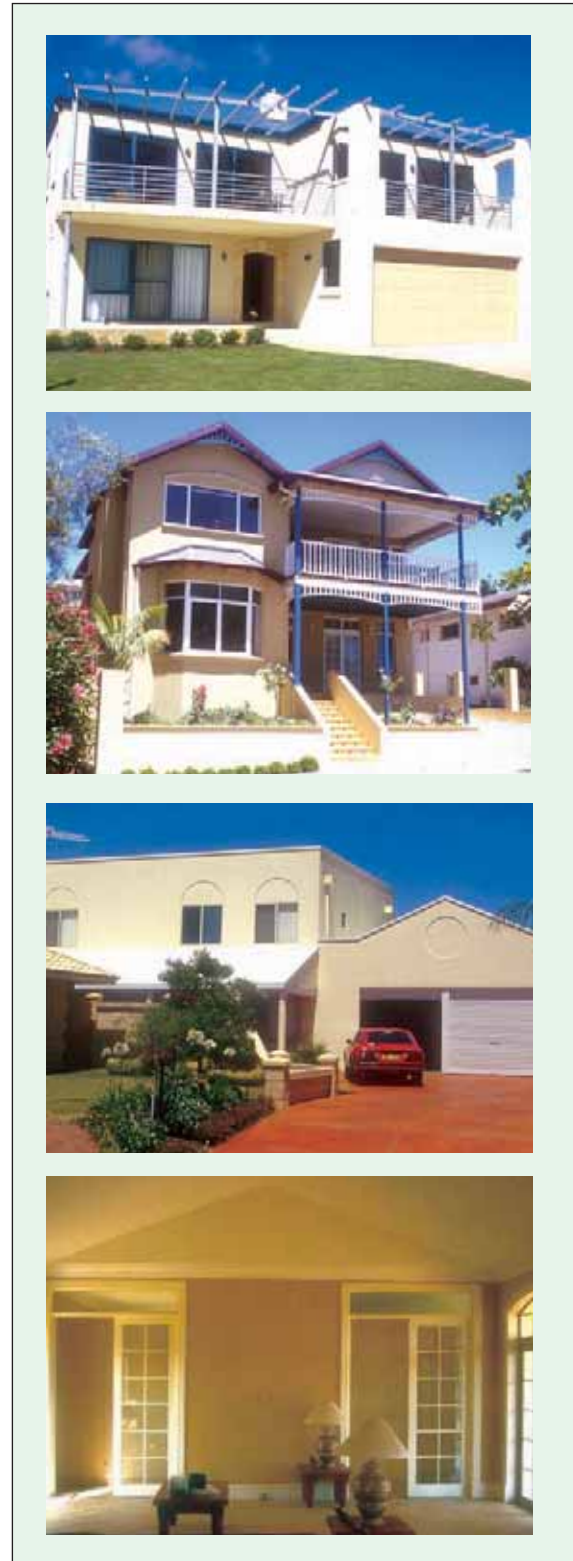
Figure 57 Concrete panel houses

- As the panels are reinforced concrete, the simplest approach is to design the walls to resist hydrostatic forces. If this is uneconomic, then it is vital to have near-floor level openings for the entry of

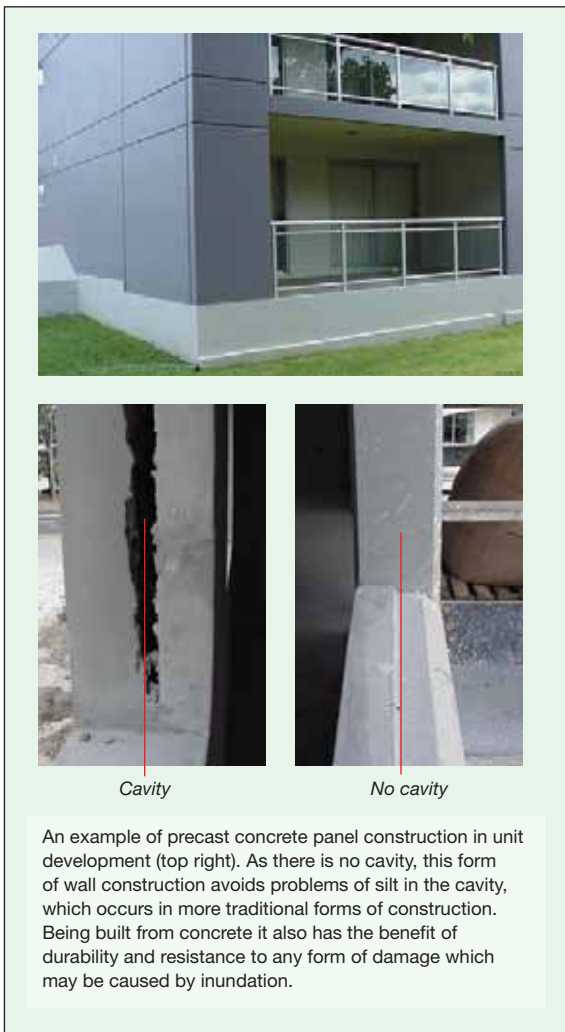
Figure 58 The advantages of concrete panel housing

rising floodwaters to prevent unbalanced hydrostatic forces forming (see Section 3.2.1). Section 3.2.1.3 gives advice on the provision of sufficient water inlets which can also allow outflow of receding floods. Construction details of openings are best left to the designer, but consideration should be given providing efficient floodwater entry and exit while also providing a thermal, vermin and intruder barrier.

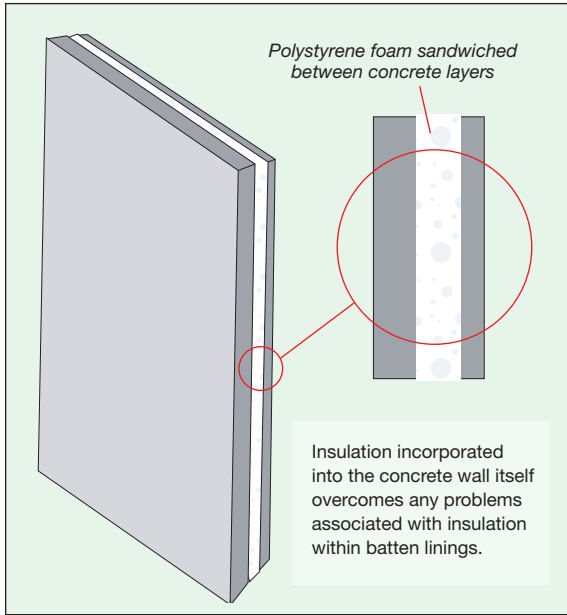
Figure 60 Insulation incorporated into concrete panels

While battened linings result in the formation of a cavity and a moisture trap, it does not reduce the flood advantage that CPH offers because the structural performance of the concrete wall will not deteriorate. Additional insulation should be incorporated in the wall itself in the form of sandwich construction, (Figure 60).

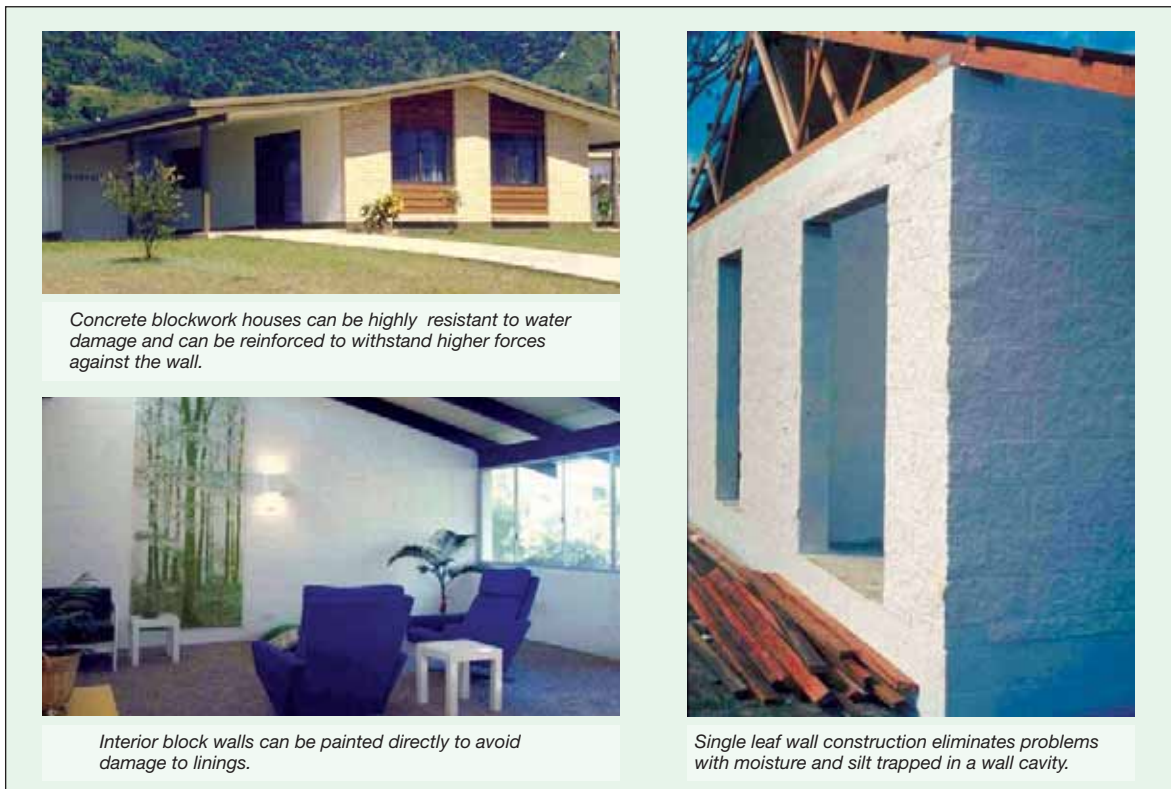
Figure 61 Concrete blockwork houses

Concrete block walls also have the benefit that they can be reinforced to increase their strength in bending, which brick constructed walls are unable to resist. Reinforced concrete or concrete block walls can also be used to provide extra strength to walls at risk from debris and flow velocity.

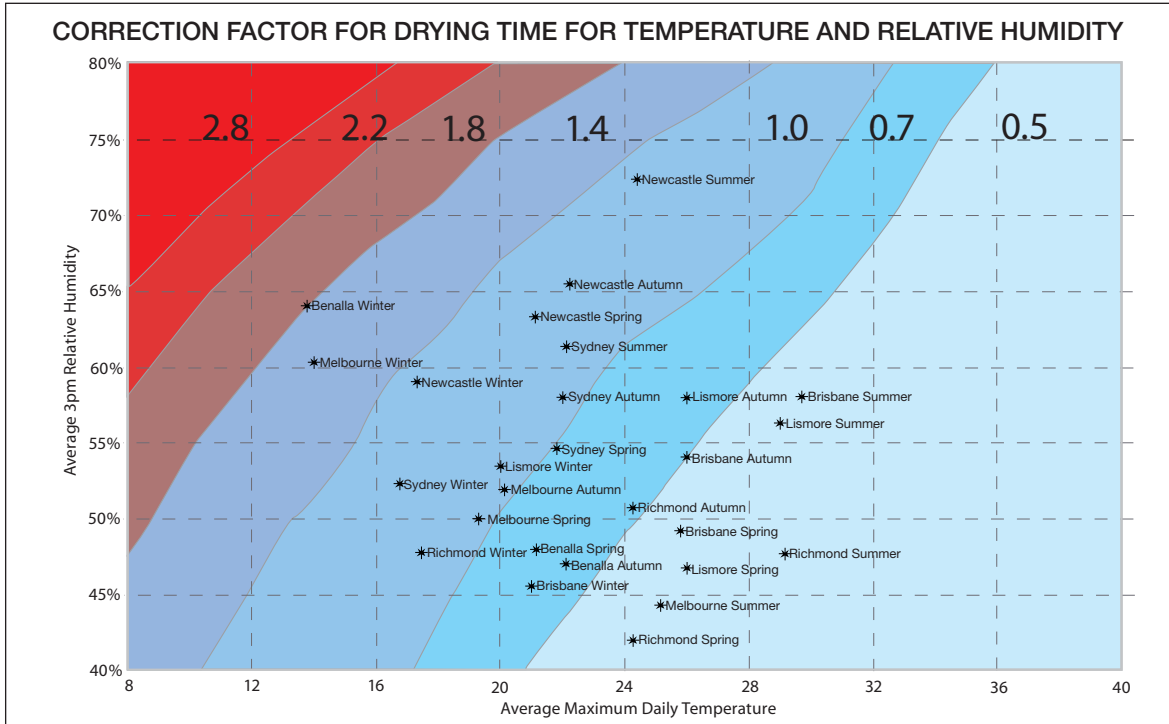
Figure 62 Correction factors for drying rates

These drying times are for Sydney during winter and Figure 62 contains a diagram with correction factors. These factors are presented as a function of maximum daily temperature and 3 pm relative humidity. Thus, the average 3 pm relative humidity and the average maximum daily

temperature in Sydney during winter are 52% and 17°C respectively, and the correction factor is 1. In contrast, the conditions for Richmond (NSW) during summer are significantly drier and hotter, with the average maximum daily temperature being 30°C and average 3 pm relative humidity 47%, and thus the correction factor is 0.5 so that all the suggested drying times could be halved.

These drying times are provided only as a guide and such factors as post-flood weather conditions, house aspect, ventilation details, etc will influence the times. For example, following a flood, extreme weather patterns may persist. Under these circumstances, it would be advisable to adopt a slightly more conservative correction factor to cover this variability.

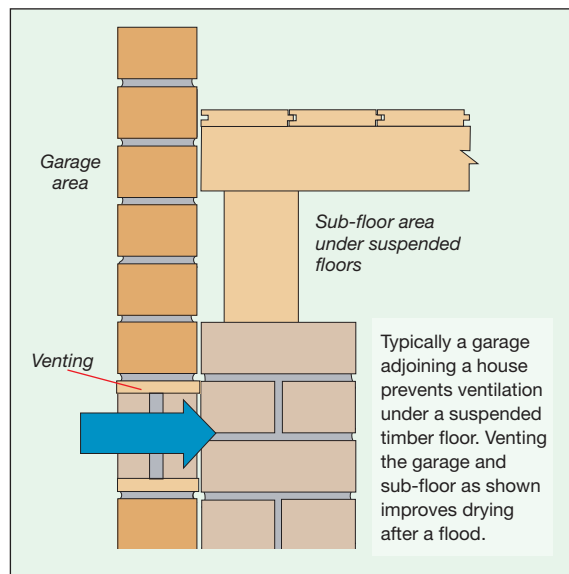
Figure 63 Venting a garage and sub-floor to assist drying

Another common problem area is where the garage adjoins a house with a suspended timber floor. Usually the garage prevents sub-floor ventilation on that side of the house and hence the sub-floor area dries very slowly. Venting the garage and the sub-floor space can assist in solving this problem, (Figure 63).

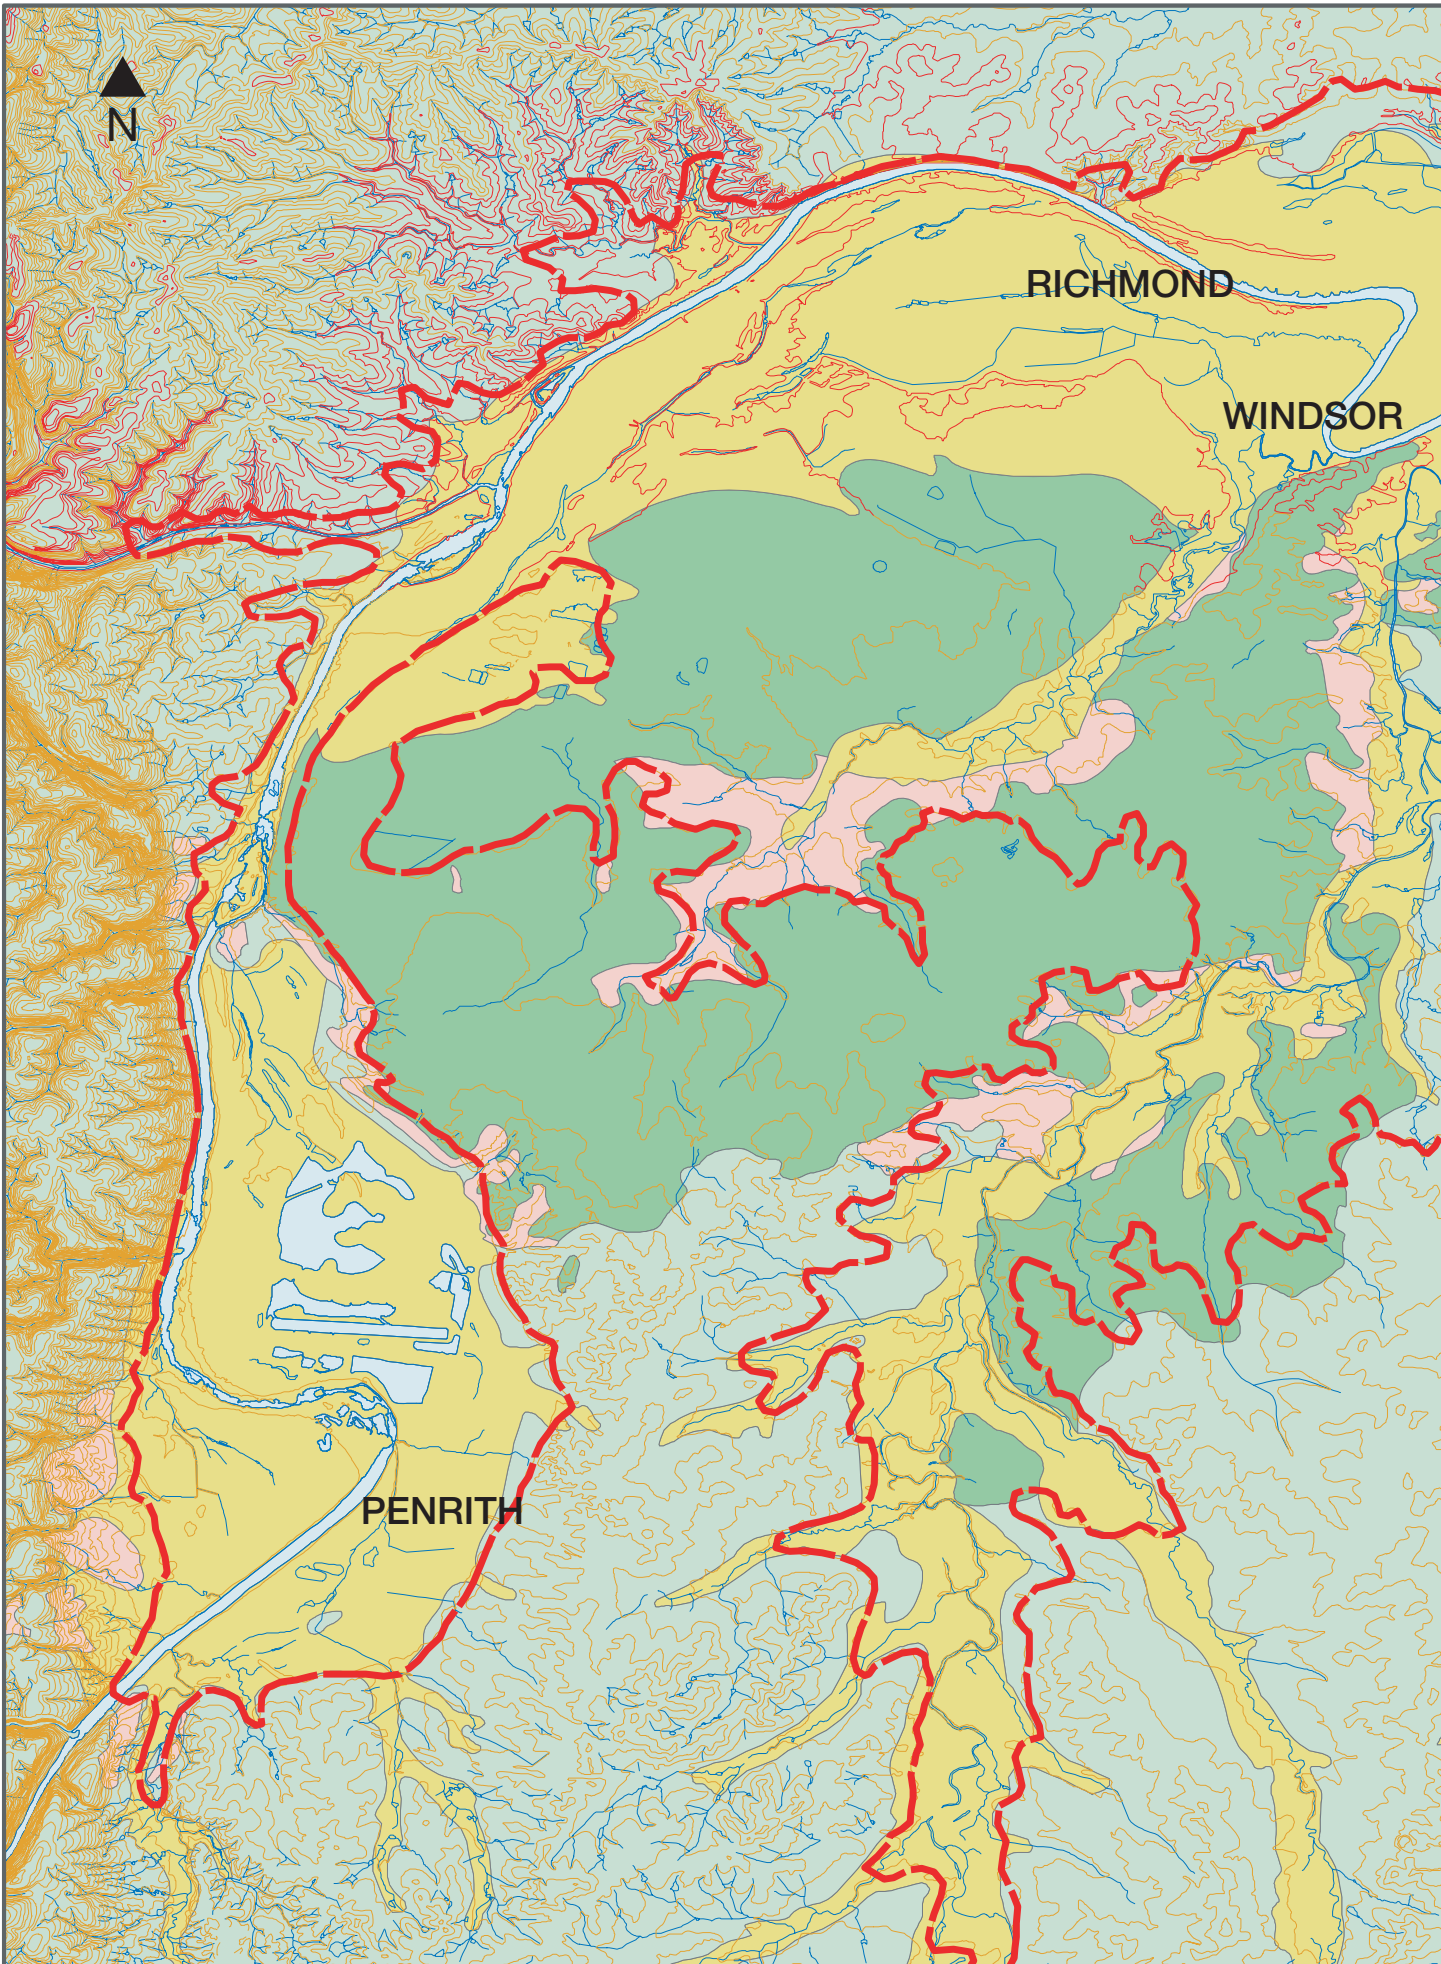
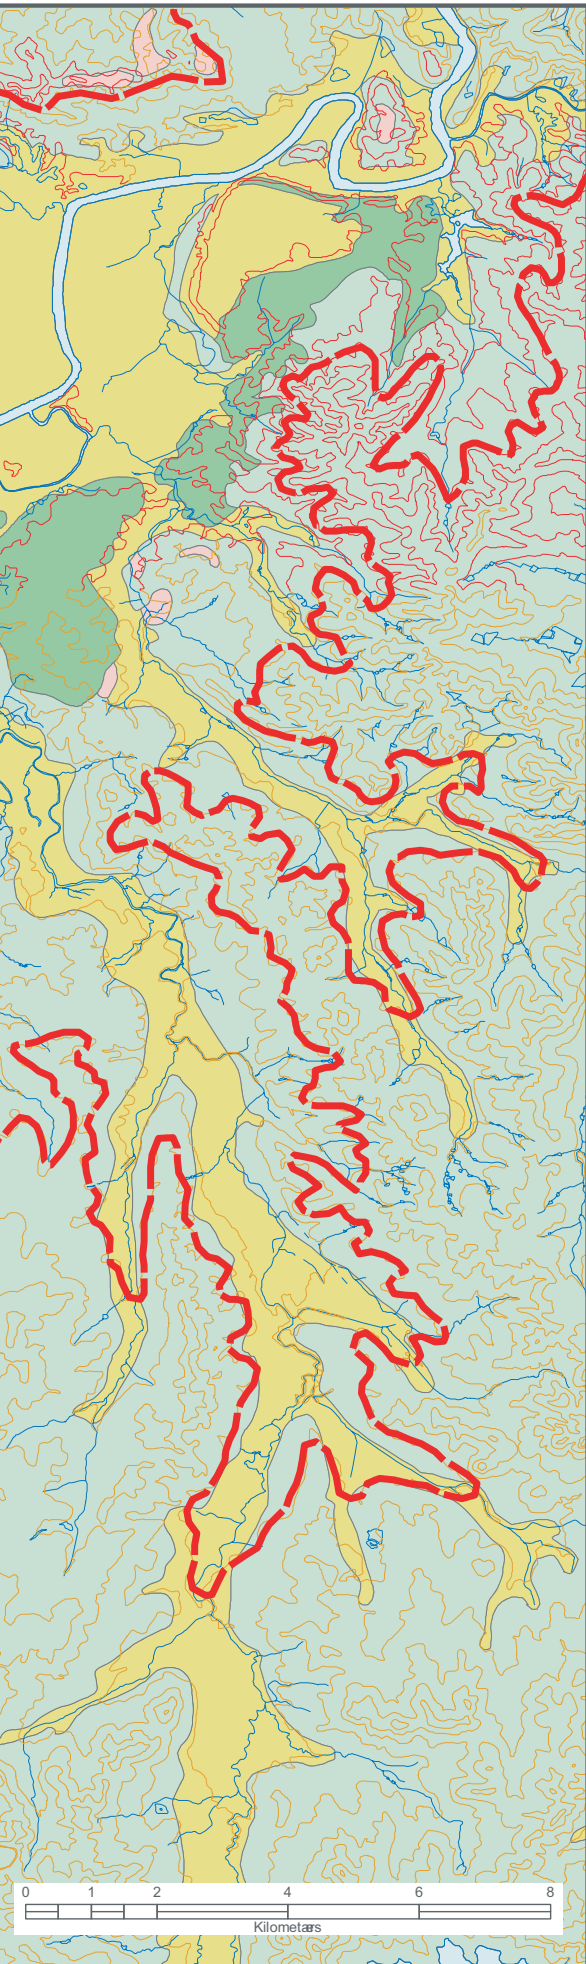
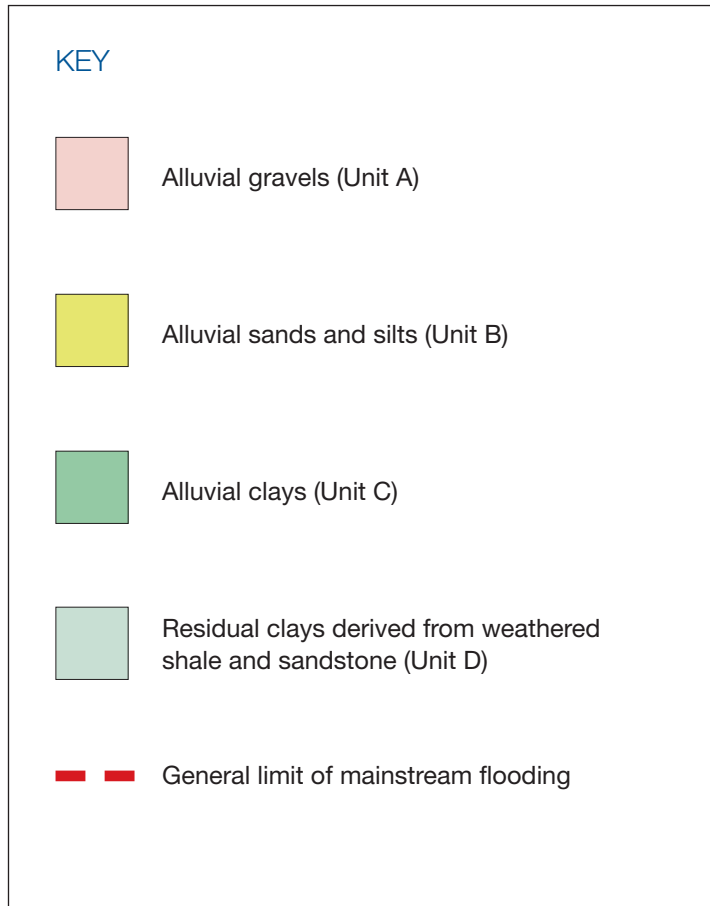
Figure 64 Hawkesbury-Nepean soil map

The soil map shown in Figure 64 for the Hawkesbury Nepean valley is divided into four main geotechnical units – alluvial gravels, alluvial sands and silts, alluvial clays, and residual clays. Table 5.1.1 considers these typical soils and identifies their likely problems.

GEOTECHNICAL UNIT	POTENTIAL GEOTECHNICAL ISSUES
<p style="text-align: center;">Unit A (Alluvial gravels)</p>	<ul style="list-style-type: none"> • Gravel materials of this unit are expected to be erodible where water velocity is in excess of 3m/sec although some gravels may erode at much lower velocities. • Relatively permeable nature of the gravels facilitates drainage of the materials following inundation. • Low shrink-swell potential. • Minimal loss of strength on saturation.
<p style="text-align: center;">Unit B (Alluvial sands and silts)</p>	<ul style="list-style-type: none"> • The sandy and silty nature of the materials in this unit, may be erodible where water velocity is in excess of 0.2m/sec to 0.6m/sec. These soils are therefore the most erodible of all soils within the project area. • Relatively permeable compared with Units C and D. • Low shrink/swell potential. • Minimal loss of strength on saturation.

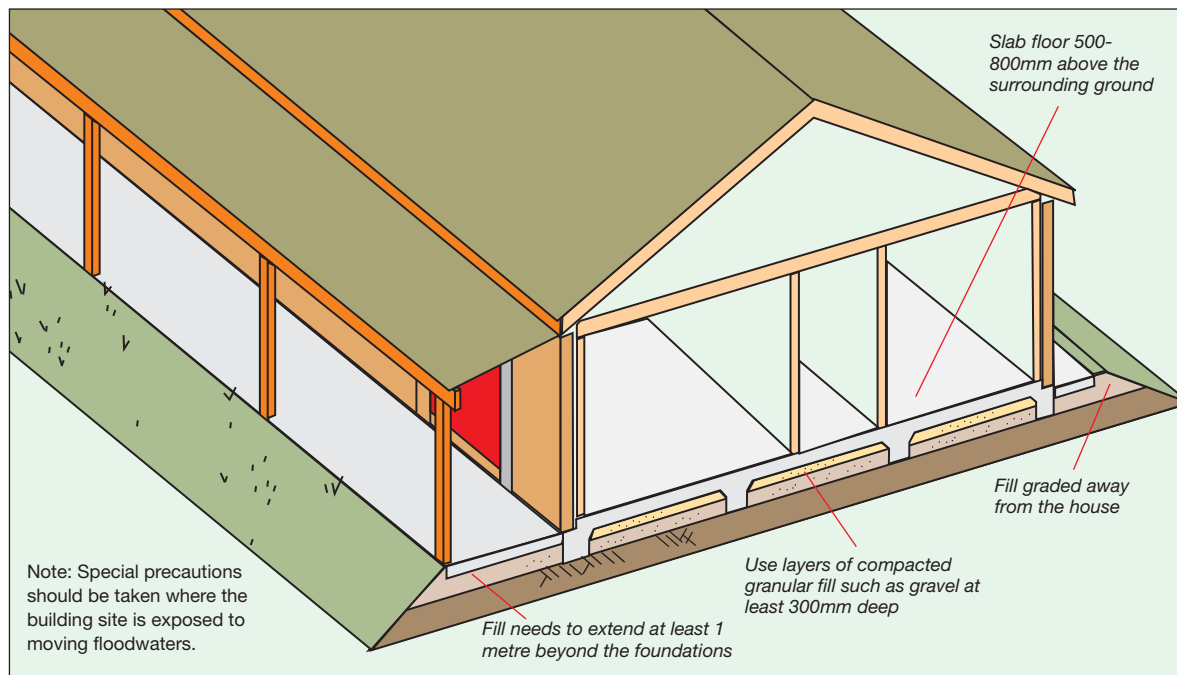
Figure 67 Raising the slab on alternative fill

size the drainage infrastructure to cope with runoff from very high intensity storms and blockages in flow paths. Raising the slab is a more desired solution which will reduce the probability of the house flooding, prevent ponding against the walls, and improve the drainage around the house. Fill should be at least 300mm deep and extend one metre beyond the foundations of the house. As an alternative to standard soil, the fill material could consist of coarse granular material, such as gravel, which is relatively stable.

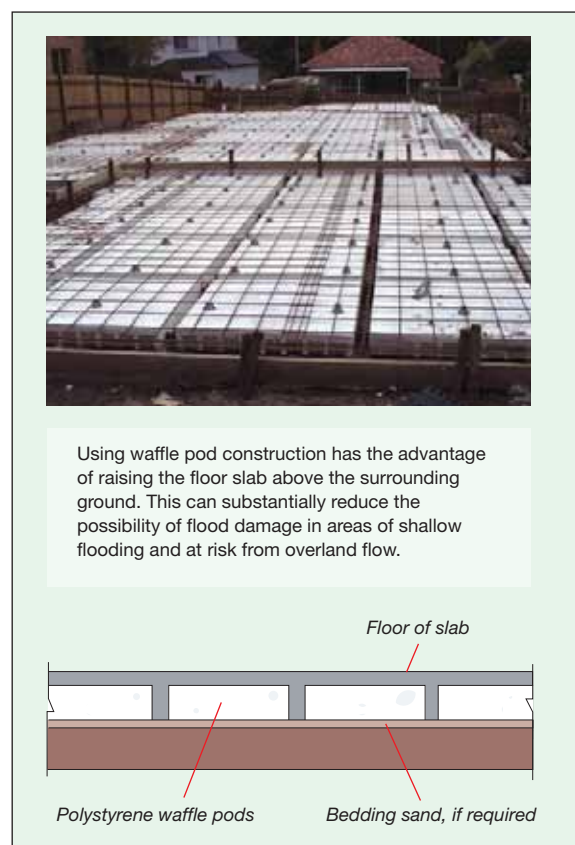
Figure 68 Waffle pod construction

Raising of the slab could also be achieved using waffle pods, (Figures 68 and 69).

Waffle pods can be constructed using polystyrene or similar blocks as permanent formwork. This can also assist with insulation of the underside of the slab. However, consideration needs to be given to the extra buoyancy that will be associated with the blocks. In some rare cases, this additional buoyancy may result in flotation of the house or create stresses not allowed for in the slab.

Raising the slab via fill or waffle slabs needs additional attention where flow velocities may lead to erosion of the fill and possible undermining of the house.

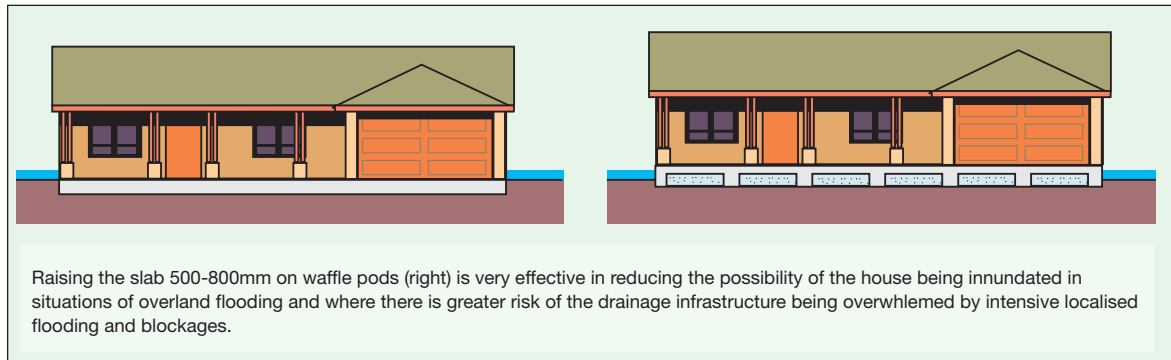
Figure 69 Raising the slab using waffle pods

Pier and beam construction should be considered ahead of cut and fill foundations on floodplains.

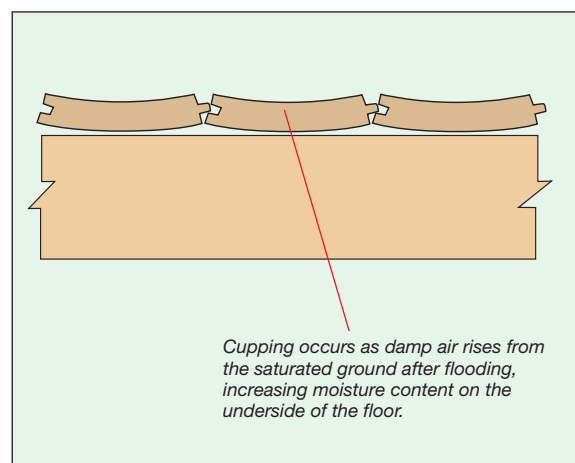
Figure 71 Cupping of strip flooring after immersion

- Both particleboard and plywood lose about 50% of their strength after 96 hours of immersion. Consequently, caution has to be taken when reloading such a floor especially if still wet .
- Particleboard floors may have to be entirely replaced. Depending on the period of immersion, particleboard will have a residual strength loss of 25% after drying. Plywood sheeting regains most of its normal strength after drying.
- Strip flooring recovers its full strength. However, while it is wet it may buckle and cup, “popping” its nails. It can also swell to such an extent that it pushes surrounding walls out of position, (Figure 71).
