REDUCING VULNERABILITY OF BUILDINGS TO FLOOD DAMAGE

Guidance On Building In Flood Prone Areas

Prepared for the Hawkesbury-Nepean Floodplain Management Steering Committee

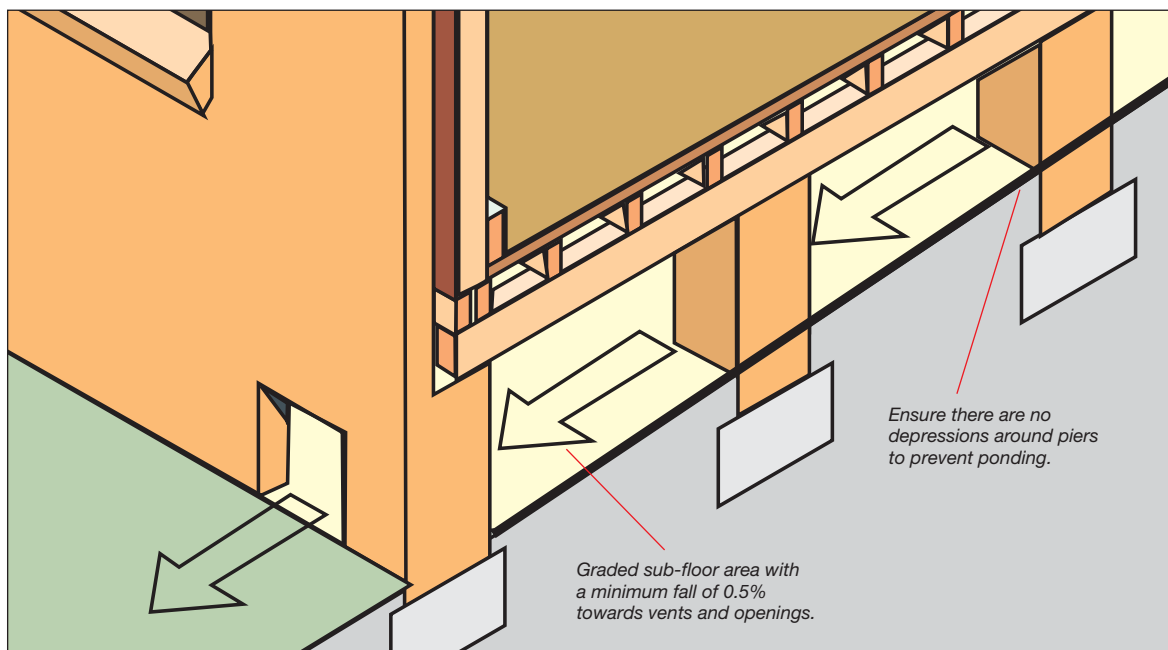
Figure 72 Graded sub-floor area to prevent ponding

levels. These are often created when strip footings are not backfilled. The sub-floor area must be filled and levelled to ensure that it is highest at the centre and drains to the edges. During floods, hollows can be scoured by fast flowing water, (Figure 72).

There should be no hollows under the house which may hold water and maintain high moisture

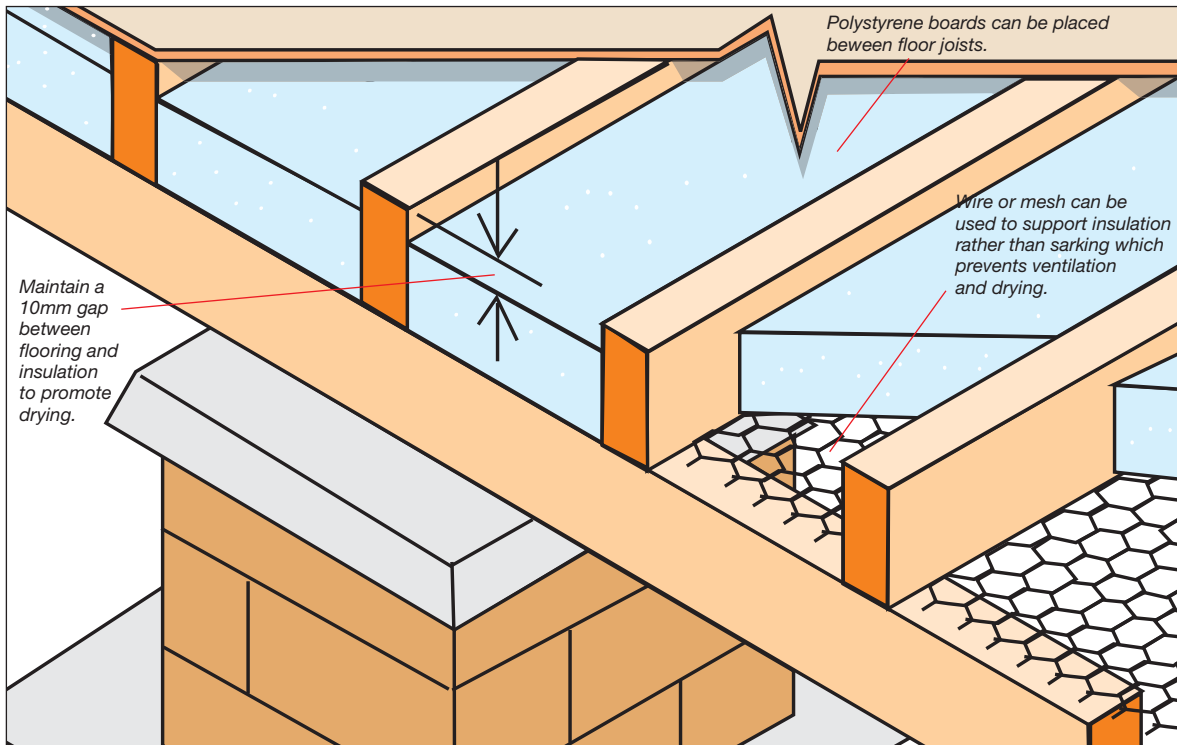
Figure 73 Under floor insulation

If insulation of suspended timber floors is required, it is recommended that polystyrene boards, or similar, be installed between the floor joists and held in place by wire mesh. Alternatives are reflective foil stapled to the underside of the joists, or polystyrene boards laid under the flooring, (Figure 73).

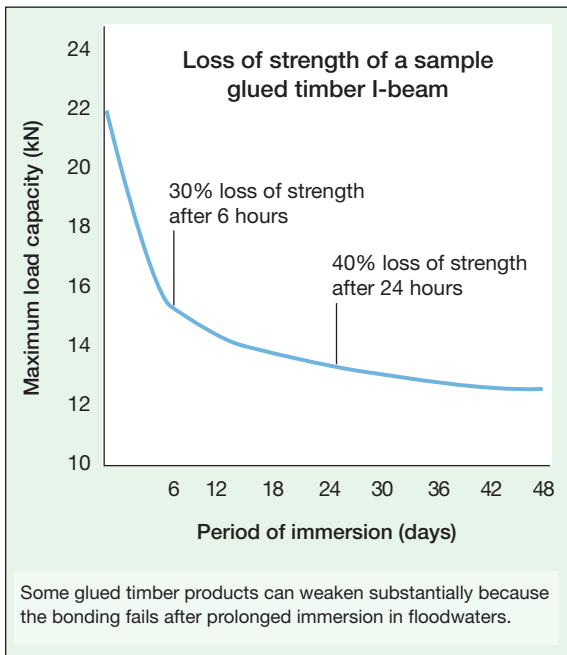
Figure 75 Loss of strength of a sample glued timber I-beam

can lose significant strength and have an increase in deflection when loaded. For example, glued I-beams with oriented strand board (OSB) webs showed a strength loss of around 45% and metal web timber trusses showed a loss of around 35%. Glued connections can fail and nail plate connectors can release their grip at much lower loads when wet. Recovery of strength after drying depends on the type of engineered beam. For this reason, their use in locations where they may be immersed in floodwater requires special considerations, (Figure 75 and 76).

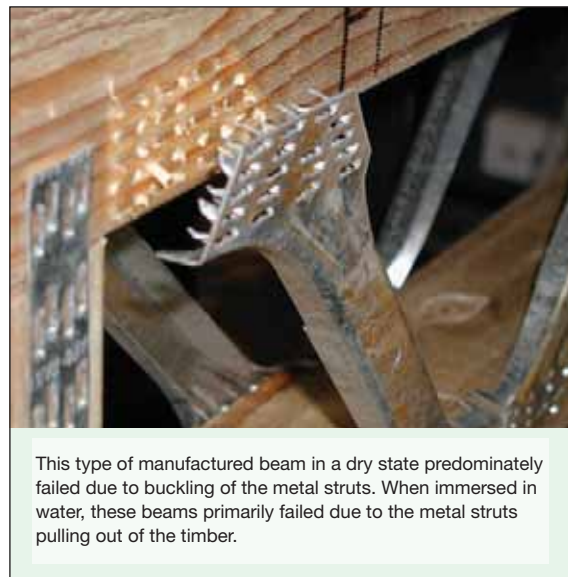
Figure 77 Beam failure

There is a wide range of different types of engineered timber and timber/steel composite beams available and their performance varies when wet, (Figure 77). The limited testing for these guidelines is not to provide advice on specific products, but to examine the types of problem that might be encountered and how they might be alleviated. The following suggestions are made for the use of any beam which has been glued, or has nail plates, punched connector plates or similar connections:

- If possible, moisture resistant adhesives (such as resorcinol glues) should be used throughout the beam.
- The allowable span for engineered beams should be reduced to around 70% of that normally used. For example, when providing a beam for an actual span of 5 metres, a beam suitable for a span of 7.2 metres under the same loading should be used. Alternatively, the beam should be

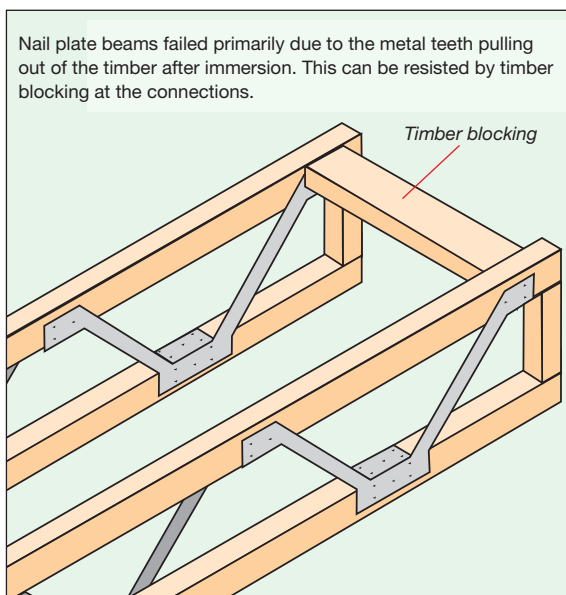
Figure 78 Blocking of nail plates

- Where possible, nail plate or similar connectors should be installed with additional grip. This may be achieved by using plates with longer or more teeth (or nails) as normally required or perhaps by “blocking” between the beams bearing on the nail plates to restrict parting of the connector from the timber, (Figure 78). Any measures adopted are especially important in areas of high shear or compression forces, e.g. the first few plates at the end of simply supported spans, and should be undertaken to manufacturer’s recommendations or other qualified professional advice.

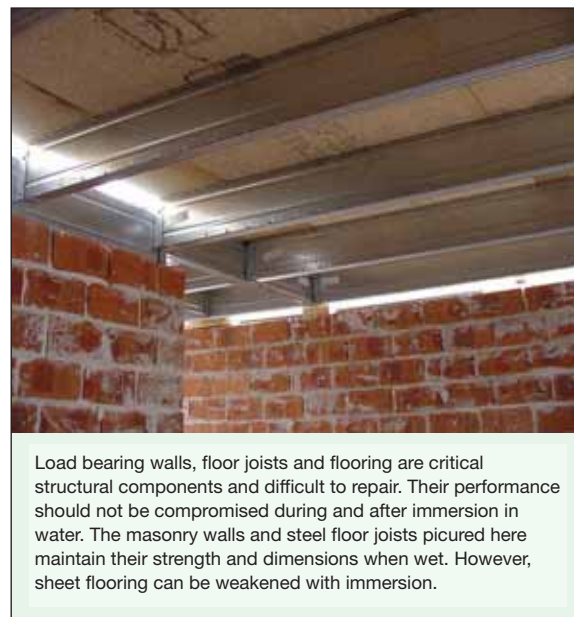
Figure 79 Use of steel beams

Many of the problems associated with suspended floors can be reduced by the use of steel support members. As part of steel framing systems, floors are now sometimes supported on light gauge steel beams. Open section steel members are preferred over closed, hollow sections which may trap silt, water and other contaminants, (Figure 79). This material may be hard to remove and may prolong the drying period and increase the risk of corrosion.

galvanised it is likely that they should perform satisfactorily after one-off flooding. However, when selecting an appropriate system consider the following issues:

- whether all components are adequately protected against corrosion,
- impact of cutting and/or welding on corrosion protection systems,
- whether the members are closed or open sections,
- whether trapped silt or other contaminants or debris may promote corrosion,
- whether the system will be accessible and easily cleaned after flooding.

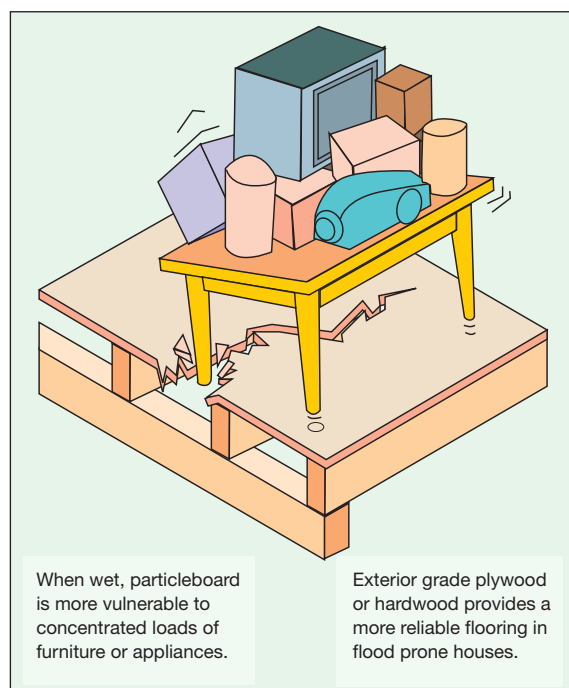
Figure 80 Concentrated loads

Particleboard is even more undesirable in areas likely to be subjected to high furniture and other “dead” (i.e. static) loads. This is especially the case where individual legs of heavy furniture and appliances, e.g. beds and heavy tables, do not effectively spread the load to the floor joists and can punch through a weakened floor, (Figure 80).

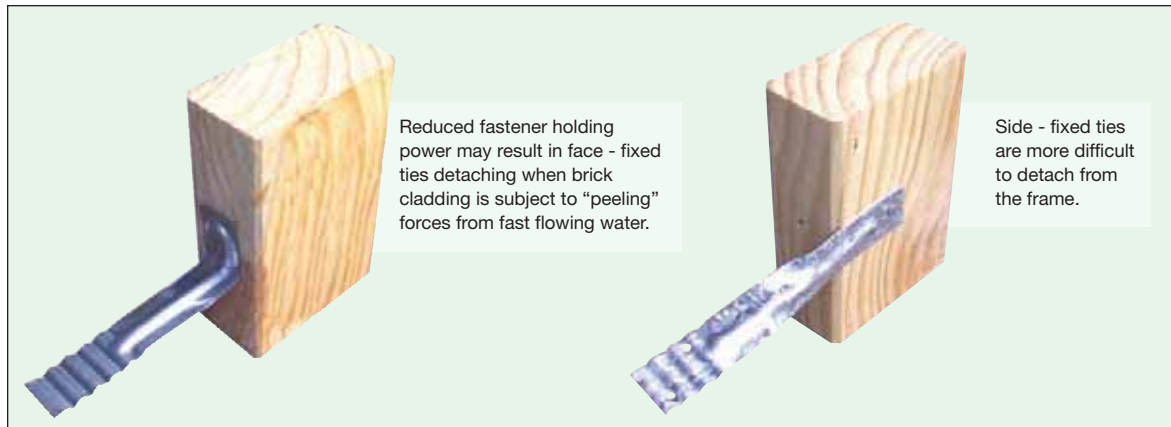
Figure 81 Preferred brick wall ties

Side-fixed brick ties will resist pull-out better preventing water forces peeling bricks away from the frame.

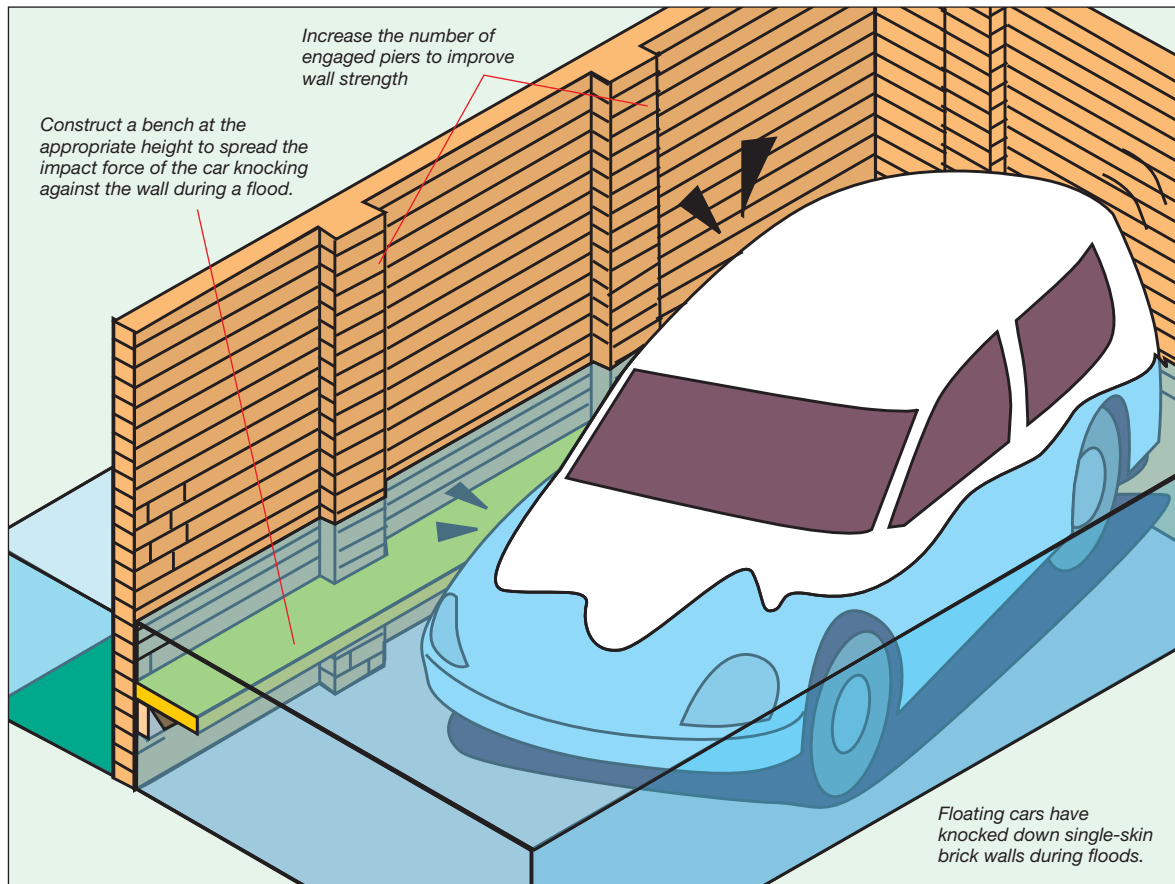
Figure 82 Protecting garage walls

Single skin brick walls on garages sometimes collapse during flooding. A contributing factor to this is that floating cars can impact on the wall. To reduce the chance of this happening, consideration should be given to decreasing the distance between engaged piers or otherwise strengthening or protecting the wall. For example, a workbench could be placed along the wall which would help shed the load to the engaged piers rather than the single skin portion of the wall, (Figure 82).

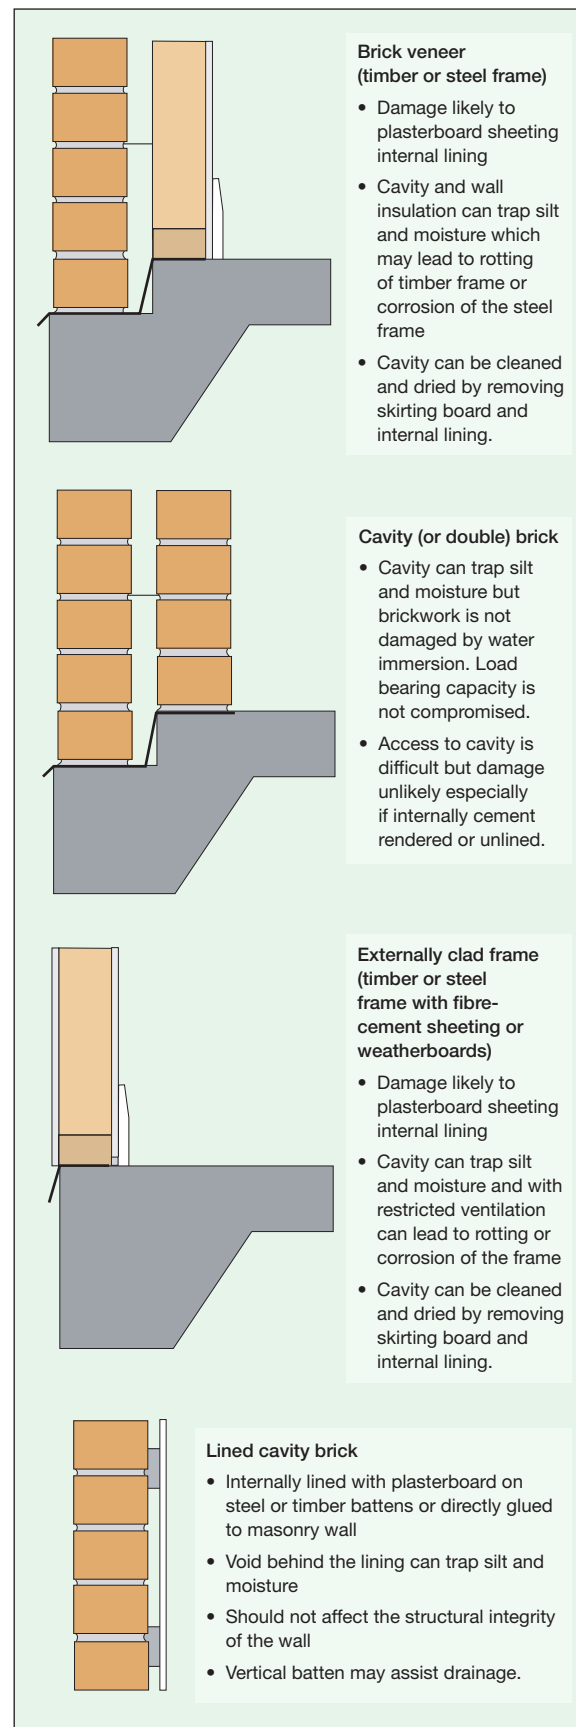
Figure 84 Problems in wall cavities

- Wall insulation materials can trap silt and moisture and slow the drying process by restricting air circulation. Some types of insulation may slump when wet, increasing the chance of deformation of the wet plasterboard or contact with the external skin.

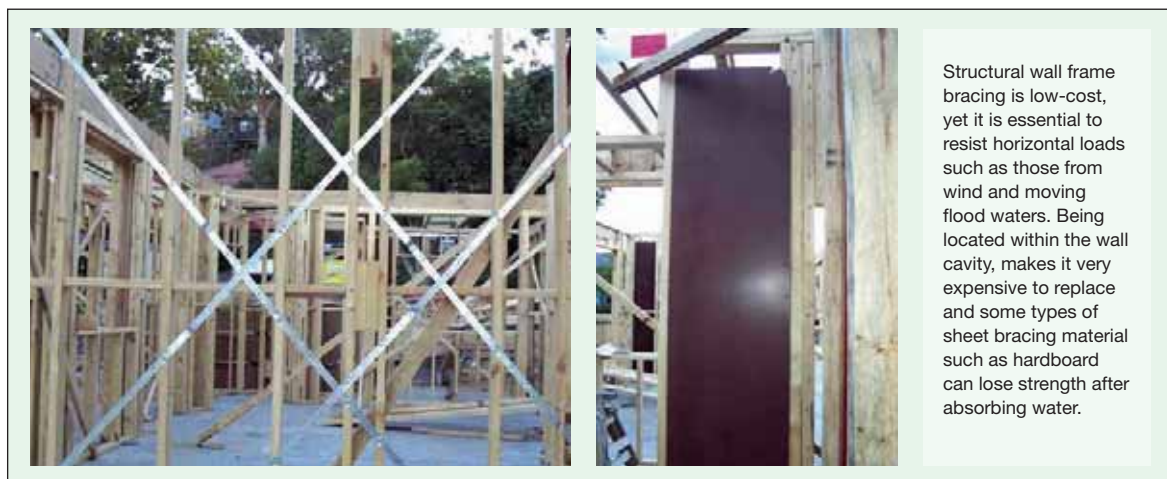
Figure 85 Durable frame bracing

Some wall bracing materials reduce in strength when wet, in particular hardboard sheet bracing, (Figure 85). The exception is galvanised steel strap bracing, which is unaffected and able to cope with floods longer than flash flooding. Section 5.4.3 provides advice on the best materials for wall bracing. Where sheet bracing is used, it is recommended the spacing between nails be decreased and that the nails be positioned as far as possible from the edge of the bracing. Bracing which may suffer permanent damage increases the risk of failure under high wind or possibly earthquake loading.

The design strength of sheet bracing should be downgraded to account for 30% loss of its capacity when wet.

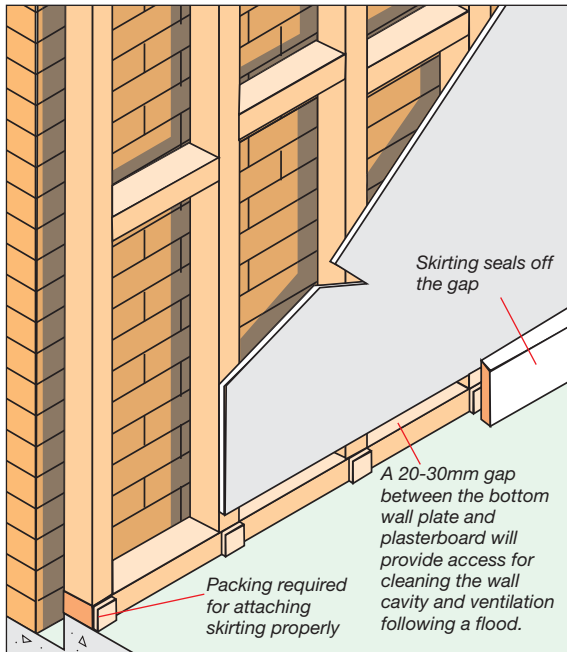
Figure 86 Providing internal access to wall cavities

Raising all lower plasterboard sheets on internal walls slightly above the bottom wall plate will allow access to the cavity for cleaning after flooding.

All lower sheets of plasterboard can be attached with a 30mm gap above the bottom wall plate level. This allows access to the cavity following a flood for ventilation and cleaning purposes. Skirtings will cover this gap and packing will be required between the skirting and the bottom plate to assist attachment. Additional backing could be considered in the middle of studs to support the bottom edge of plasterboard, (Figures 86 and 87).

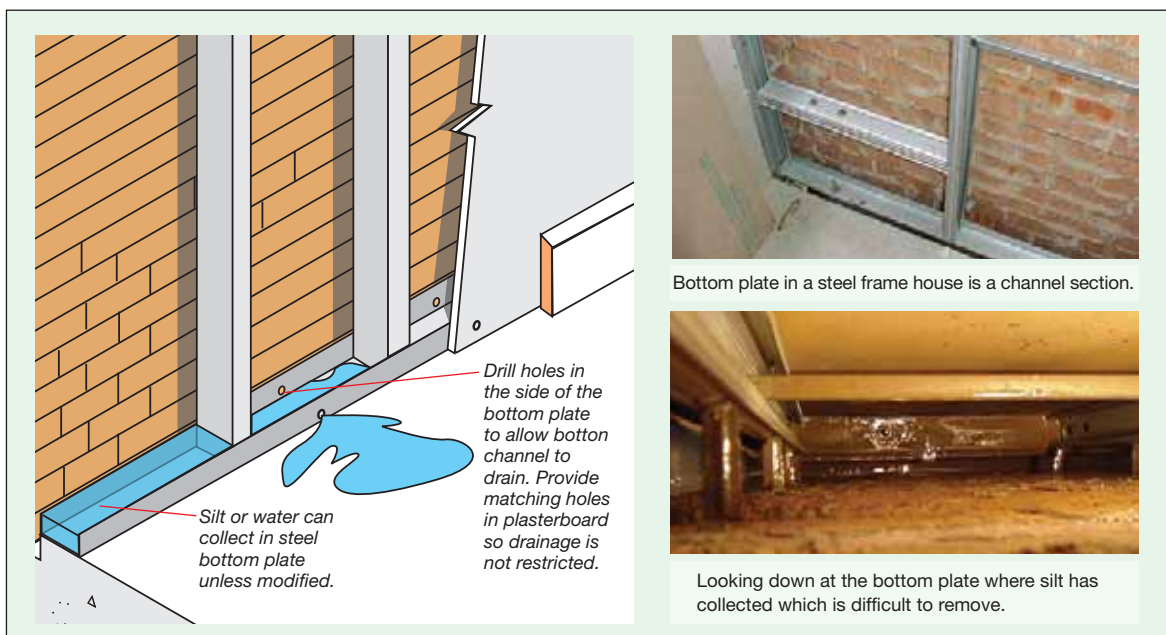
Figure 88 Drainage of steel frame

If steel framing is used, holes should be drilled in the side of the bottom plate to allow the bottom channel to drain and to be hosed out, (Figure 88).

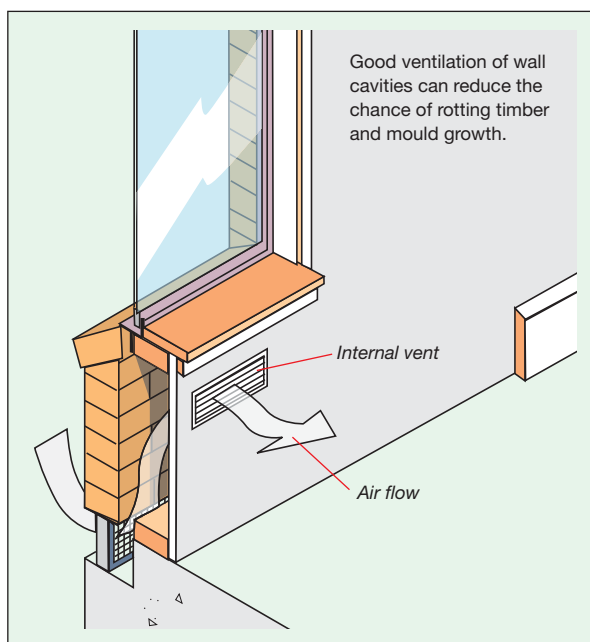
Figure 89 Venting under windows

Such vents should be provided under long windows as experience has shown that these areas act as moisture traps and dry out very slowly after a flood, (Figure 89).

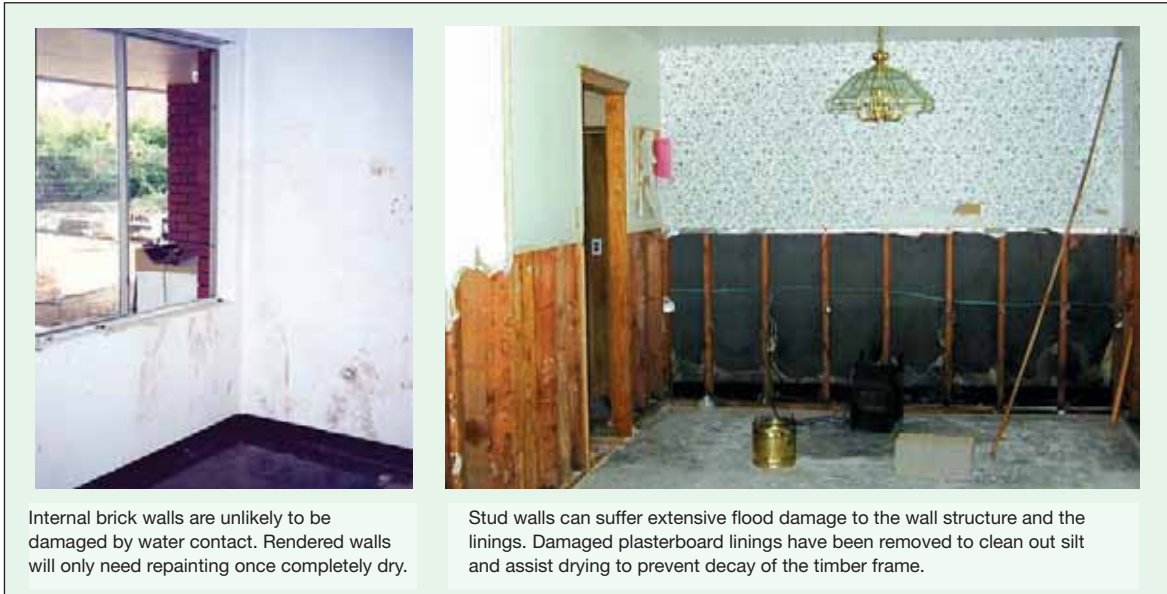
Figure 90 Internal linings

In locations with a severe silt problem, linings may need to be removed to access the cavity so that it can be cleaned out, (Figure 90). The use of more durable internal linings such as fibre cement which are screwed, not nailed and glued, to facilitate removal and re-use are a good option. Alternatively, the use of weatherboard cladding externally could provide an alternative method of accessing the cavity by removing a few boards.

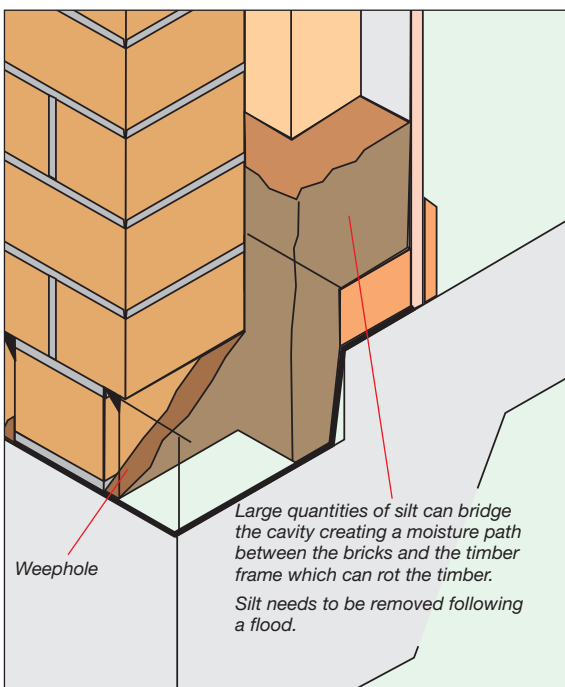
Large quantities of silt can bridge the cavity creating a moisture path between the bricks and the timber frame which can rot the timber. Silt needs to be removed following a flood.

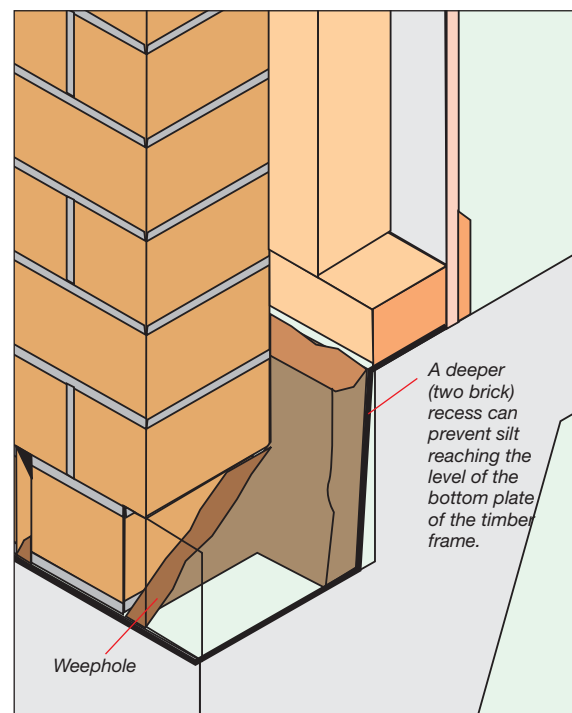
A deeper (two brick) recess can prevent silt reaching the level of the bottom plate of the timber frame.

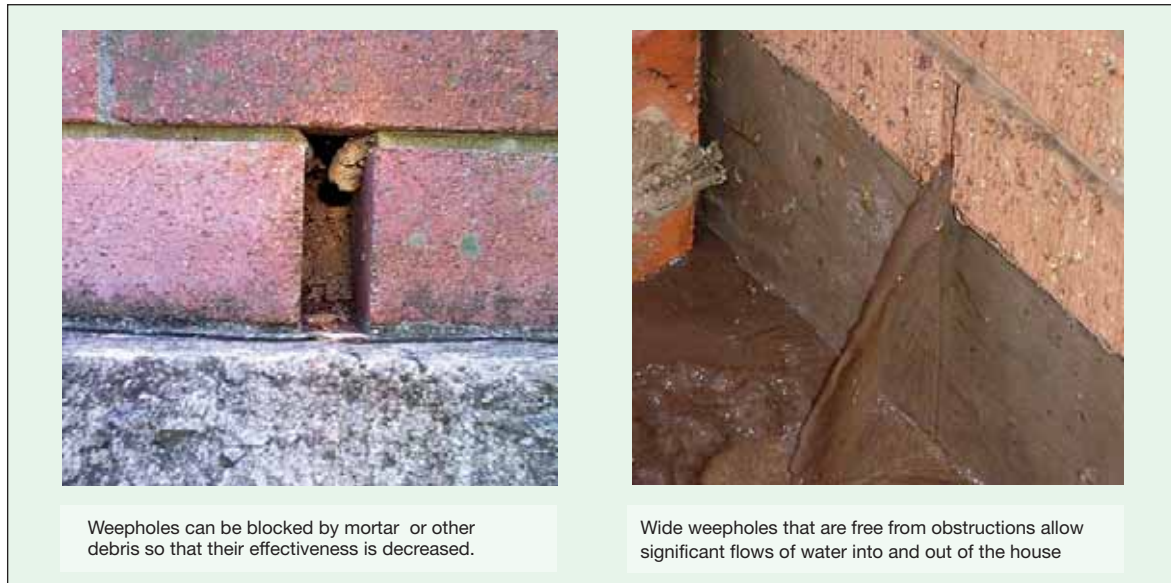
Figure 93 Careful detailing of weepholes to avoid problems

Keeping the base of the cavity clean from building waste and mortar droppings during construction will reduce the possibility of moisture transfer to the framing, (Figure 93).

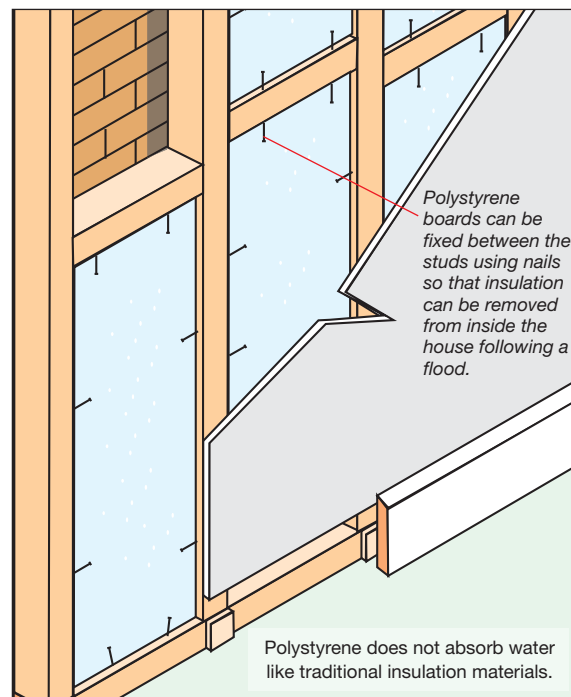
Figure 94 Polystyrene insulation in walls

The buoyancy forces of polystyrene during flooding will require firmer fixing of the boards than in standard installation and they may need to be removed for cleaning or drying the cavity after a flood. The fixing should allow insulation boards to be removed from inside the house by using medium/heavy gauge nails partially driven into the studs at a distance from the lining slightly bigger than the thickness of the polystyrene boards. The boards would then sit between the lining and the exposed portion of the nails. Four nails could be used in each bay formed by adjacent studs and the noggings, (Figure 94).

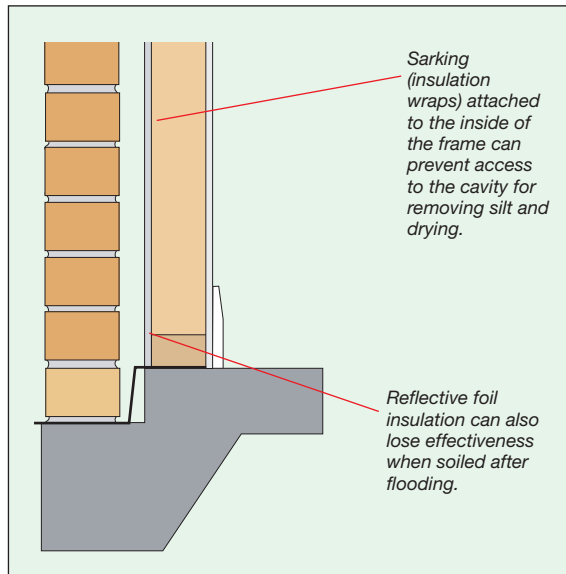
Figure 95 Problems with access to the cavity

The use of reflective foil placed between the studs and the cladding or bricks is less effective because it may lose significant R-value with the post-flood deposition of silt and other matter, (Figure 95).

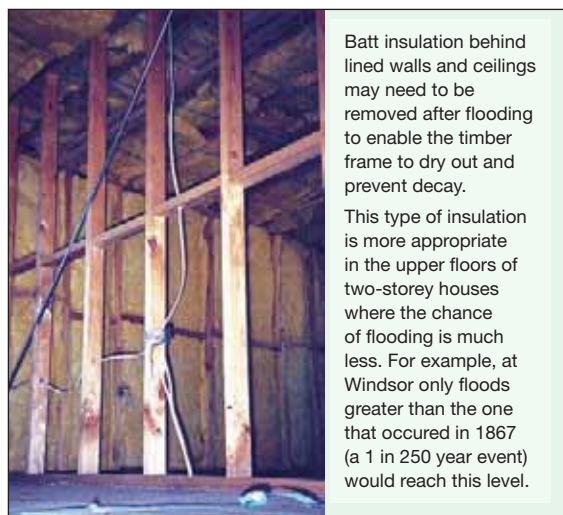
Figure 96 Problems with batt insulation

Conversely, flooding can affect insulation and reduce its effectiveness. It is important to consider the difficulty and cost involved in replacing flood damaged insulation, (Figure 96). It is much better to use the correct insulation to begin with than have to remove cladding or linings to access flood-damaged insulation. This is particularly important in walls and ceilings attached to roof rafters.

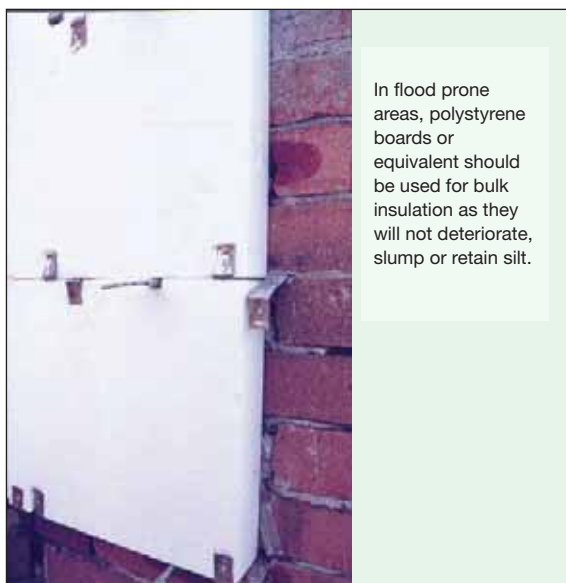
Figure 97 Use of polystyrene insulation

It is recommended that in flood prone areas, polystyrene, or similar boards be used for bulk insulation applications as they do not have these disadvantages, (Figure 97).

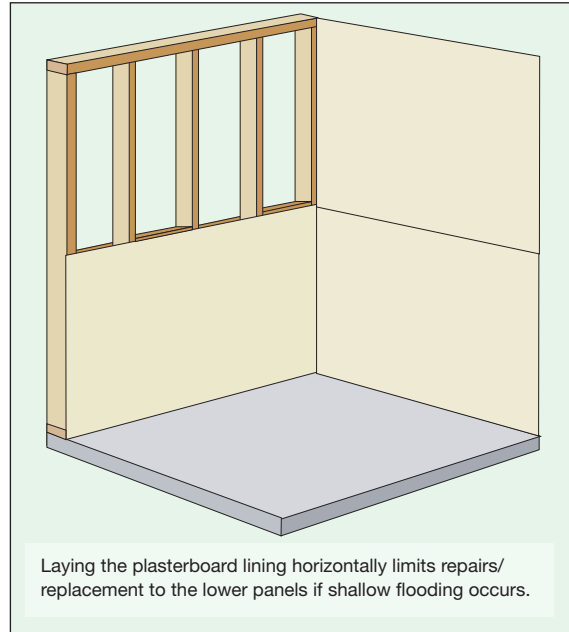
Figure 98 Laying of wall lining panels

Plasterboard panels should be laid horizontally rather than vertically (as in normal practice), so that if damaged in shallow flooding, only the bottom panels require replacement, (Figure 98).

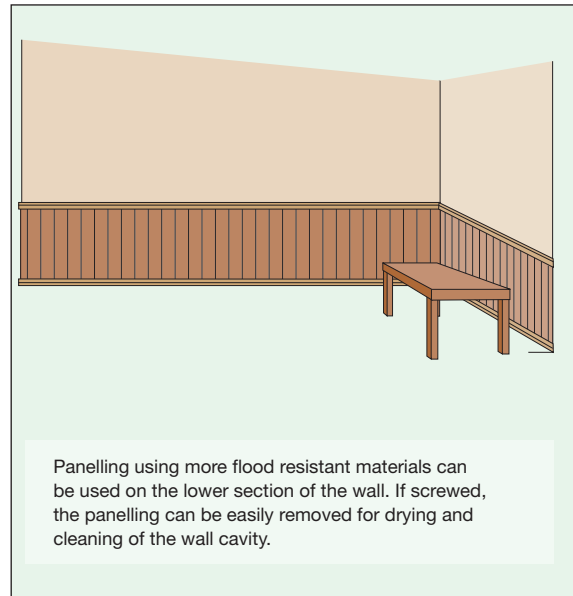
Figure 99 Panelling on the lower wall

A compromise can be made using a mix of materials. For example, timber panelling could be used in the lower portion of the wall with plasterboard higher up where there is less chance

of flooding. The join could be hidden by a dado rail. The panelling could also be screwed so that it can be easily removed to clean and ventilate the cavity, (Figure 99).

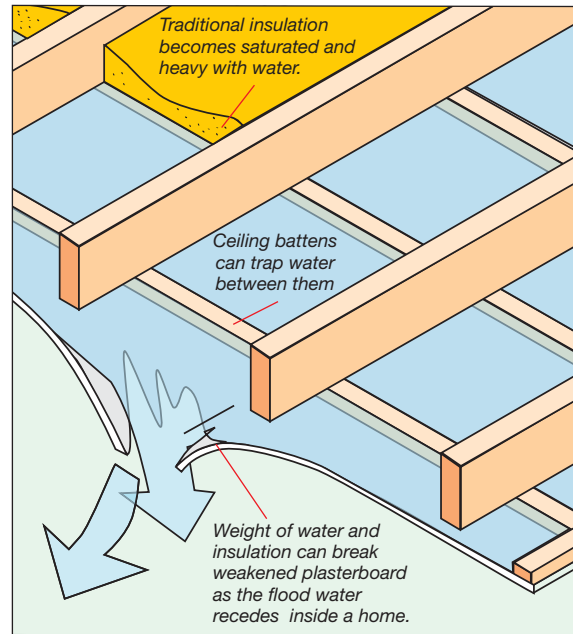
Figure 100 Problems of flooded ceilings

- Plasterboard ceilings may survive relatively short periods of immersion. However, being substantially weakened by longer immersion, they are normally destroyed by their own weight, and the weight of any trapped water and wet insulation as the water level falls. False ceilings are likely to be similarly damaged. Even if the ceiling does not collapse, it is likely that it will suffer permanent sagging, (Figure 100).

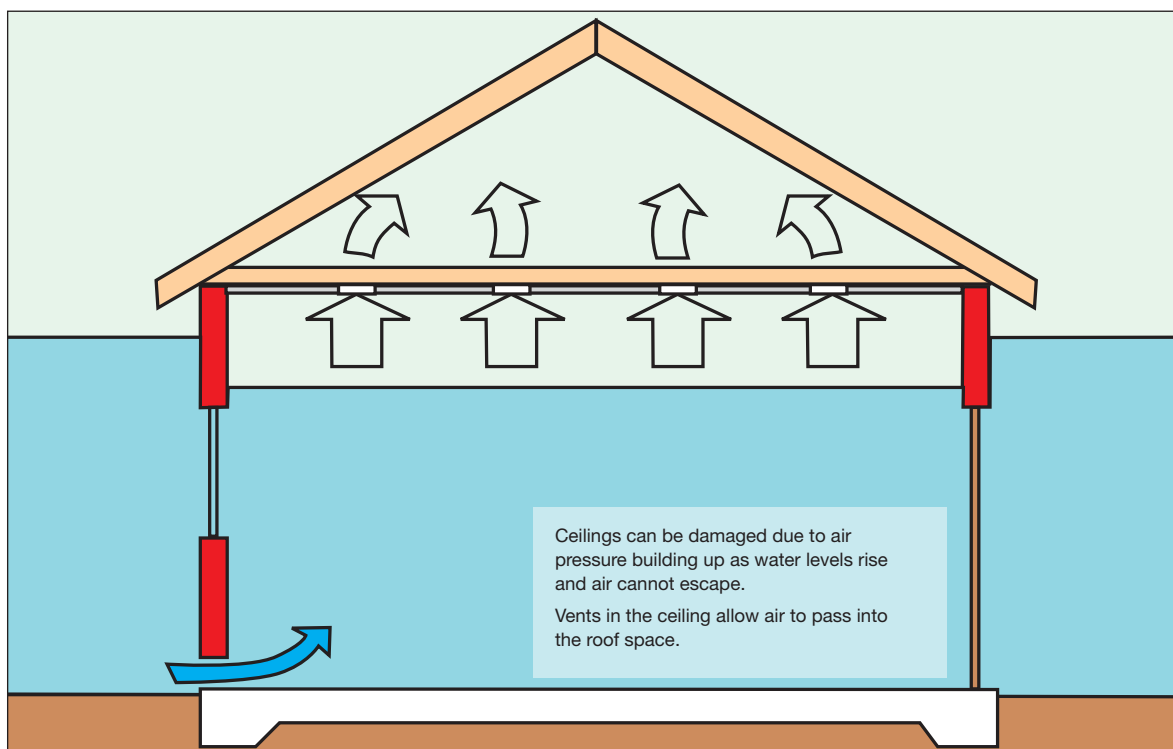
Ceilings can be damaged by high pressure forming in the trapped air inside rooms. Venting ceilings can avoid this problem.

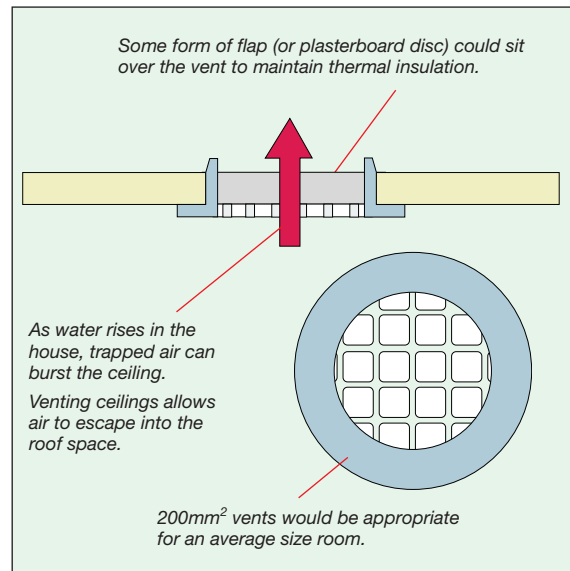
Figure 102 Ceiling vents to release air pressure

Provided the vents do not automatically shut, they could also assist in draining water from the roof space as the water level falls.

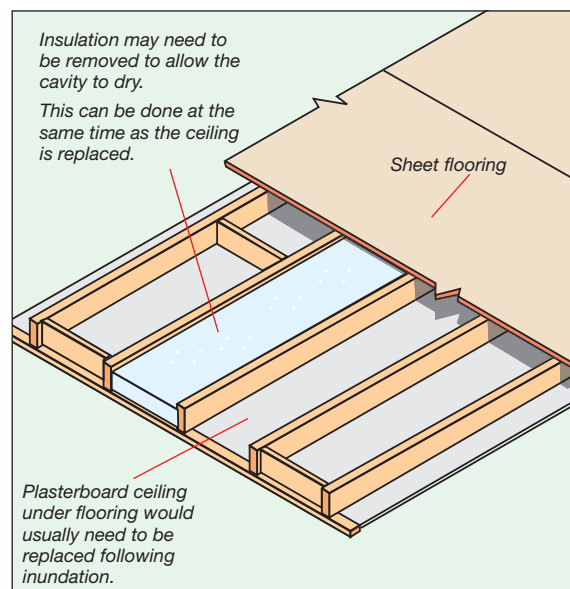
Figure 103 Repair of intermediate floors and ceilings

Given the extra height of ceilings and hence much lower chance of flooding (about a 1 in 300-year event at Windsor), it is not cost-effective to use alternative materials to plasterboard in the ceiling. If flood waters do reach the ceilings, they will

need to be replaced. When the ceiling is removed, access will be available to the ceiling space for cleaning and drying, (Figure 103).

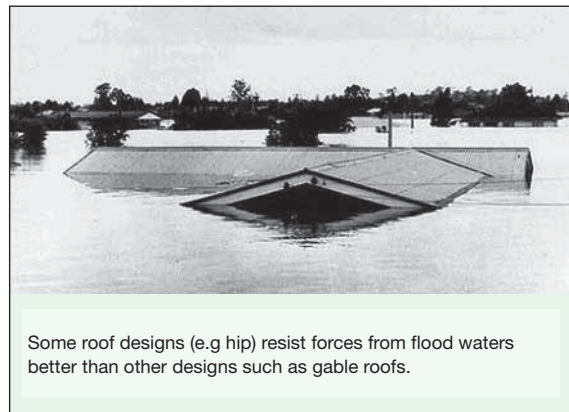
Figure 104 Roof design is important in resisting forces from flood waters

As flooding of the roof is likely to be rare, elaborate measures to reduce flood damage become less economical and difficult to justify. However, good practice can help reduce damage in severe events, (Figure 104).

Some roof designs (e.g hip) resist forces from flood waters better than other designs such as gable roofs.

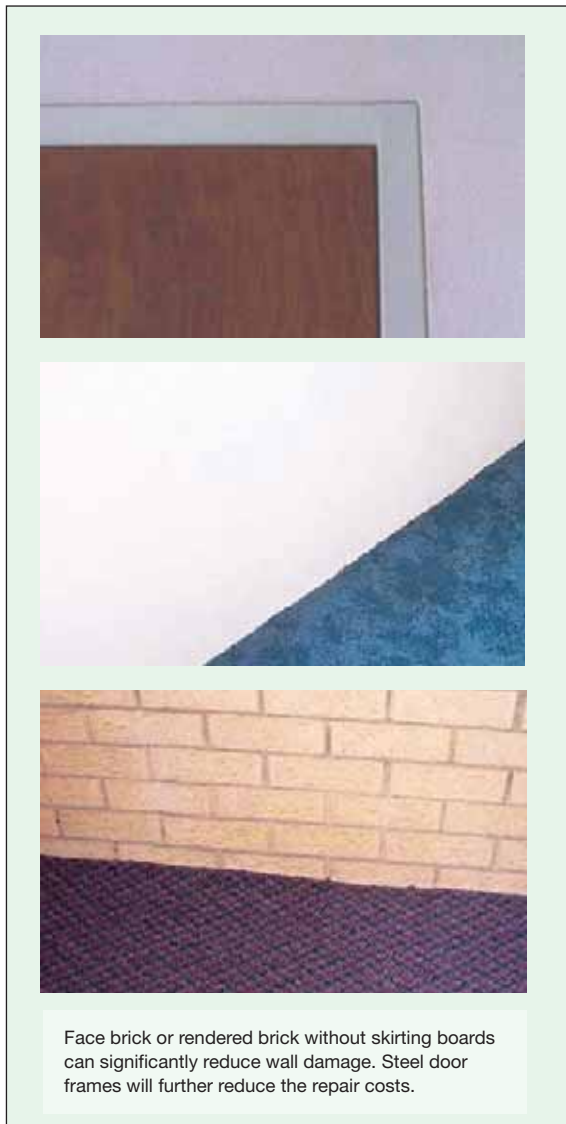
Figure 105 Reducing timber skirtings and architraves

Such construction also permits the use of steel door frames which require no architraves, (Figures 105).

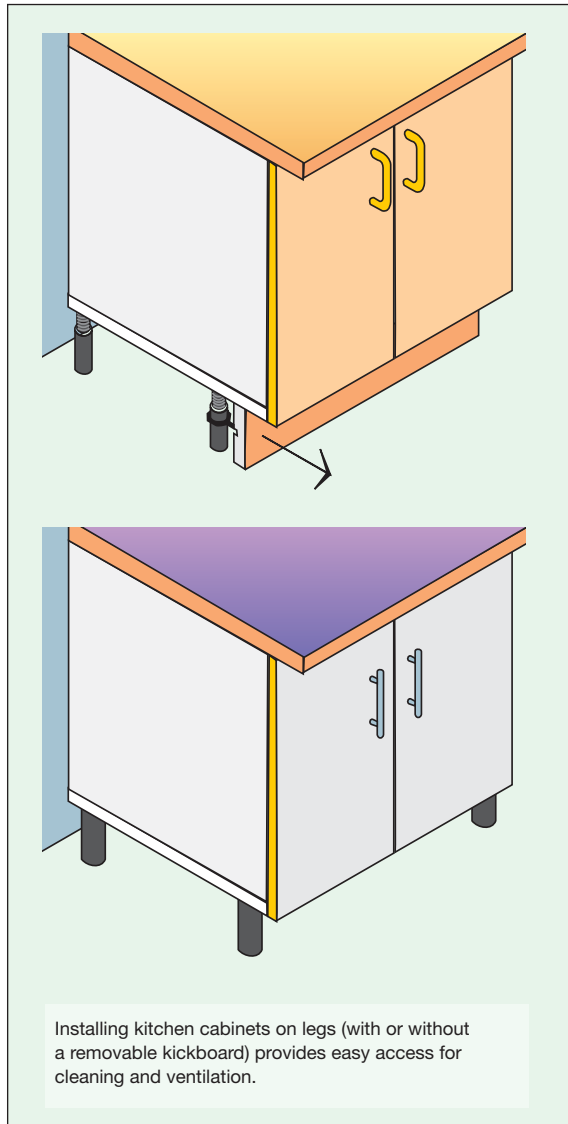
Figure 106 Access beneath kitchen cabinets

aspect that requires attention is the area behind the kickboard and under the bottom shelf. This is usually an inaccessible void space about 150mm deep between floor, wall and cupboard. Floodwater and debris can enter this area and provision must be made to be able to clean and dry this space. One solution is to use a removable kickboard and support the base of kitchen cupboards off the floor on short metal or plastic legs, (Figure 106).

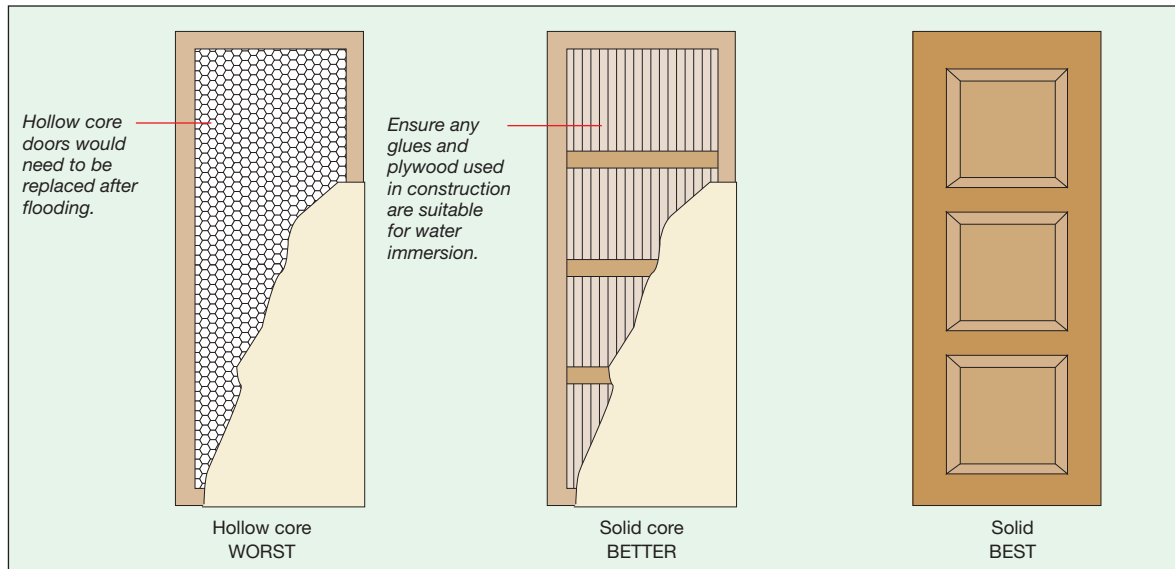
Figure 107 Rating of doors in flood events

Hollow core doors are relatively inexpensive and their replacement in a severe (though rare flood event) could be far more economic than providing solid doors, (Figure 107).

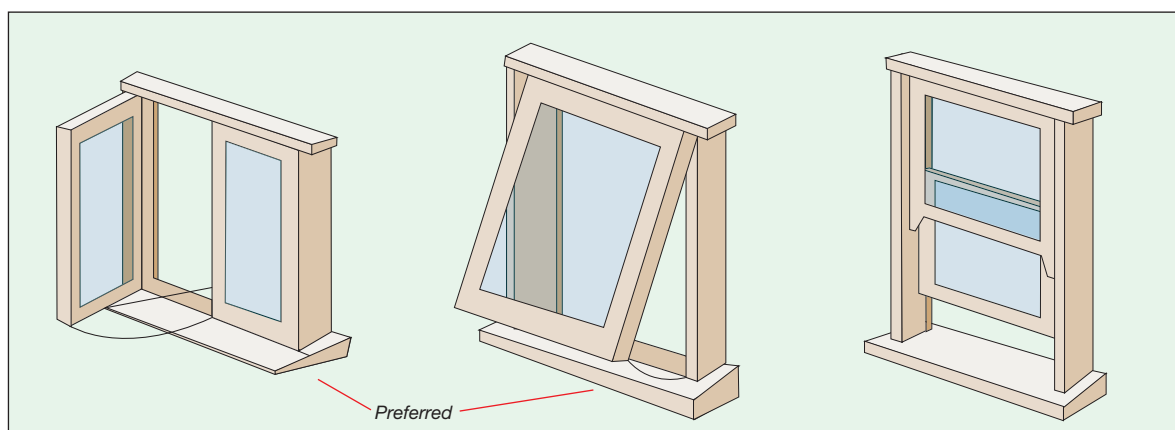
Figure 108 Timber window types

Timber windows absorb water and may result in difficulty opening them until they are dry. It is difficult to ensure that the timber is fully sealed as protection can be lost from rubbing surfaces. Consideration could be given to using windows which have less rubbing surfaces e.g. hopper windows in preference to sash windows, (Figure 108).

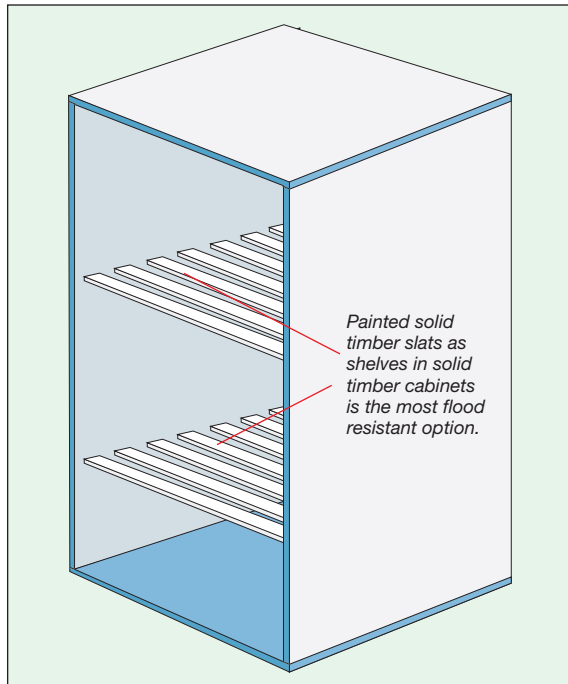
Figure 109 Flood compatible shelving

The most often used material for built-in furniture, including kitchen cabinets, is particleboard coated with plastic sheeting or laminate. Experience shows that particleboard loses its strength, swells and fragments when saturated and will have to be renewed after a flood. Laminated particleboard bench tops are similarly affected. However, an economic alternative (with similar benefits of low-cost, quick and simple construction and ease of cleaning) would be difficult to find, (Figure 109).

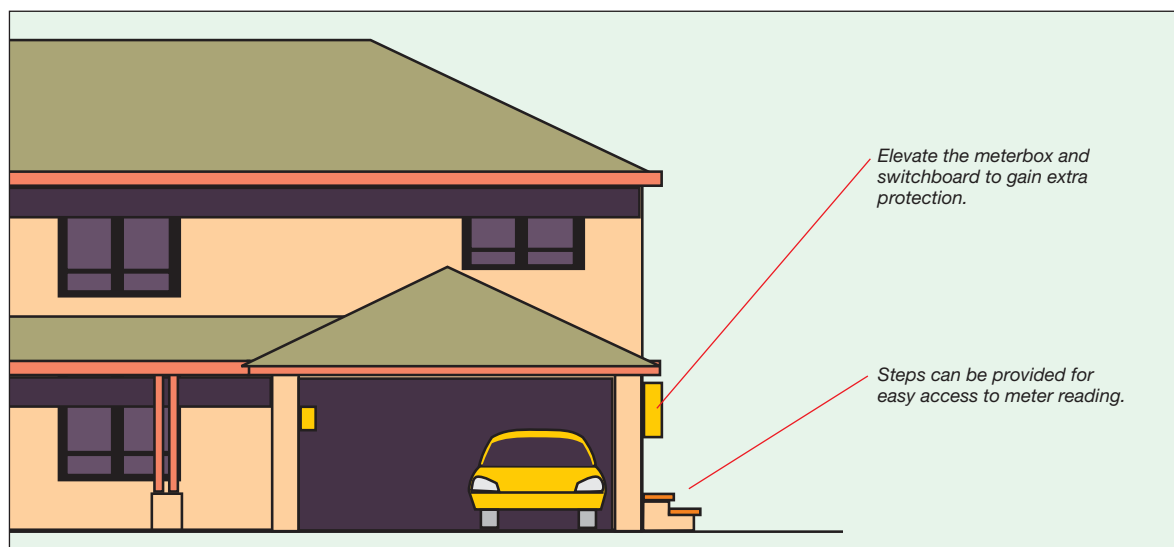
Figure 110 Elevated switchboards and meterboxes

In some cases major items such as switchboards and meter boxes, which contain easily damaged and expensive to repair or replace items, could be relocated to the upper floor or located higher under the eaves of single-storey houses to gain extra protection. However, it is normal for electricity suppliers to want the meter located close to the ground so it is readily accessible for their inspection and reading. Accordingly,

it is desirable to provide appropriate access to the upper floor or, for single-storey houses, to provide a separate raised platform with stairs. The electricity supplier and local council should be consulted to check on any requirements they may have. In addition, individual components should be located as high as possible within the meter box or switchboard, perhaps by making the box wider rather than taller, (Figure 110).

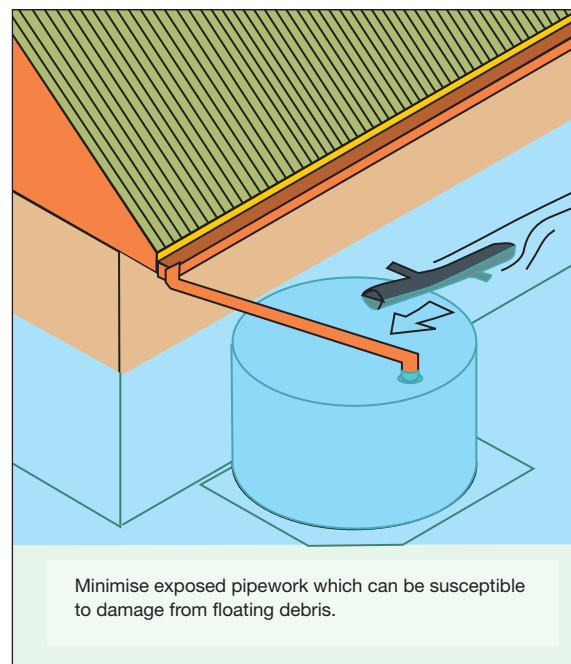
Figure 112 Exposed pipework

- Damage to exposed and buried components of the water supply systems including pipes and storage tanks from scour and floating debris, (Figure 112).

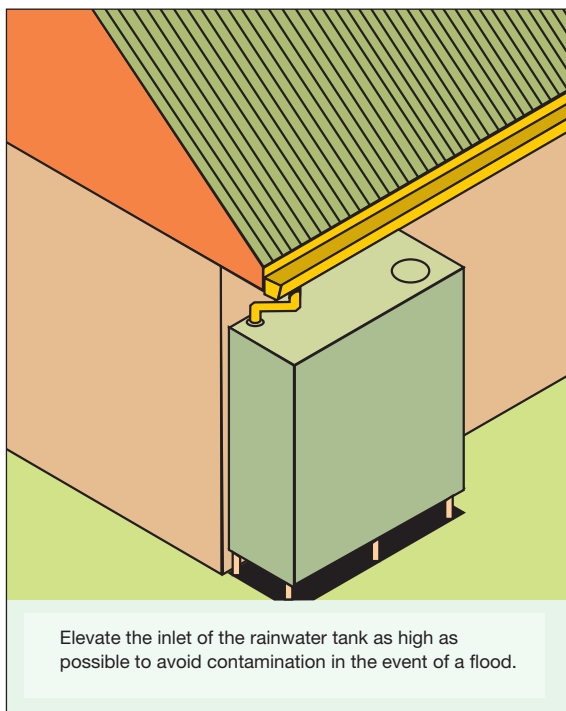
Figure 113 Rainwater tanks

To reduce the possibility of the water in rainwater tanks becoming contaminated, the inlet should be located as high as possible so it does not become submerged, (Figure 113).
