REDUCING VULNERABILITY OF BUILDINGS TO FLOOD DAMAGE

Guidance On Building In Flood Prone Areas

Prepared for the Hawkesbury-Nepean Floodplain Management Steering Committee

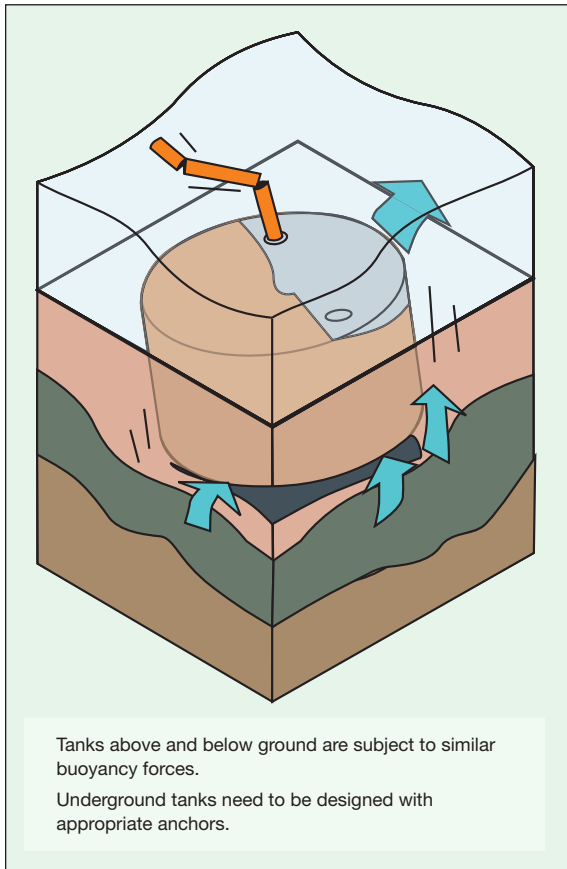
Figure 114 Flotation of buried tanks

Tanks (e.g. heater oil, septic, water heaters, rainwater, air ducts) may float, pop out of the soil, break away, or be damaged by floating debris. As well as damaging the system itself, this could also cause other damage due to impact or contamination from leaked contents. Associated pipes can break under dynamic forces especially where they pass through walls or are connected to equipment, (Figure 114).

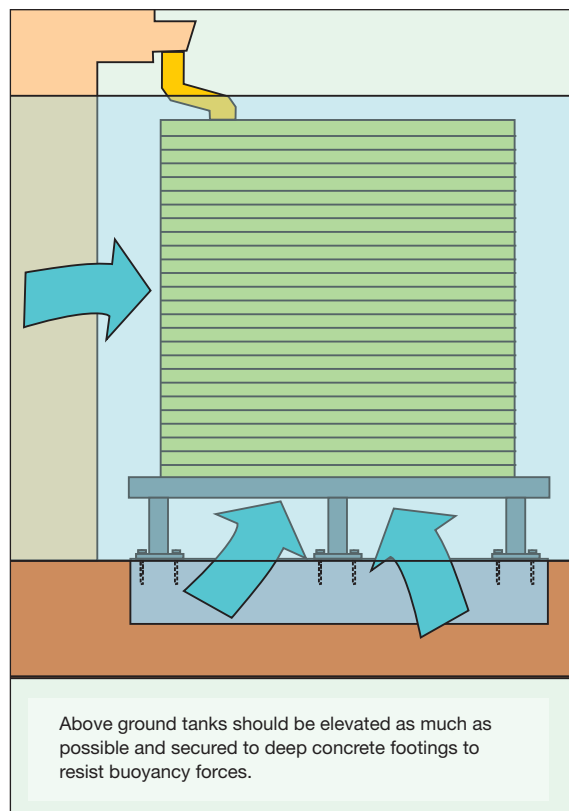
Figure 115 Protecting above ground tanks

Where feasible, above ground tanks should be elevated as much as possible to reduce the buoyancy forces but the support structures need to be designed to resist the forces. The supporting posts or columns should have deep concrete footings embedded below expected erosion and scour lines, (Figure 115).

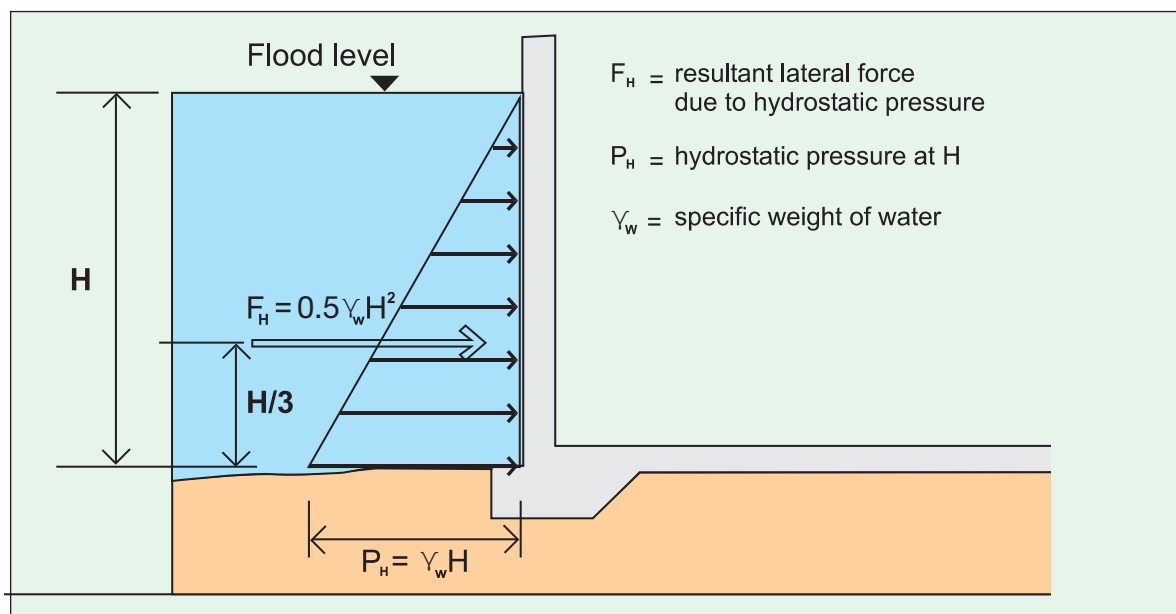
Figure 116 Hydrostatic forces result in a triangular distribution of force up the wall

= $1000 \text{ kg/m}^3 \times 9.8 \text{ m/s}^2 = 9,800 \text{ N/m}^3$) and H is the height (in metres) of the water against the wall surface as shown in Figure 116. Pressure increases proportionally with water depth so that pressure has a triangular distribution down the wall. The resultant horizontal hydrostatic force, F_H (in Newtons) acting per metre width of wall is given by the average pressure distribution times the wall area:

The buoyant force (F_B) is calculated by determining the volume of water displaced in the submerged or partially submerged object, and multiplying it by the specific weight of water. Figure 116 depicts a house with a slab on ground floor subject to a water level surcharge equal to H . The buoyant force, F_B , is then:

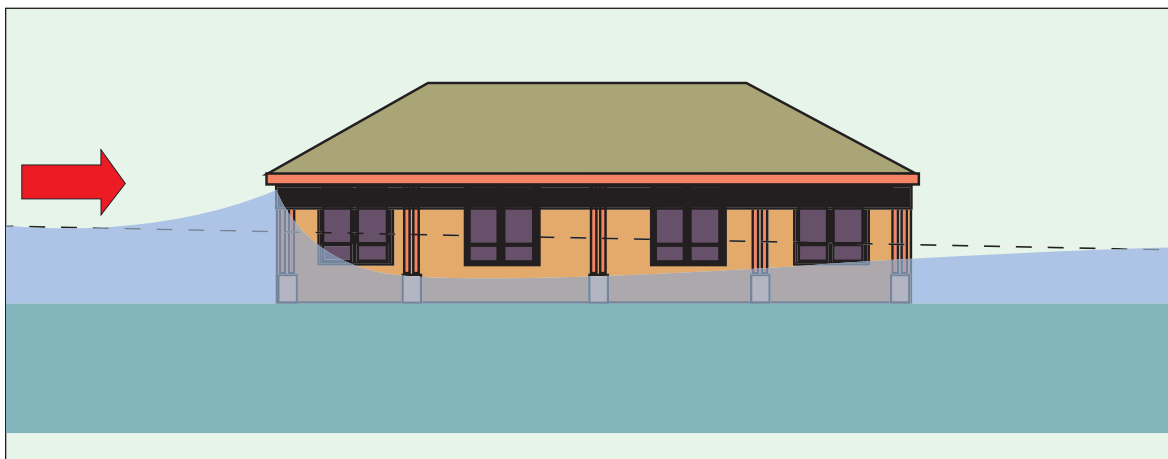
Figure 117 Hydrodynamic forces result mainly from the afflux on the upstream wall of the house

Pressures and associated forces vary because water levels are not constant when there is flow around a house. Generally the water depth increases on the upstream walls and decreases on the side and rear walls as shown in Figure 117. As long as there are sufficient openings in the walls and floors of the house, the internal water level will be relatively flat (somewhere between the external upstream and downstream levels). The increased water depths on the upstream walls result in an inward force on the wall. Similarly, the decreased water depths that normally occur on the side and rear walls result in an outward force on the wall that tends to strip the wall away from the house.

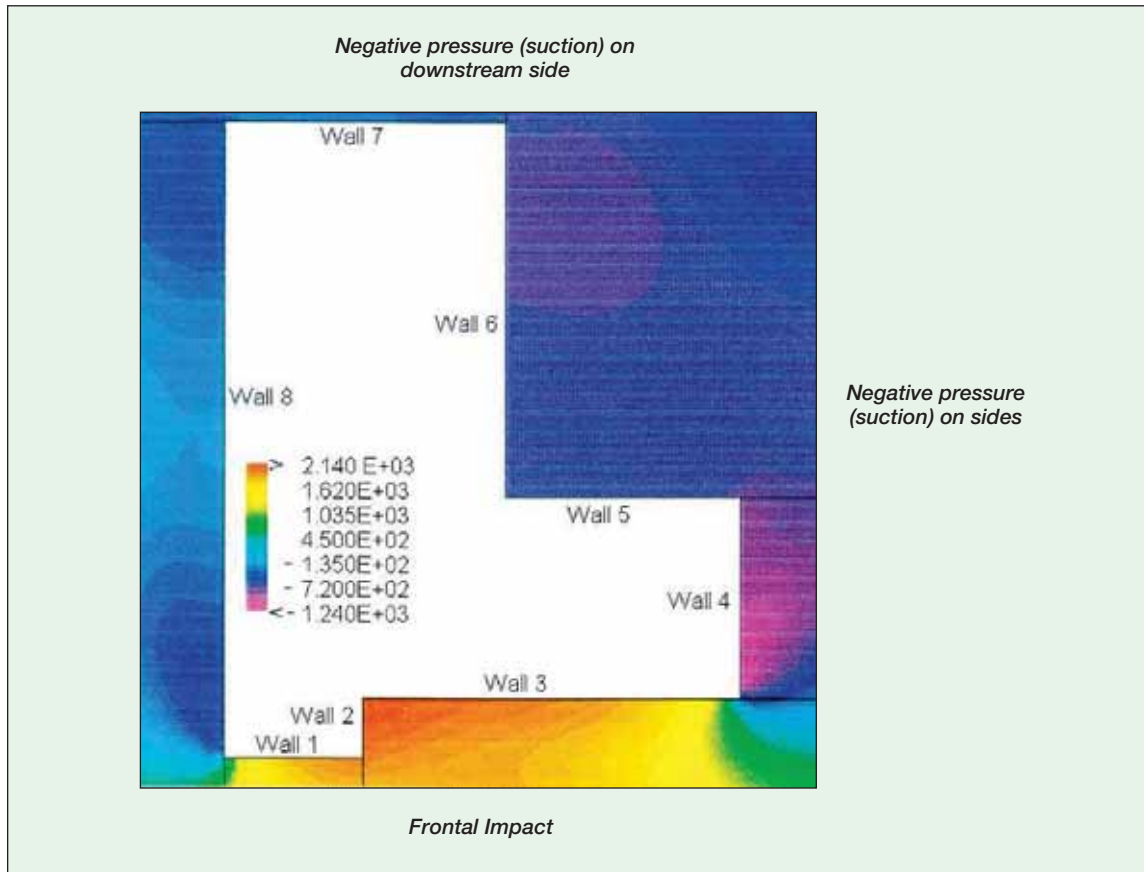
Figure 119 Pressure on walls of a house due to moving water, Water 2.4 m Deep, Pressures in Pascals

Figure 119 shows the pressures that occur around a house as determined by three-dimensional modelling of the flow around a house. These represent only the hydrodynamic pressures (i.e. the hydrostatic component is excluded) and represent a flow with an approach velocity of 1.5 metres/sec and 2.4 metres deep (eaves level of a single-storey house).

Calculating all the forces imposed on a house from flowing water is complex as it depends on a number of variables. It is important to appreciate that the water velocities around a house can be very different when the house is located in a close group of houses or on its own in an open field. Any change in velocity can significantly change the pressures on the walls. This is discussed in more detail in Appendix B.

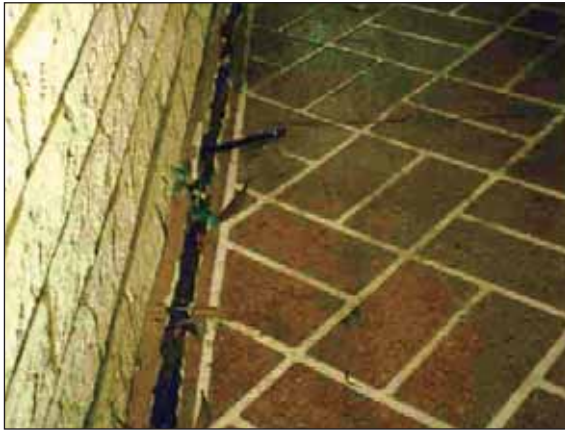
Figure 120 Brick wall bowed inwards due to water force

As an inward horizontal load on the *outside* of a brick wall increases, the brick cladding initially carries most of the load with progressive deflection and bowing of the wall likely to result in cracking along the mortar joints and even through the bricks themselves, (Figure 120). The load is also transferred by the brick ties onto the internal support structure - either an inner brick wall or wall frame. As the load increases the ties may compress, bend or disconnect and the cladding may even bear directly onto the internal support frame or wall.

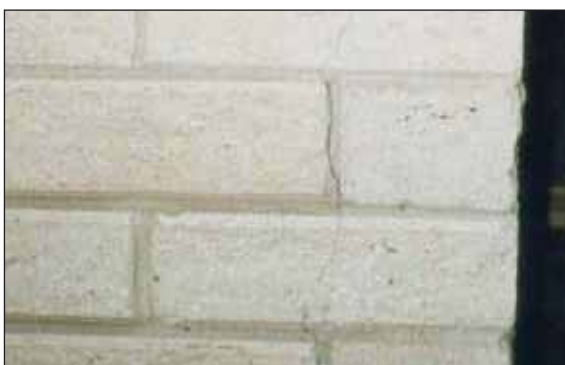
Figure 121 Vertical cracking at corner due to bowing of adjacent wall

The bowing or deflection may be sufficient to result in vertical cracking at locations where the

wall is supported by other walls. For example, the returns at the end of the walls, (Figure 121).

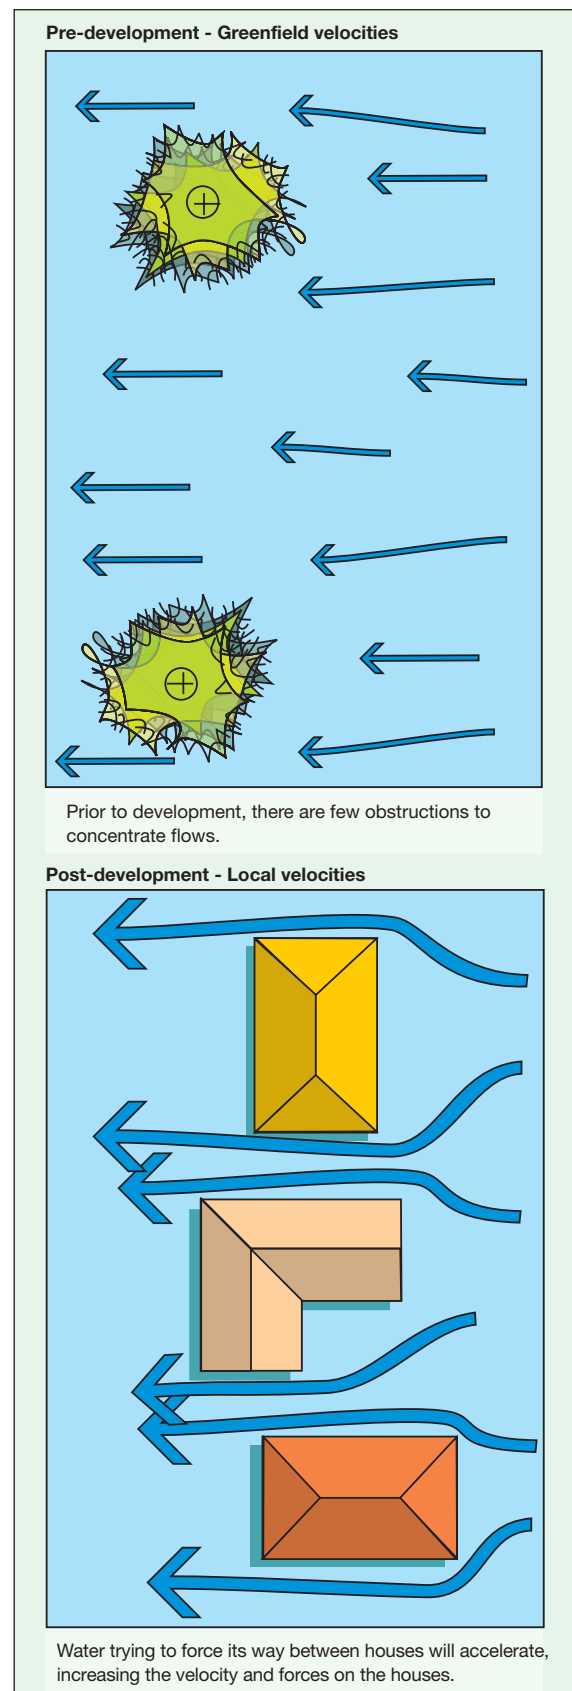
Figure 122 The difference between greenfield and local velocities

Computer modelling is commonly used in investigating flood behaviour at potential development sites and often this involves an assessment of pre and post development scenarios. Generally, the modelling results will provide a reliable estimate of the potential flood levels and flow velocities under existing conditions because physical parameters such as roughness, site topography, and flow paths are easier to determine. Sometimes results can be compared against any historical observations. However, these estimates only relate to pre-development or greenfield conditions, where in many cases the sites have been cleared and previously used for agricultural purposes, (Figure 122).

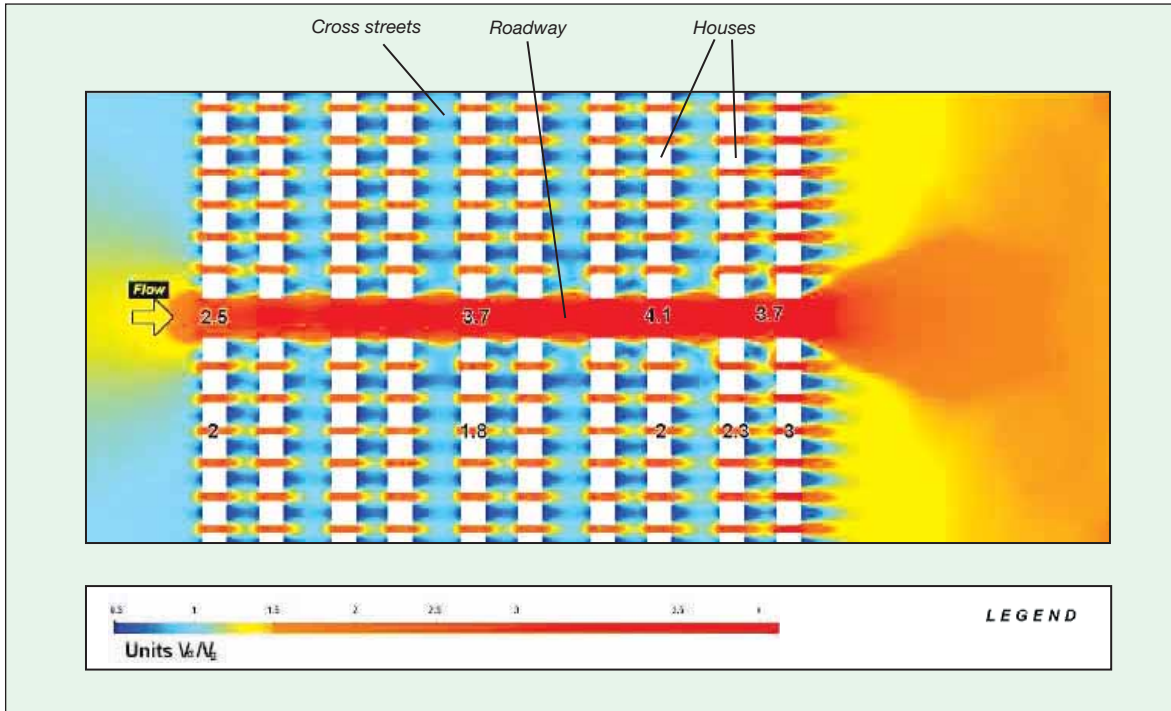
Figure 124 Increased velocity within developments

of the house. Figure 124 shows how the velocity changes between houses and within roadways of a simple rectangular grid layout of houses.

- light blue representing zones with velocities similar to the greenfield velocity,
- dark blue representing zones with reduced velocities e.g. directly in front and behind houses, and
- yellow to red representing zones with increased velocities e.g. in the roadway parallel to the flow and between houses.

This shows that velocities more than 4 times the greenfield velocities can be generated although results would be layout specific. In the above case, the flow passes through the development. Velocities could be reduced if a sufficient by-pass flow path was possible around the development.

For the same flood, the isolated house is subject to much lower velocities and forces than the same house surrounded by other houses in a subdivision because the obstructions severely restrict flow paths. Water trying to force its way between houses will accelerate, increasing the velocity and forces on the houses. Thus the “local velocity” between houses can be much greater than the greenfield velocity and the forces on the house are increased accordingly.

The more closely-spaced the houses, the higher the velocity. Any analysis of a site should examine the worst case likely to occur throughout the life

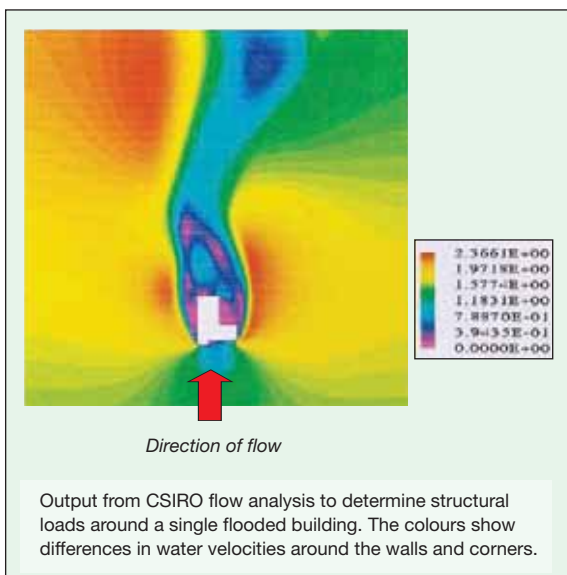
Figure 123 Flows and loads on an individual house

For example, Figure 123 shows the velocities that occur around a single isolated house in a relatively open area with no other obstructions. This demonstrates how the flow accelerates around the house with the velocities around the house up to 60% greater than the “unobstructed” greenfield velocity.

Output from CSIRO flow analysis to determine structural loads around a single flooded building. The colours show differences in water velocities around the walls and corners.

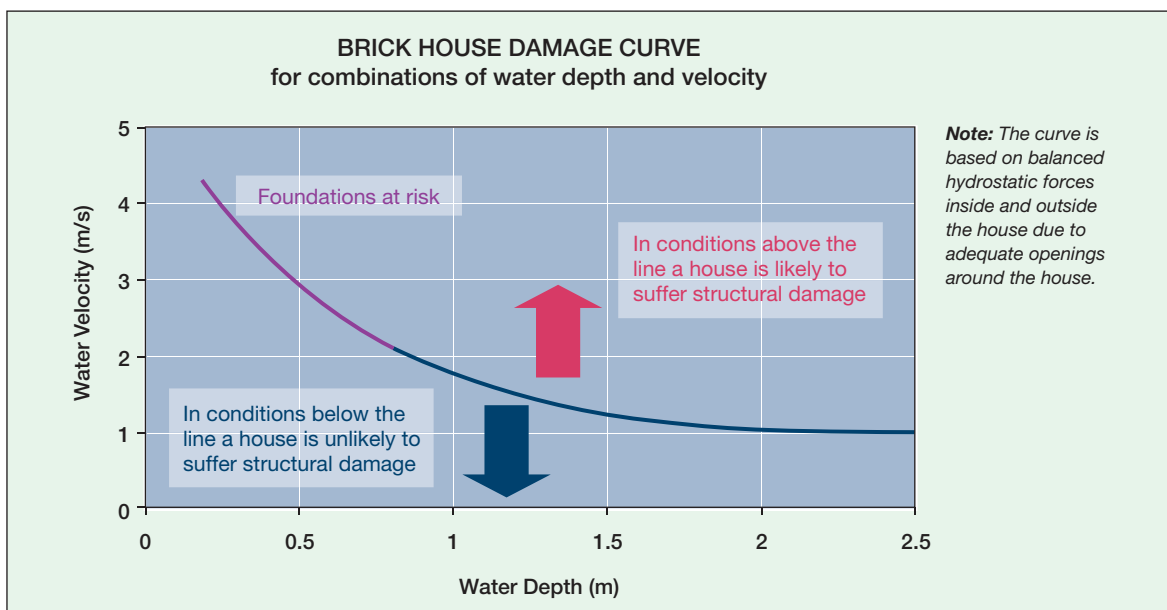
Figure 125 Water velocities may cause severe damage to a brick house

However, as a guide, Figure 125 provides an indication of water depth over the floor and flow velocity which may initiate damage to walls in a typical single storey full brick or brick veneer house.

The hydrodynamic load on the walls increases as the velocity or water depth or both increases. For example, a house with water flowing at a velocity exceeding 1.5 m/s, half way up the wall (or approximately 1.2 m deep) could suffer damage to the cladding and/or frame.

Clearly traditional brick veneer houses have limitations and are unsuitable in locations of high velocity. Consent authorities are likely to prohibit, or at least severely restrict, house construction in areas where local velocities exceed 2 m/s for shallow flooding and around 1 m/s where deeper flooding is possible.

D.2 The Brick House Damage Curve (see Figure 125)

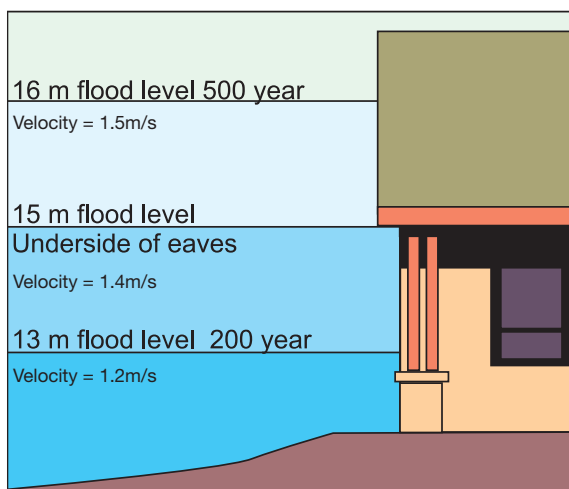
Figure 126 Example of how velocity can be estimated to select a suitable N-classification

Assume there is a site with the following conditions as illustrated in Figure 126:

Furthermore, assume that modelling of the subdivision suggests that the local velocity around the house is about 1.3 times the greenfield velocity. Hence the velocity to be used in Table C.2B is $1.3 \times 1.4 = 1.82$ m/s.

Using the appropriate return period range and water velocity in Table C.2B, the basic N classification that applies is N5.

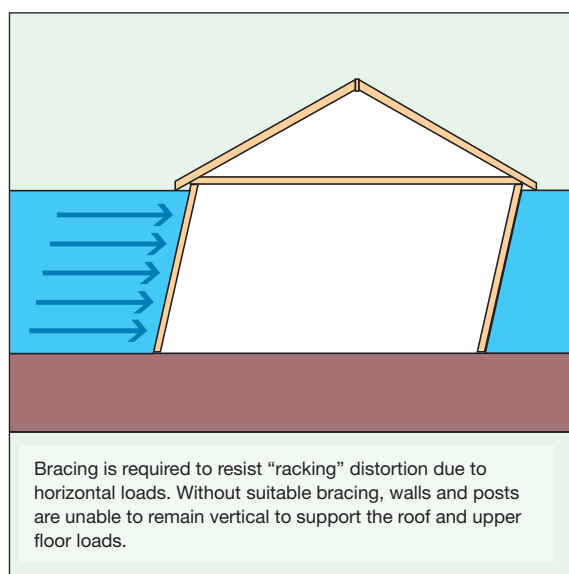
Figure 127 Racking forces on a house

Racking forces are those which occur in walls parallel to the wind or water direction and require wall bracing to resist (Figure 127).

Racking forces can generally be reduced by orientating the house along the water flow i.e. to have the least area facing the flow.

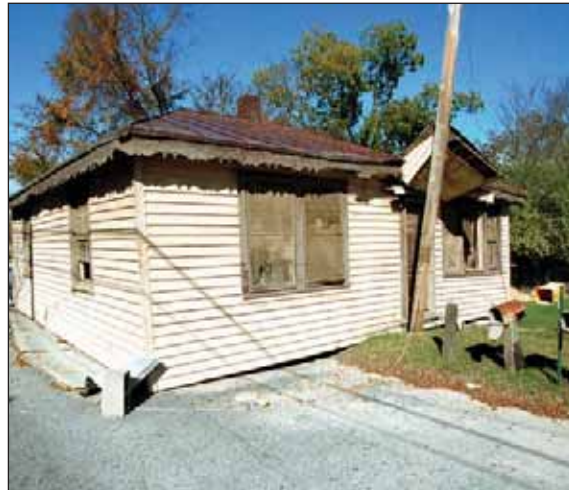
Figure 128 A floated house typical of that assumed for Black's curve

water velocity) required to slide a weatherboard house off its piers as this type of flooded house becomes increasingly buoyant with rising water levels. Figure 128 shows the type and approximate size of the house and failure mode to which Black's curve applies. This curve is very house specific and applies only to a house 32 feet long by 24 feet wide (or 7.7 squares) orientated with its long side facing the flow. Rotating the house 90° significantly changes the water velocity required to slide the house. Also a subsequent report by Cornell University (Sangrey et al) suggests Black's curve underestimates the water force by adopting a lower than usual drag coefficient.

The latter curve principally relates to light structures and considers the flotation of lightweight timber-framed houses from pier foundations. Black's work is based on estimates of the horizontal force (and the associated
